## SEISMIC STRUCTURAL ASSESSMENT OF DAMAGED CHITTAGONG PUBLIC LIBRARY BUILDING DURING 27 JULY 2003 EARTHQUAKE

### ABSTRACT

Seismic structural damage assessment is a part of post earthquake disaster management program. During the Rangamati Earthquake of Chittagong Hill Tracts in July 27, 2003, the only Public Library located at Chittagong was severely affected and undergone various degrees of damages. This paper deals with the physical damages as well as structural strength assessment of the damaged Public Library building. A detailed overview of several seismic damage evaluation documents framed by FEMA 310 has been elaborated and incorporated for seismic structural strength assessment process. Finite element frame analysis is used incorporating Bangladesh National Building Code (BNBC) seismic provisions. The difficulties existing in the structural system planning of the damaged Chittagong Public Library building and design discrepancies are documented and probable suggestive measure are highlighted in this paper.

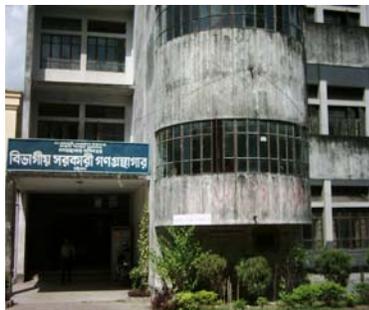
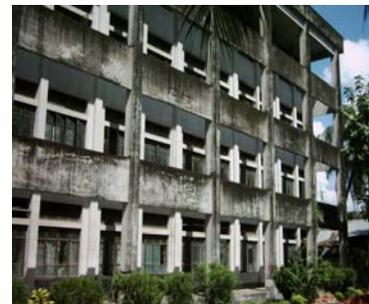
Figure 6: (a) Front view of the damaged building (b) Isometric view of the damaged building

The structural member hasn't sudden change in stiffness along both horizontal & vertical direction, which yields better results to seismic resistance. This building has excessive openings (about 50%) at side masonry walls, which doesn't yield positive results. Hence the corner where the building changes its direction has become seismically vulnerable, as there is a possibility to occur a stress reentrant phenomenon during an earthquake. Although the length of the building is more than 100 ft, no expansion joint is provided in the building. This also makes the structure seismically vulnerable.

Finally the 27<sup>th</sup> July 2003 Rangamati earthquake made the Chittagong Public Library Building, one of the hazardous buildings, in the Chittagong city and any frequent small intensity earthquakes will invite a great disaster. So it is suggested that Chittagong Public Library Building should be announced as abandoned structure without any further delay and need proper strengthening scheme to increase its seismic demand strength to protect human lives in future.
