Recent Topics related to Seismic Safety of Dams

Tatsuo OHMACHI

Professor, Tokyo Institute of Technology

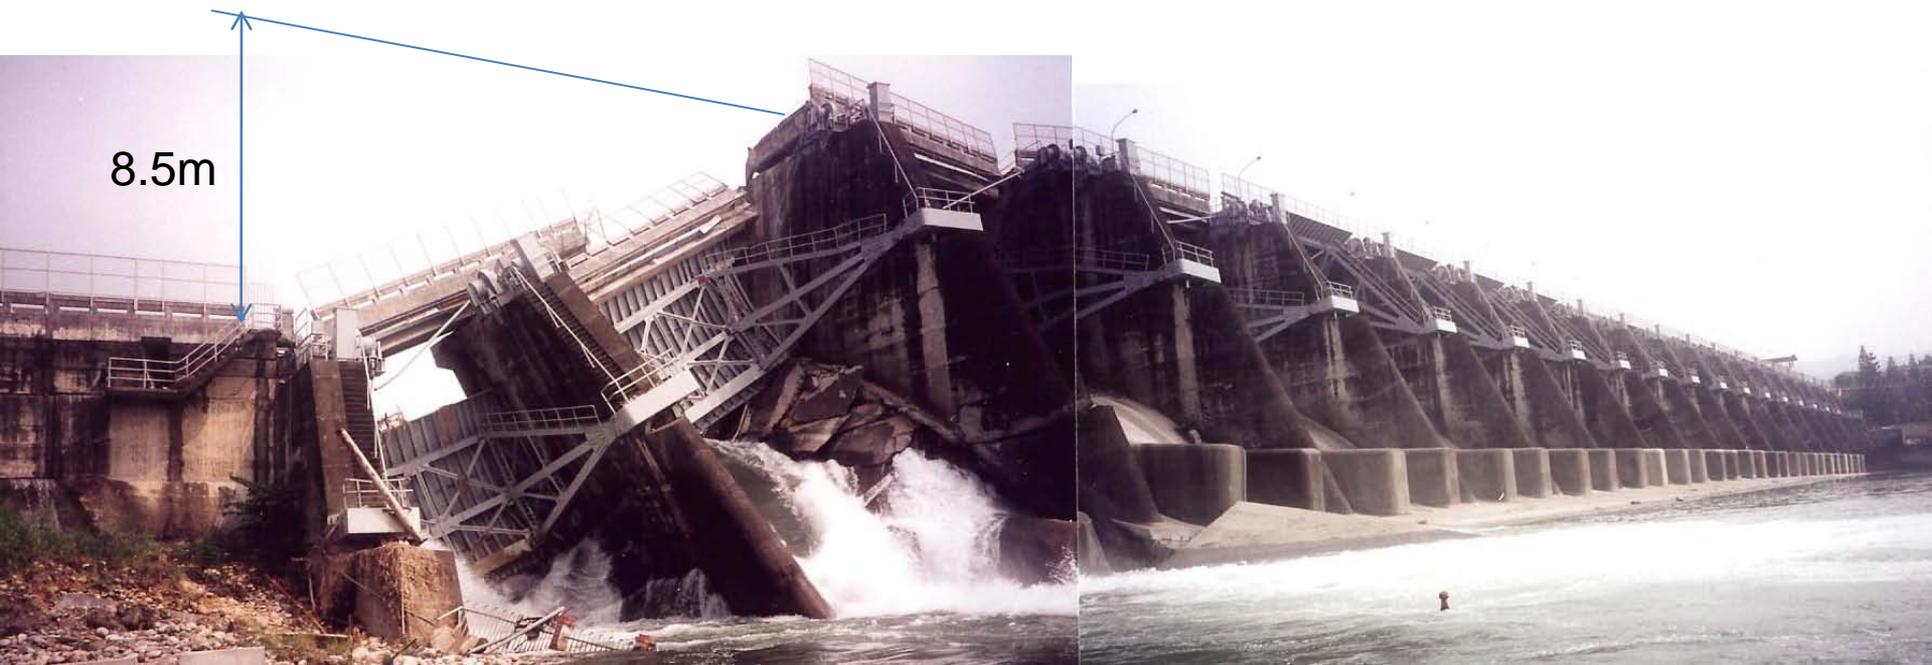
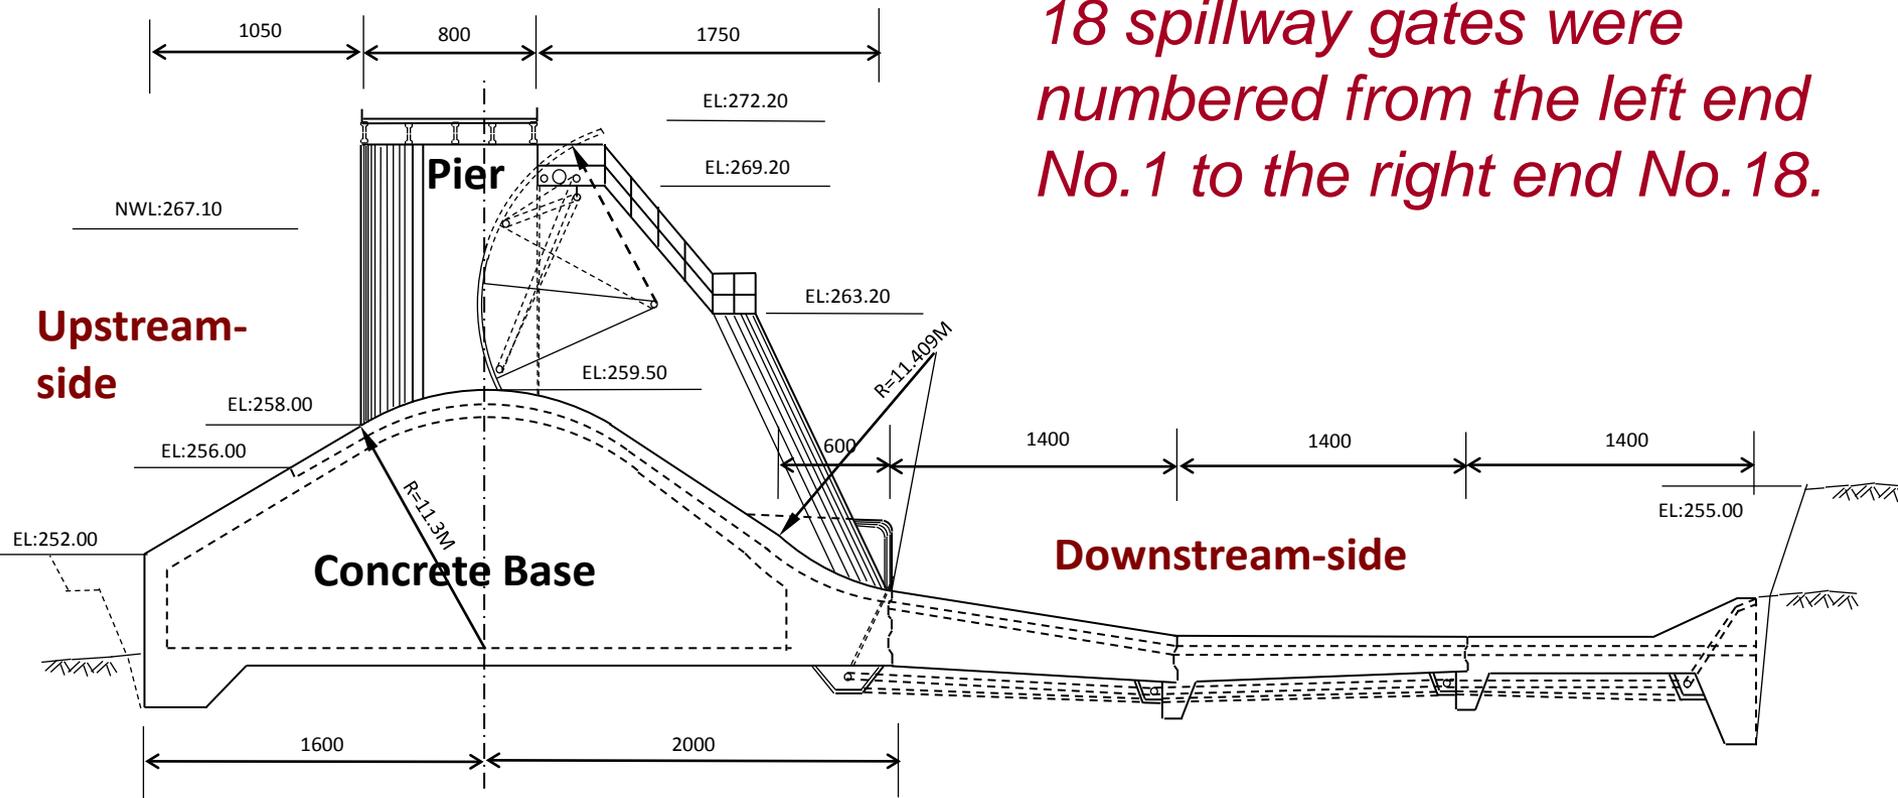
- The dam was a 357 m long concrete gravity dam, equipped with 18 spillway gates and 2 sediment flushing gates.
- **Mainly due to seismic faulting crossing the dam foundation, the right half of the dam was crushed to pieces, and offset about 8.5m**
- No casualty was reported, as a result of the dam break.

Vertical and horizontal cracks were found, here and there, on the surface of concrete base and piers.

Shih-kang Dam was restored and has been in use still now.

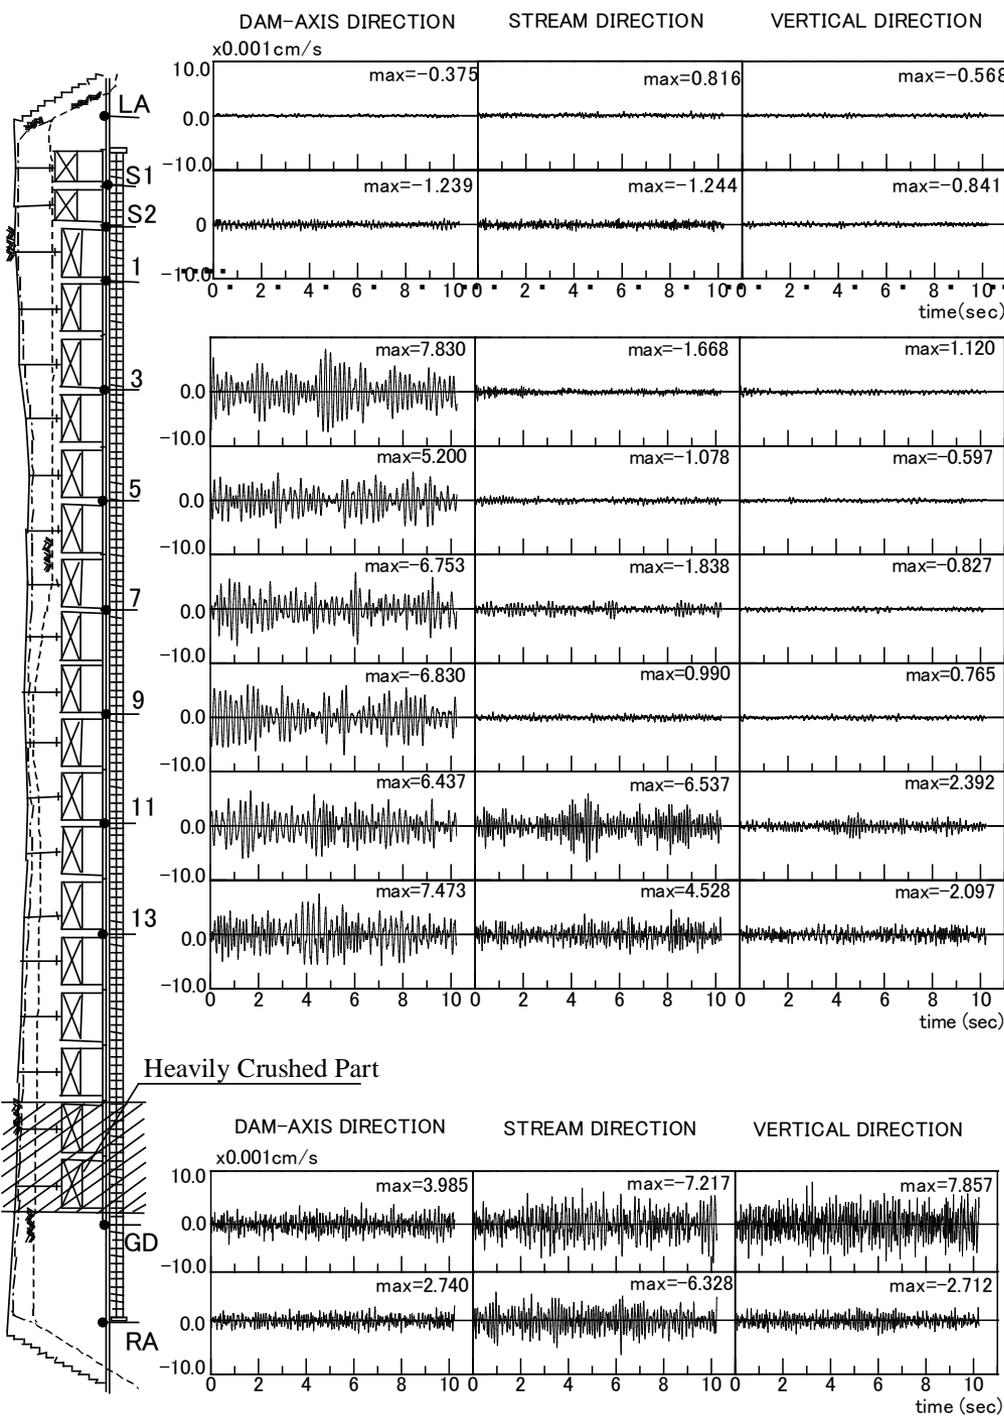
**Micro-tremors Observed
 after the 1999 Earthquake
 (1st Measurement)**
 (max=1 is 10 μ m)

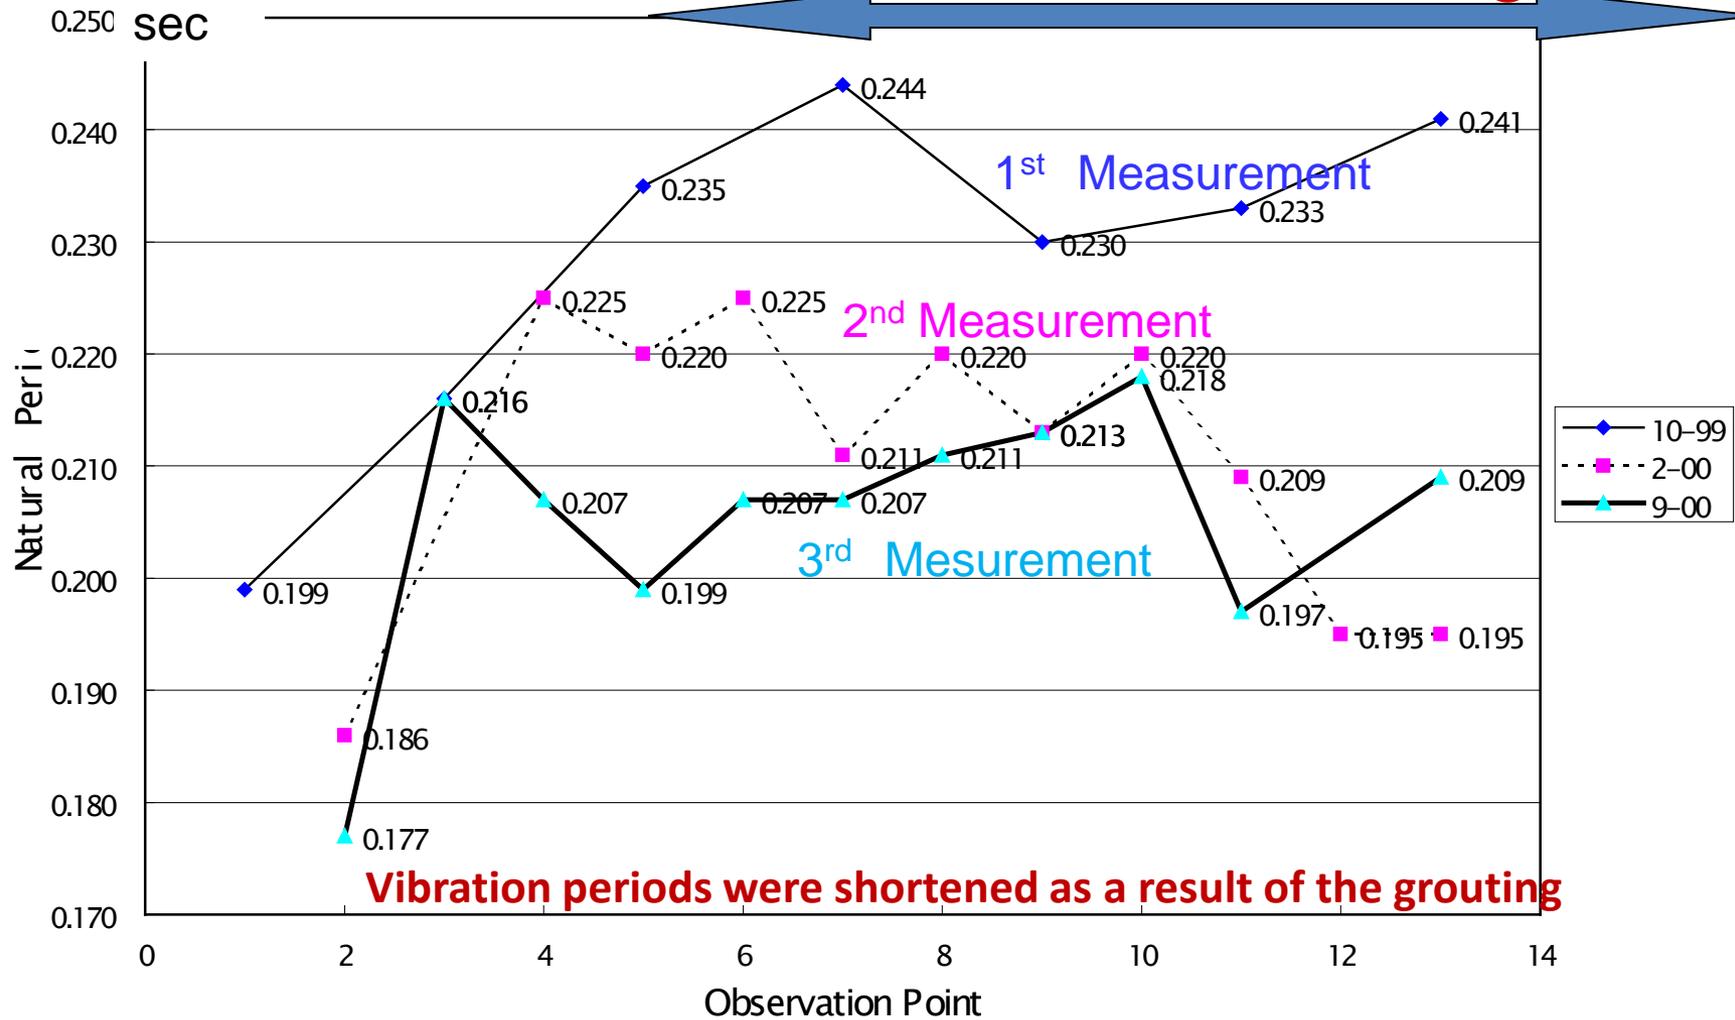
Vibration period distribution along the dam axis

Severe damage

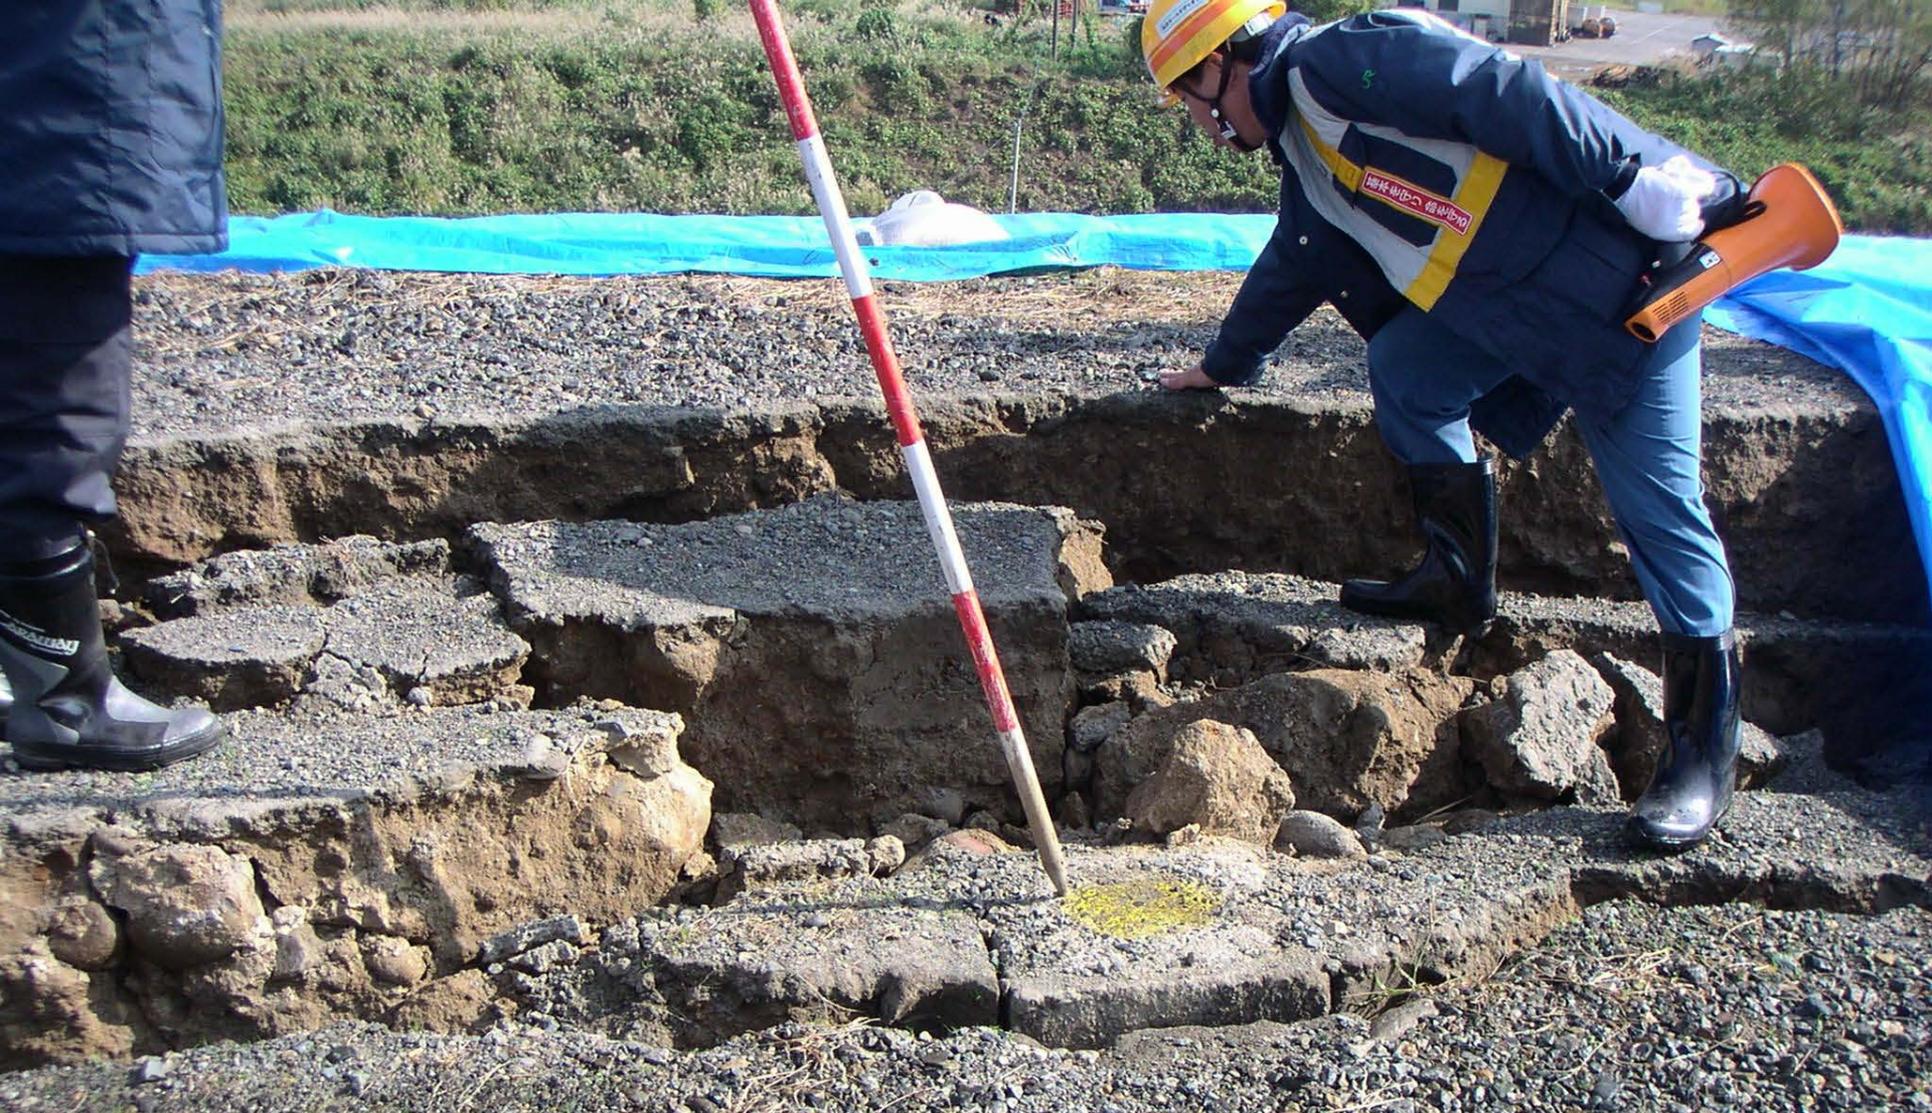
Cracks along the crest of Asagawara dam which is a 37m-high zoned fill-dam constructed in 1945.

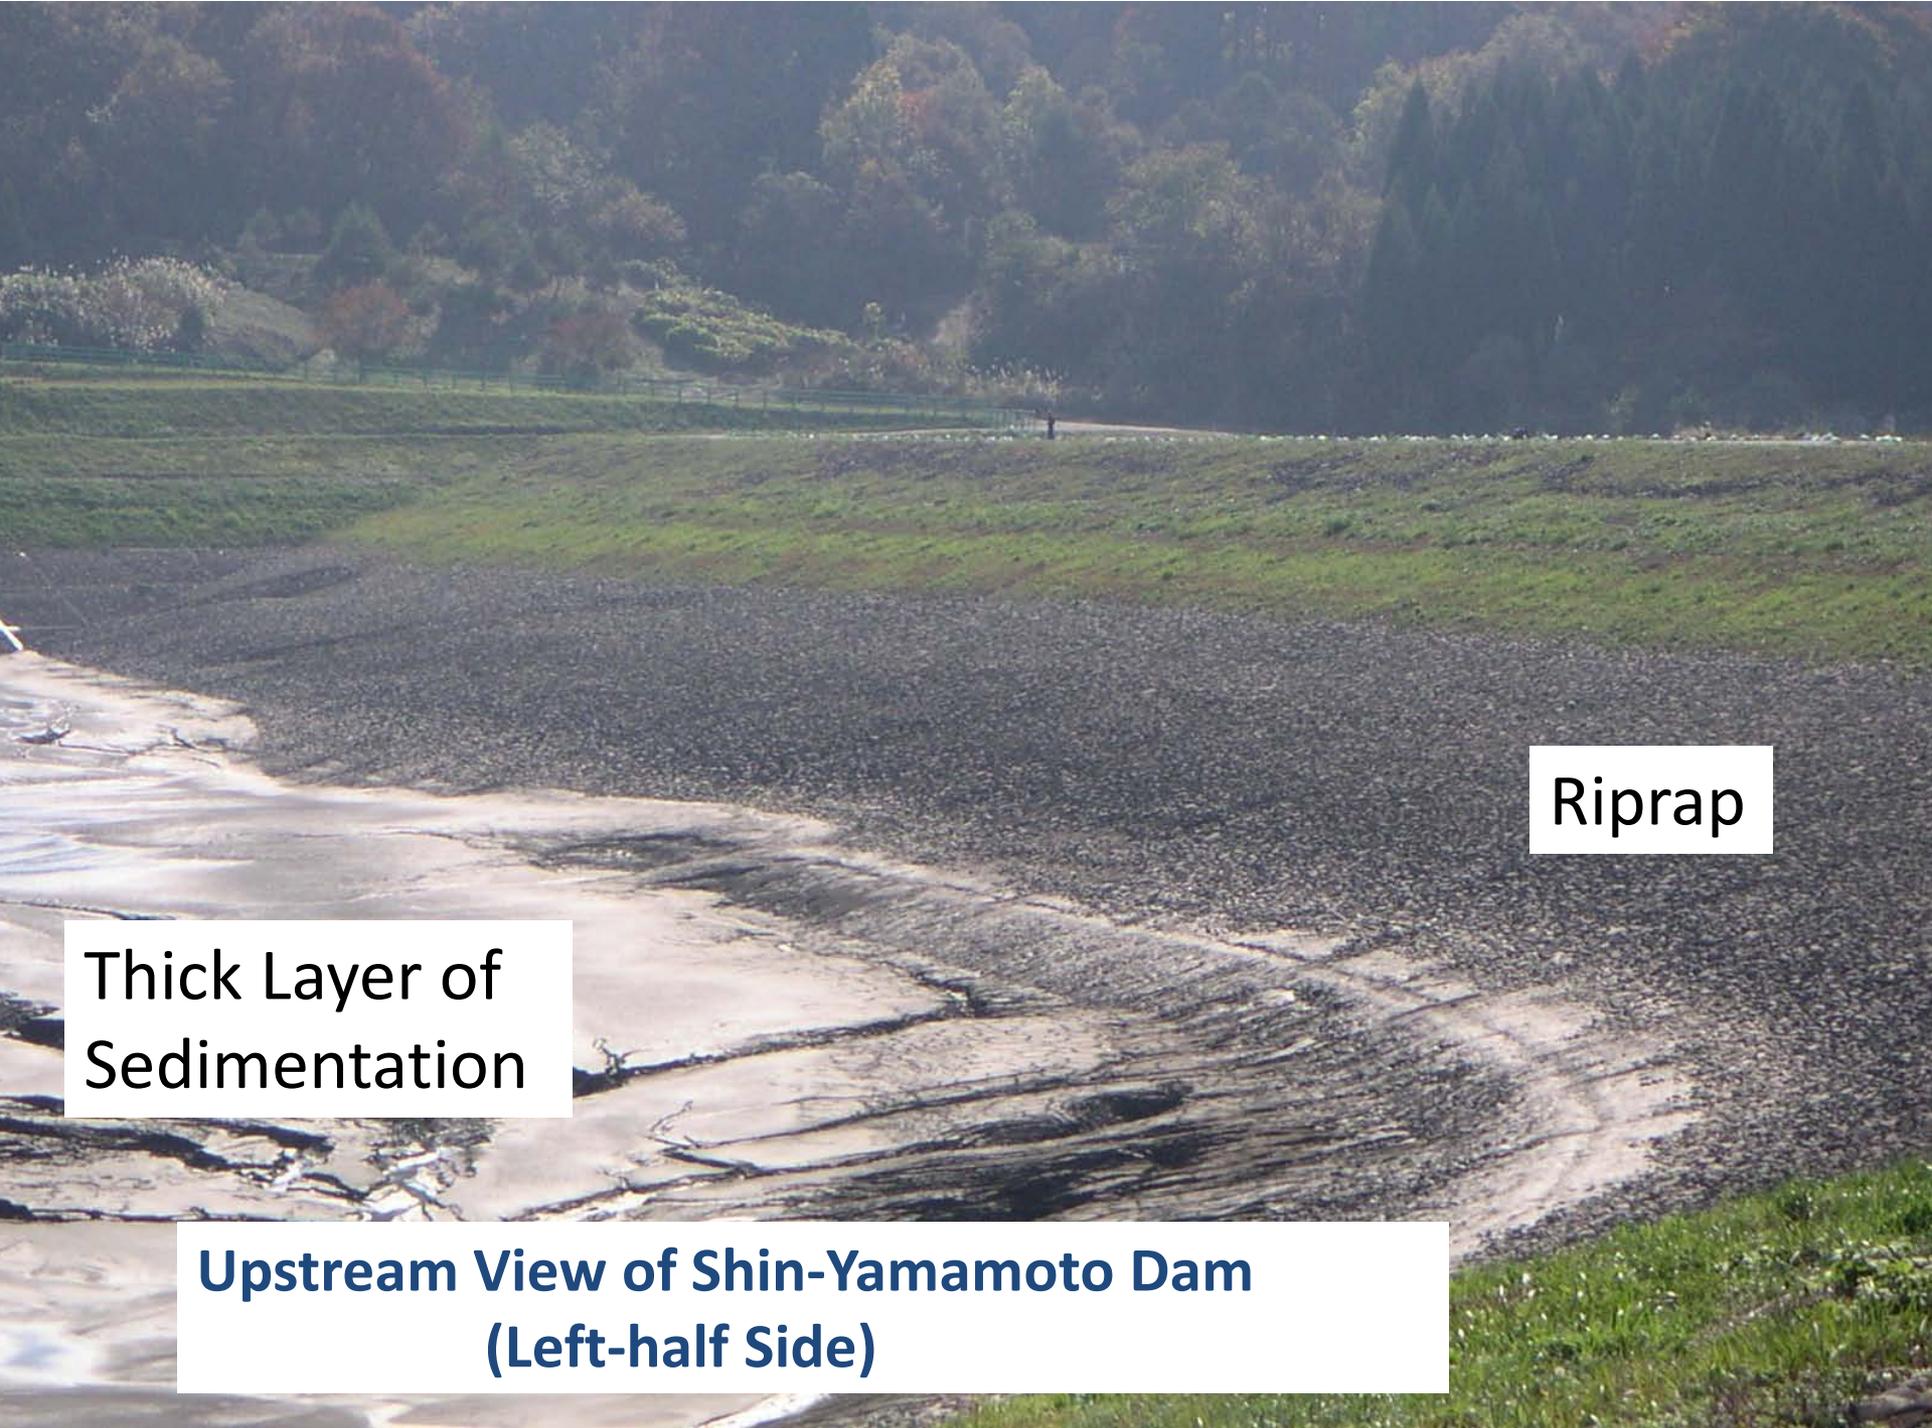
**Upstream View of Shin-Yamamoto Dam
(Left-half Side)**

Thick Layer of
Sedimentation

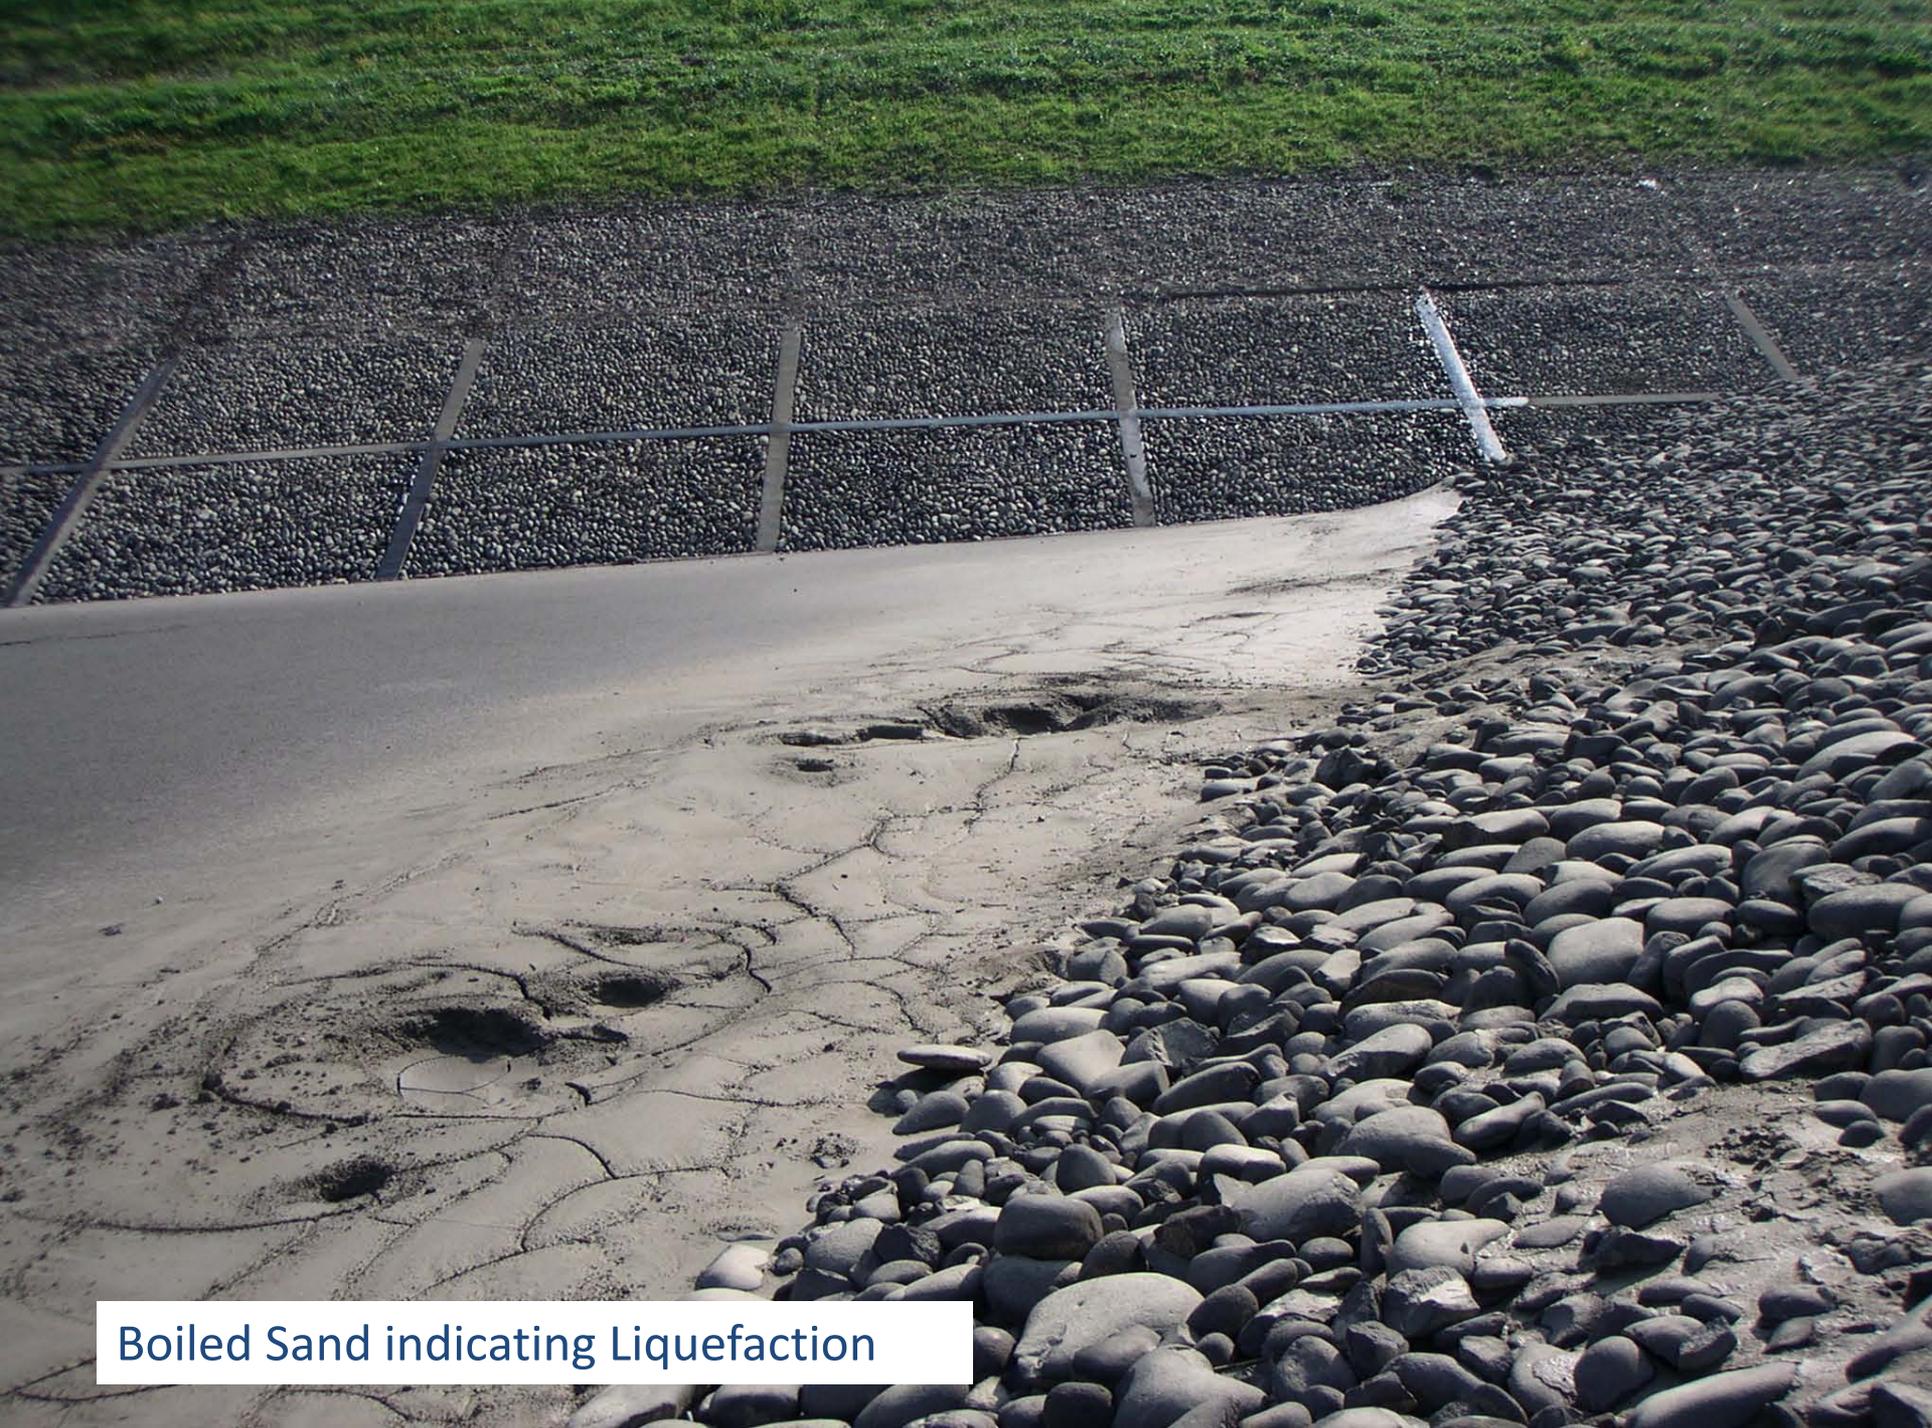
Boiled Sand indicating Liquefaction

This dam was restored by removing loosened/liquefied portions followed by re-banking with good materials and careful compaction.

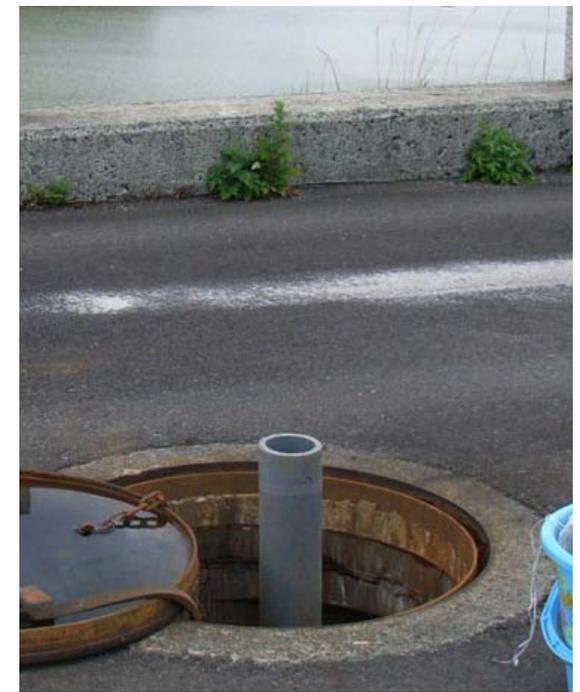
40cm settlement of the dam crest
Fortunately the dam escaped serious damage

40cm Settlement

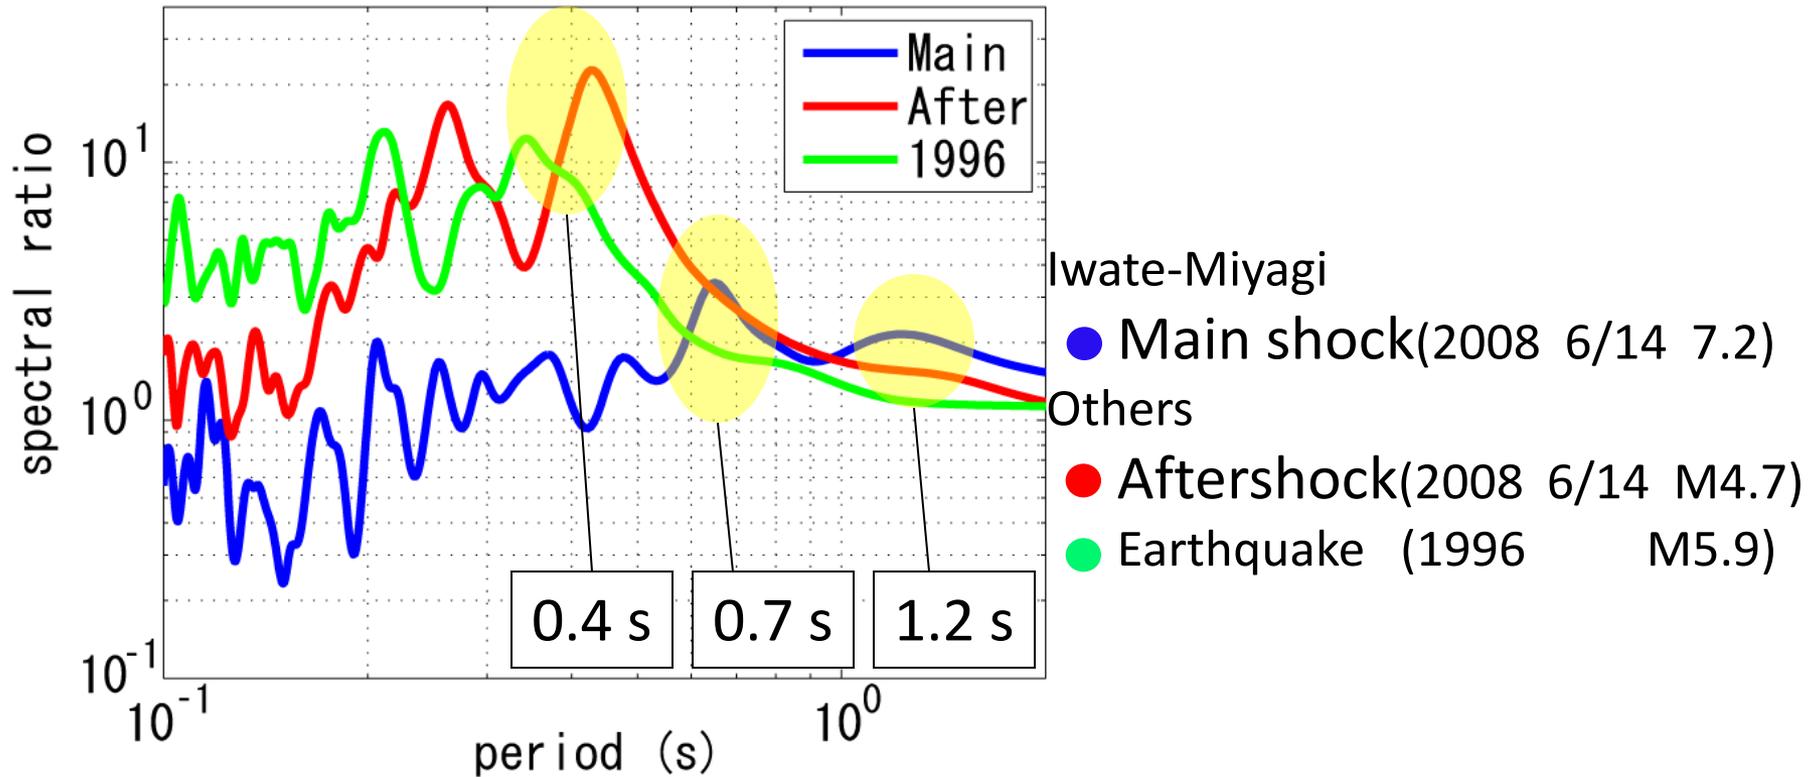
Transfer Functions of the dam

The peak period of the dam was 0.7sec/1.2 sec during the main shock and about 0.4sec in other smaller earthquakes.

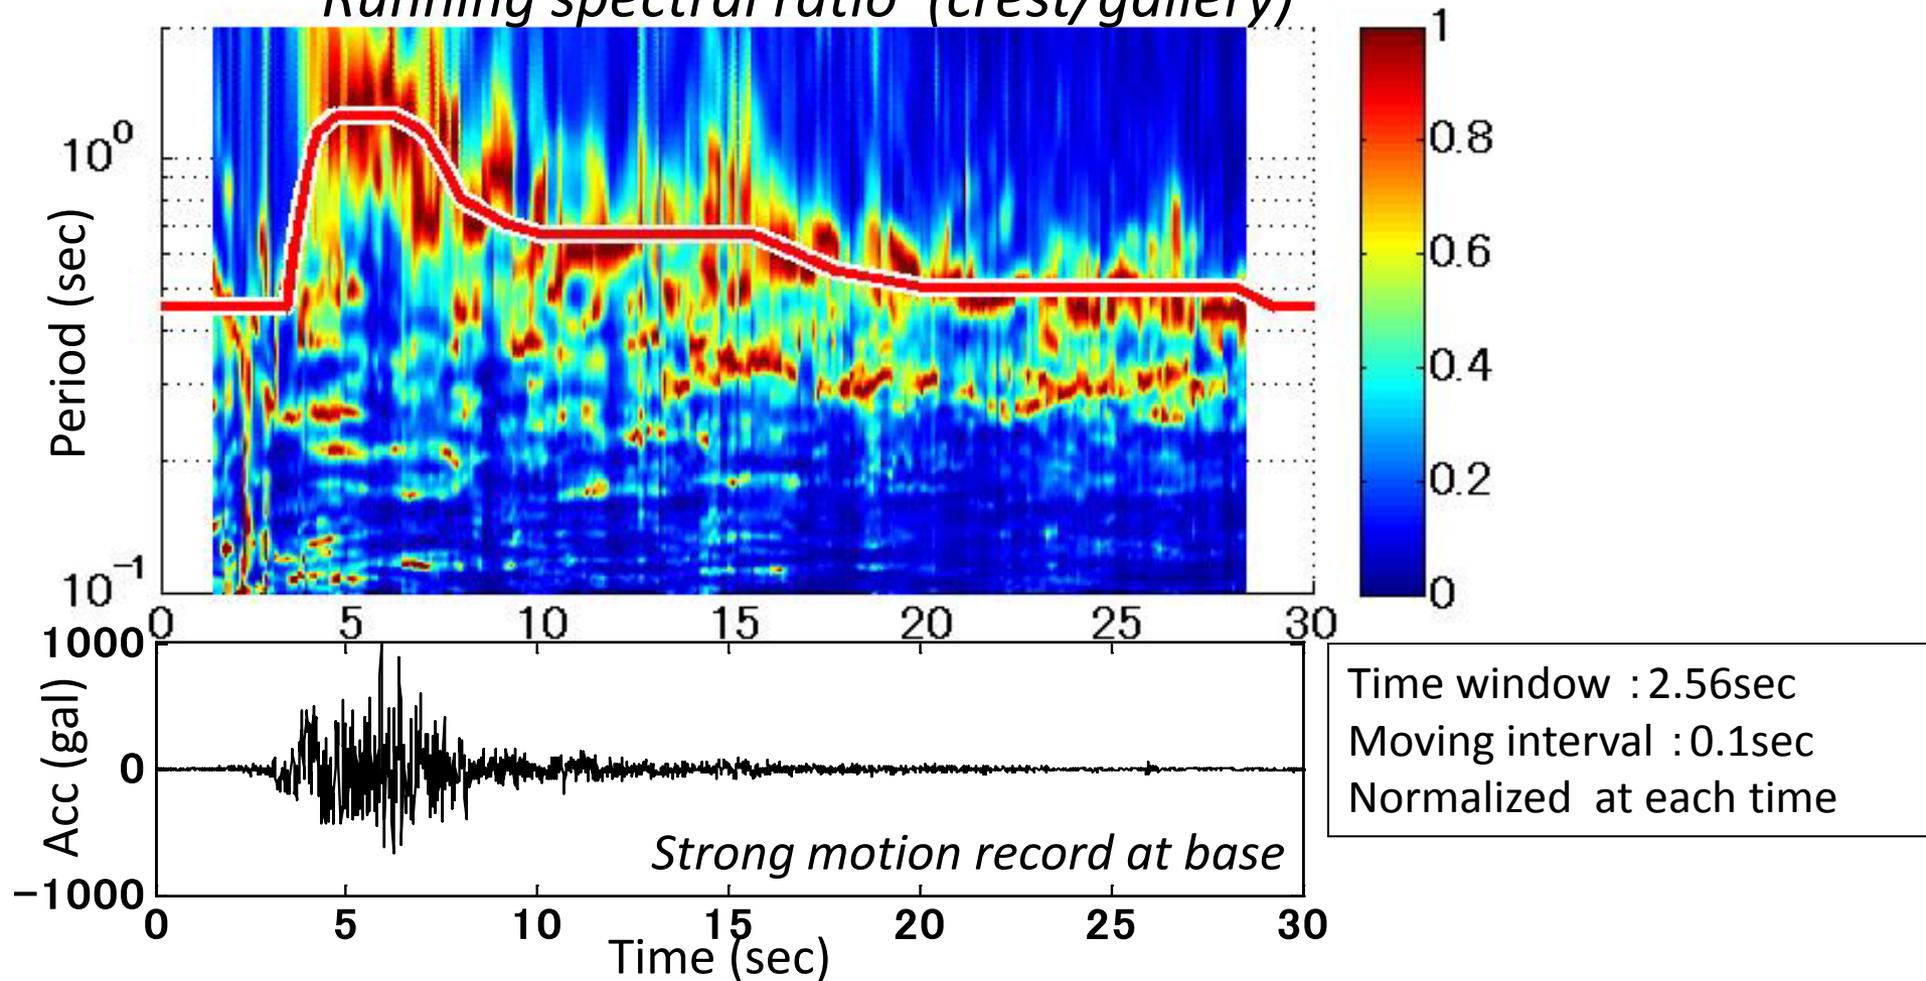
Running spectra during the main shock

The peak period was first 0.4 sec and suddenly elongated to 1.2sec by strong shaking and later shortened again to 0.5sec.

This is evidently the nonlinear response of a rockfill dam.

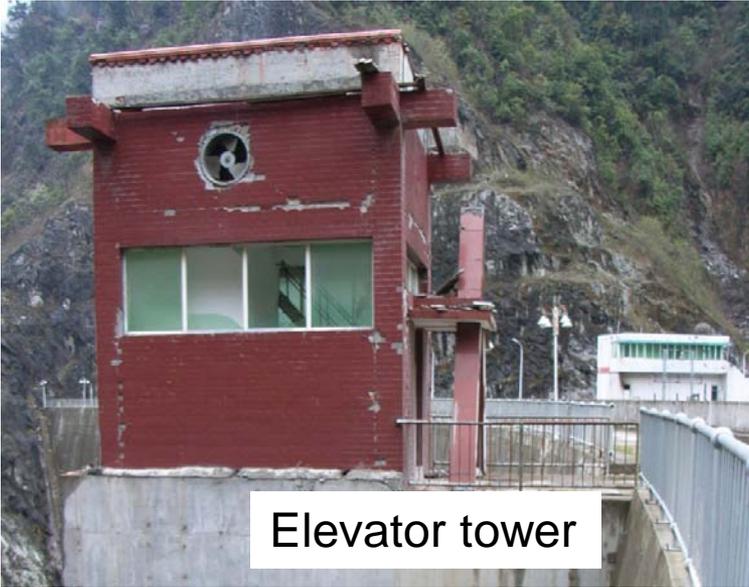
Elevator tower

No damage to dam body,
but some damage to
spillway, elevator tower,
plumb line, etc. **Moreover,**

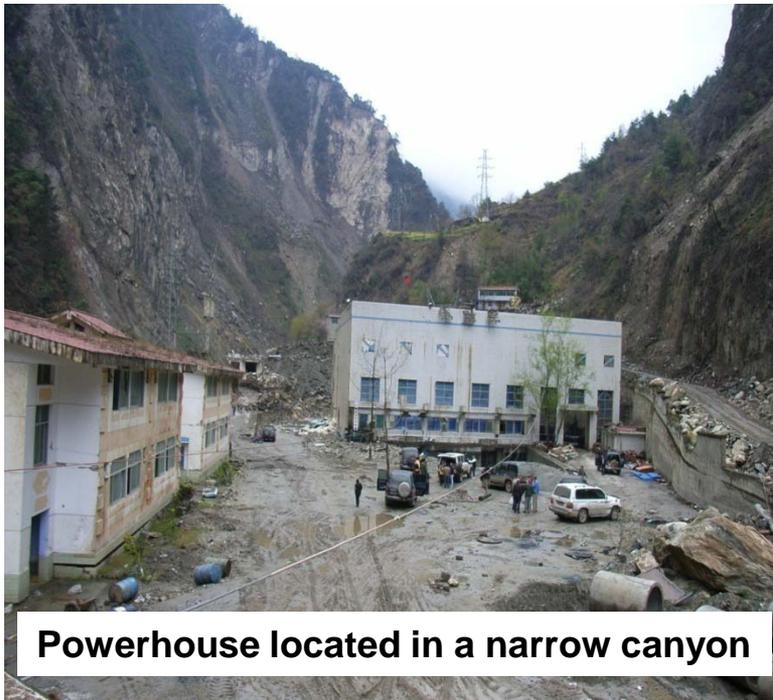
Shapai powerhouse was severely damaged mainly due to landslides.

Powerhouse located in a narrow canyon

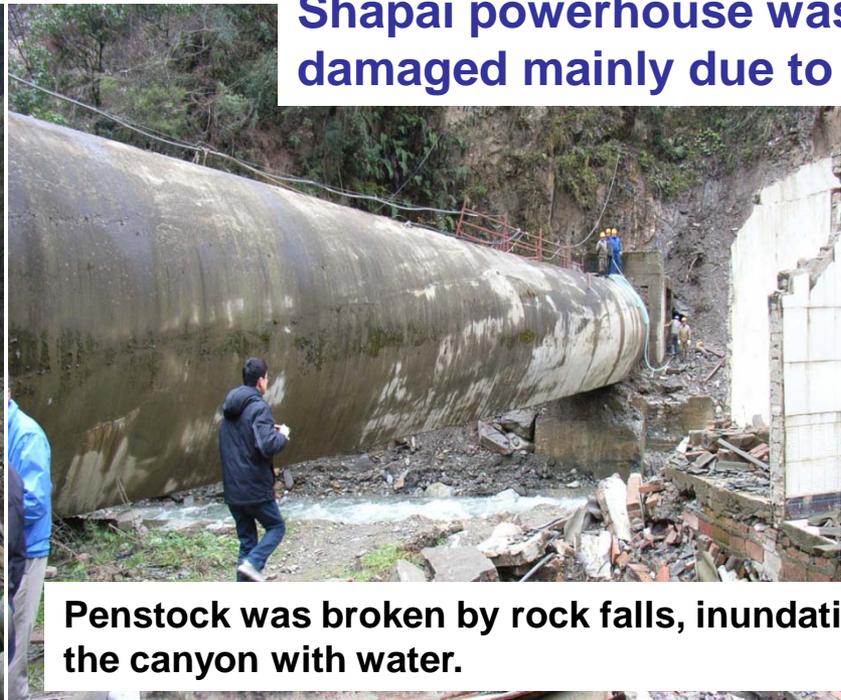
Penstock was broken by rock falls, inundating the canyon with water.

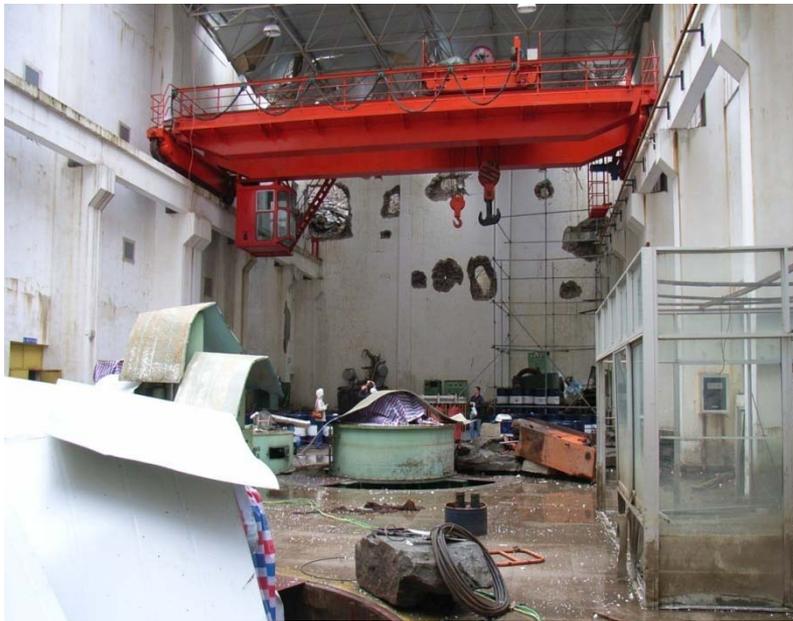
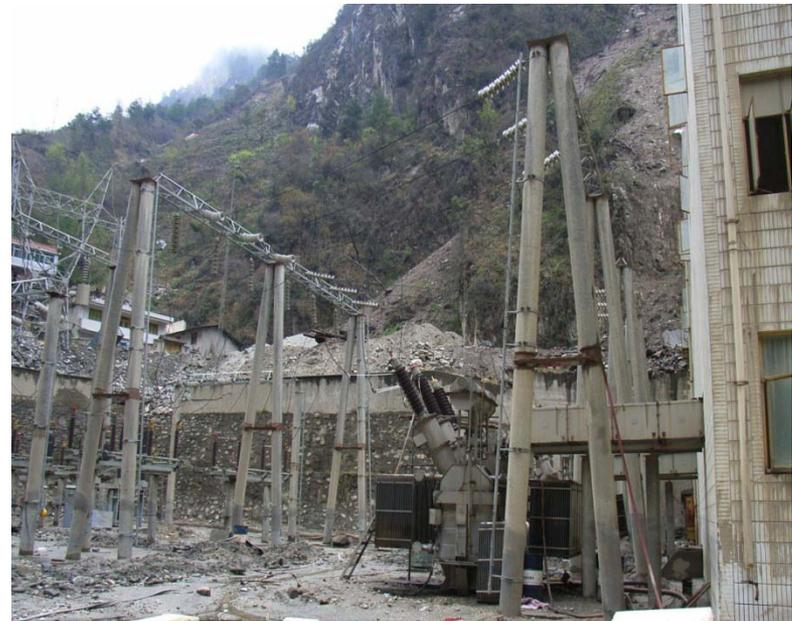
Inundated powerhouse (left) and switchyard (right)
