Estimation of earthquake resistant and earthquake proof for distribution system on Hachinohe Regional Water Supply Authority

Noboru Murakami

Hachinohe Regional Water Supply Authority
(HRWSA)

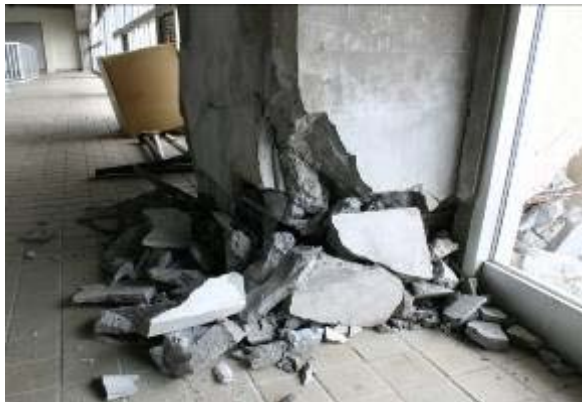
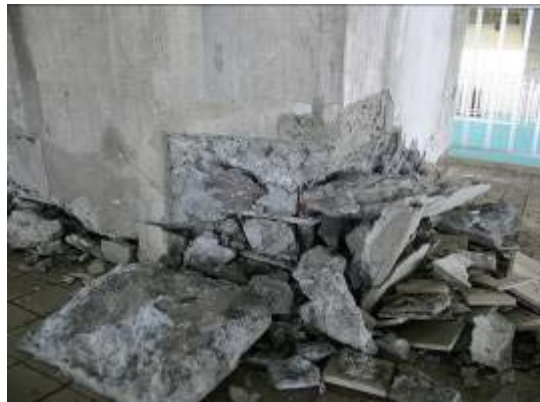
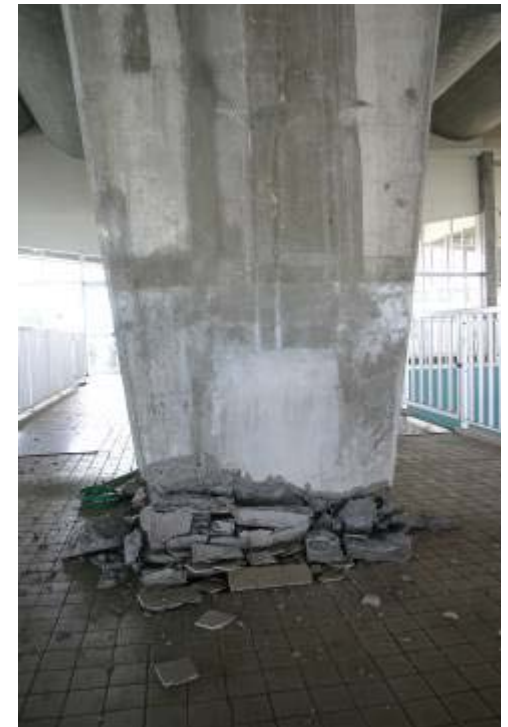
- Quake-proof diagnosis
 - ➡ Necessary of seismic reinforcement
 - ➡ Conduct reinforcement work (May, 2008)
- Engan Hokubu earthquake of Iwate prefecture occurred in July 24, 2008. (JMA magnitude 6.8)
- 3 columns were damaged.

Pic. 3 columns damaged

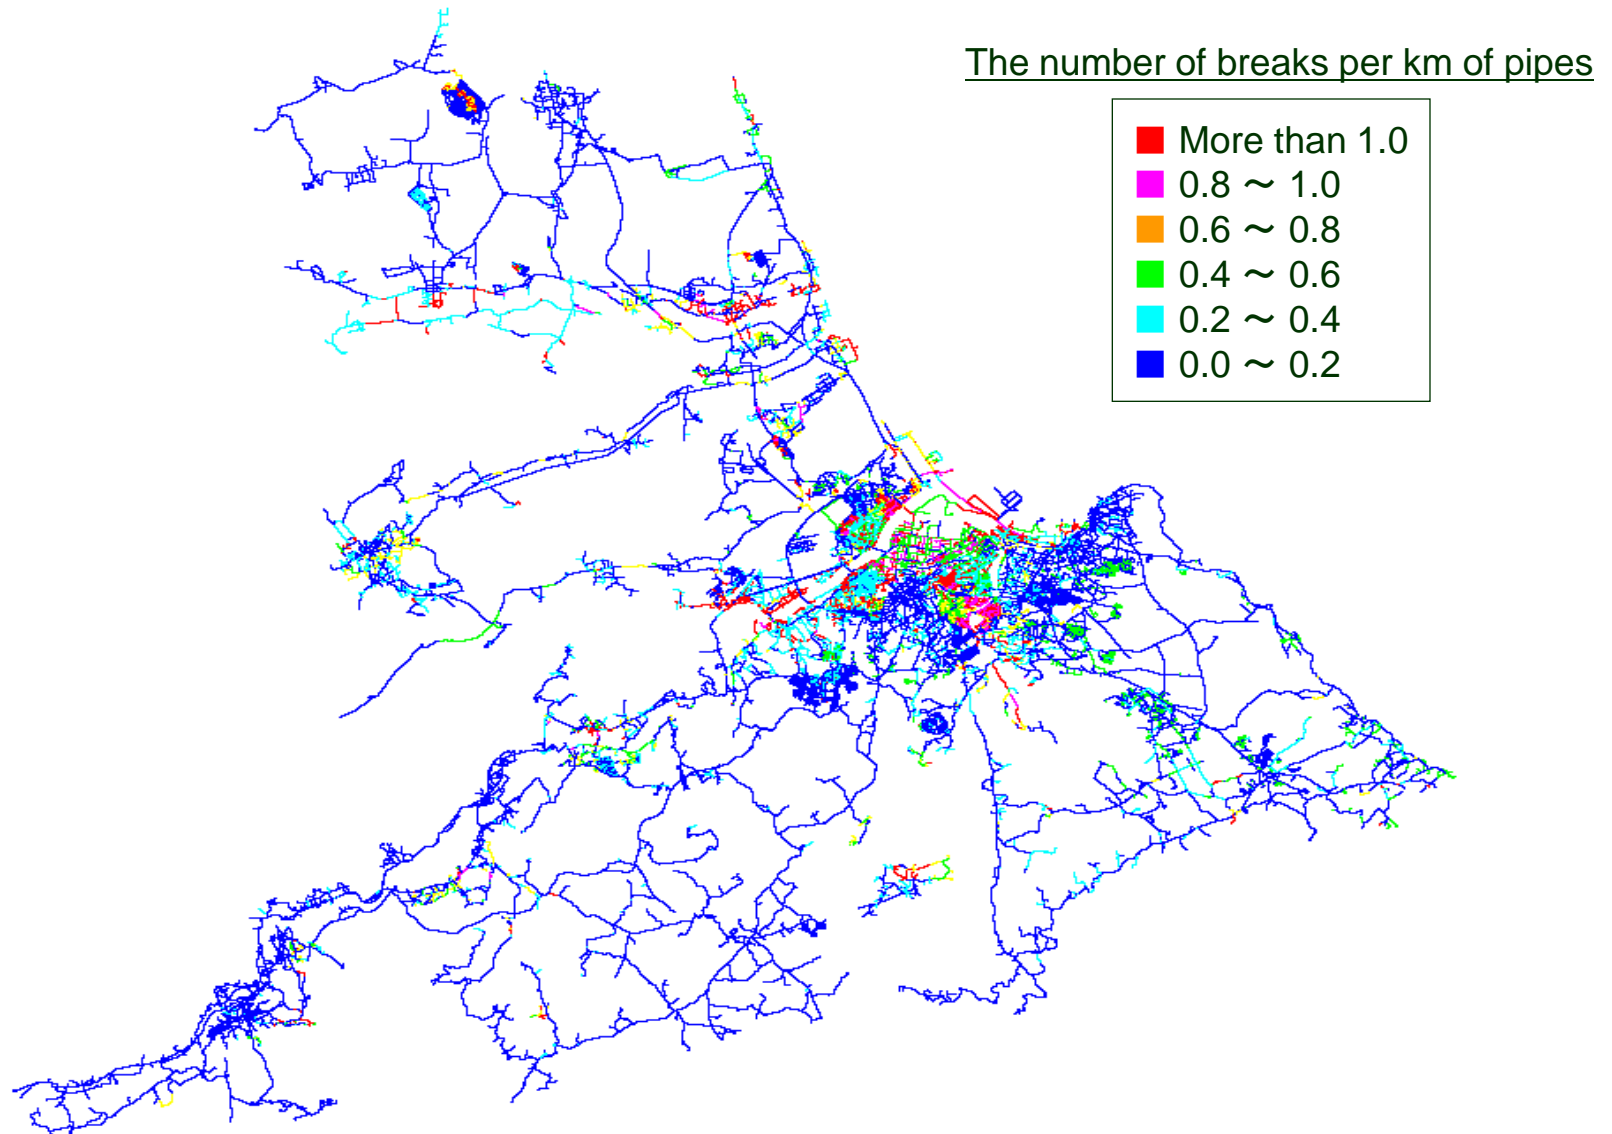
Distribution map of pipe breaks

Earthquake	PGA (gal)	Ave. Damage rate (breaks / km)	Number of breaks
Scenario pacific-side ocean trench earthquake	675	0.31	708
Sanriku Harukaoki Earthquake (1994)	602	0.06	113

Pipe material	Ave. Damage rate (breaks/km)	Number of breaks
ACP	0.49	30
CIP	0.51	9
DIP (Not seismic joint)	0.17	277
PP	0.33	58
SGP	1.08	14
SSP	0.00	0
PVC	0.76	315
Others	0.63	5

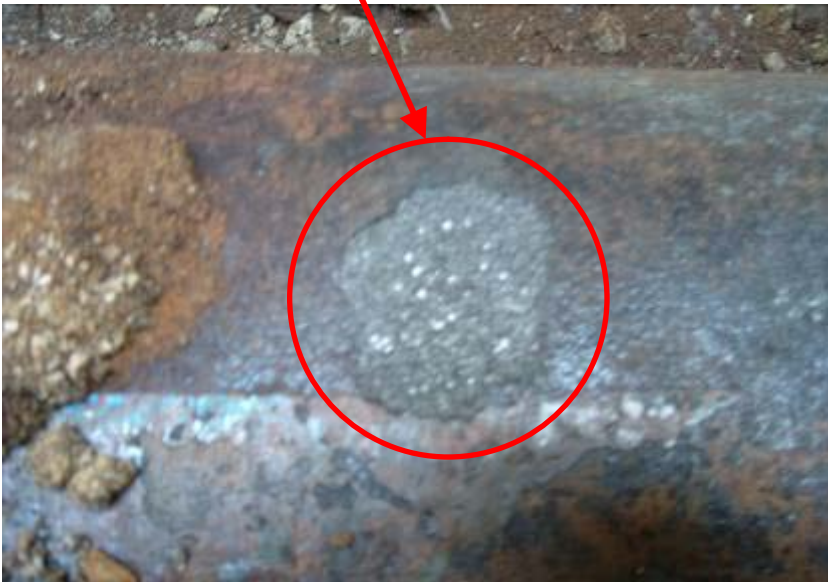
DIP ϕ 200 (installation in 1973)

Corrosion depth 1.2 mm

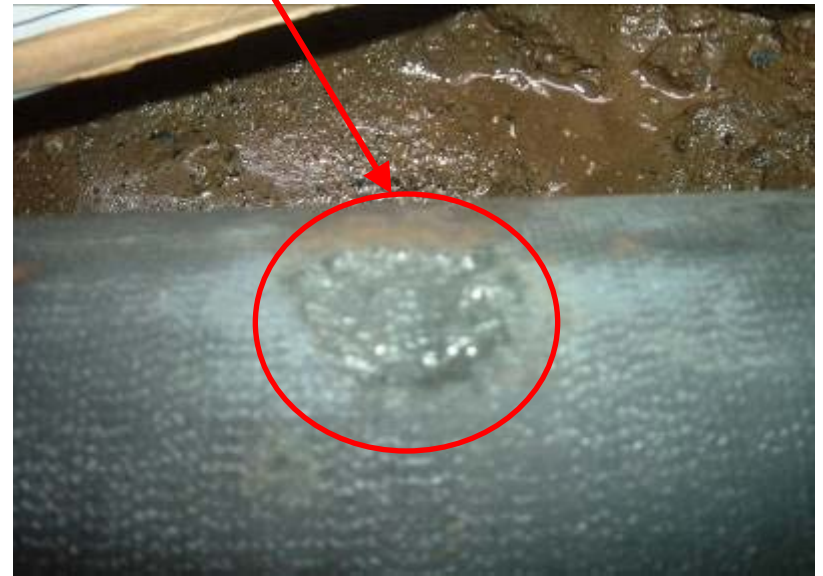
DIP ϕ 100 (installation in 1979)

Corrosion depth 1.4 mm
