Observed Structural Bridge Damage from M_w 7.8 Earthquake in Southern Turkiye (Turkey) and Model for Nonlinear Time-History Analysis

Prof. Robert K. Dowell, Ph.D., P.E.
Director, Structural Engineering Laboratory

Structural Engineering Reconnaissance Team (Mountain Goats)

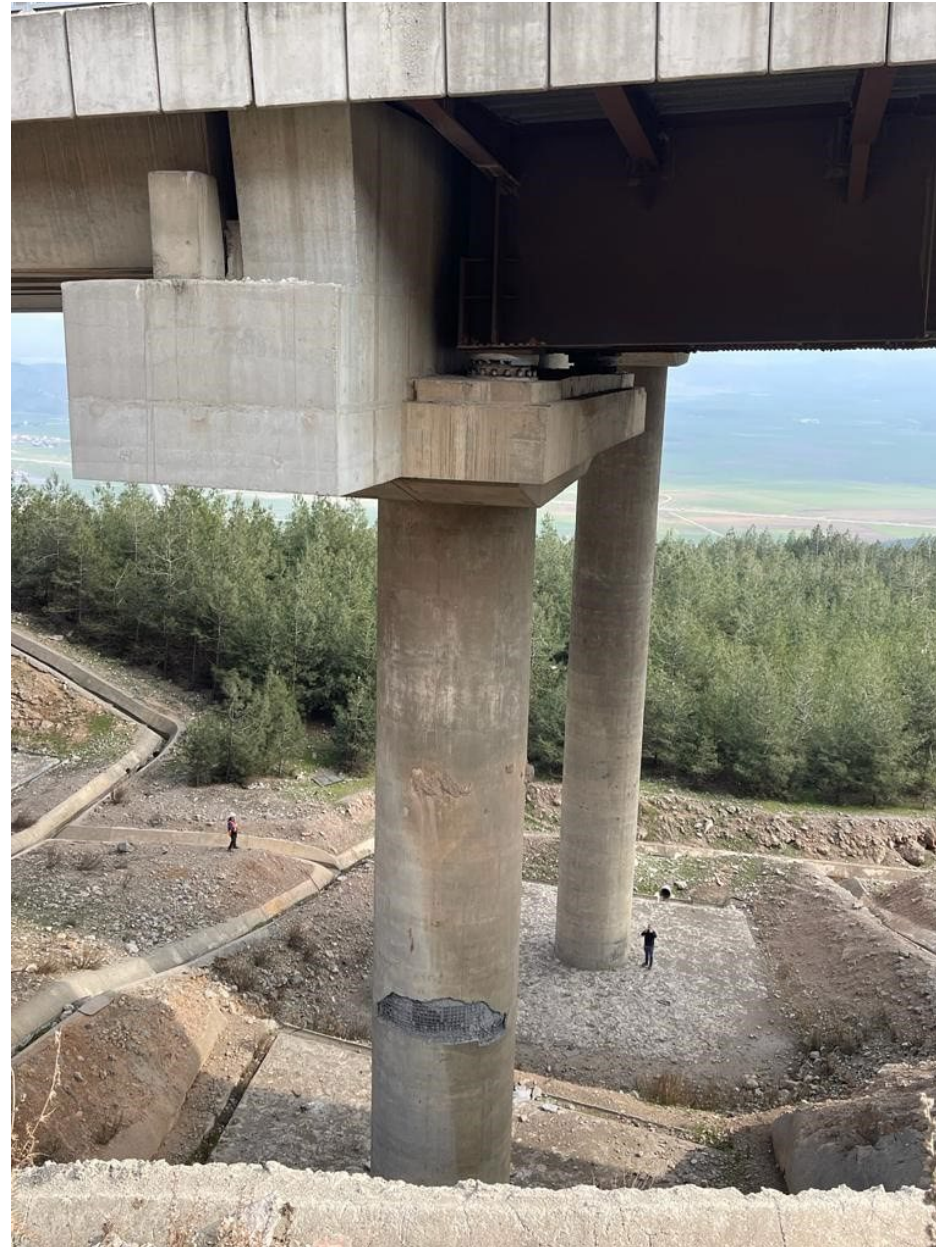
Bridge 1, 10' Diameter Cantilever RC Columns, about 80' Tall

***Plastic hinge formed
about 25% up the column
height***

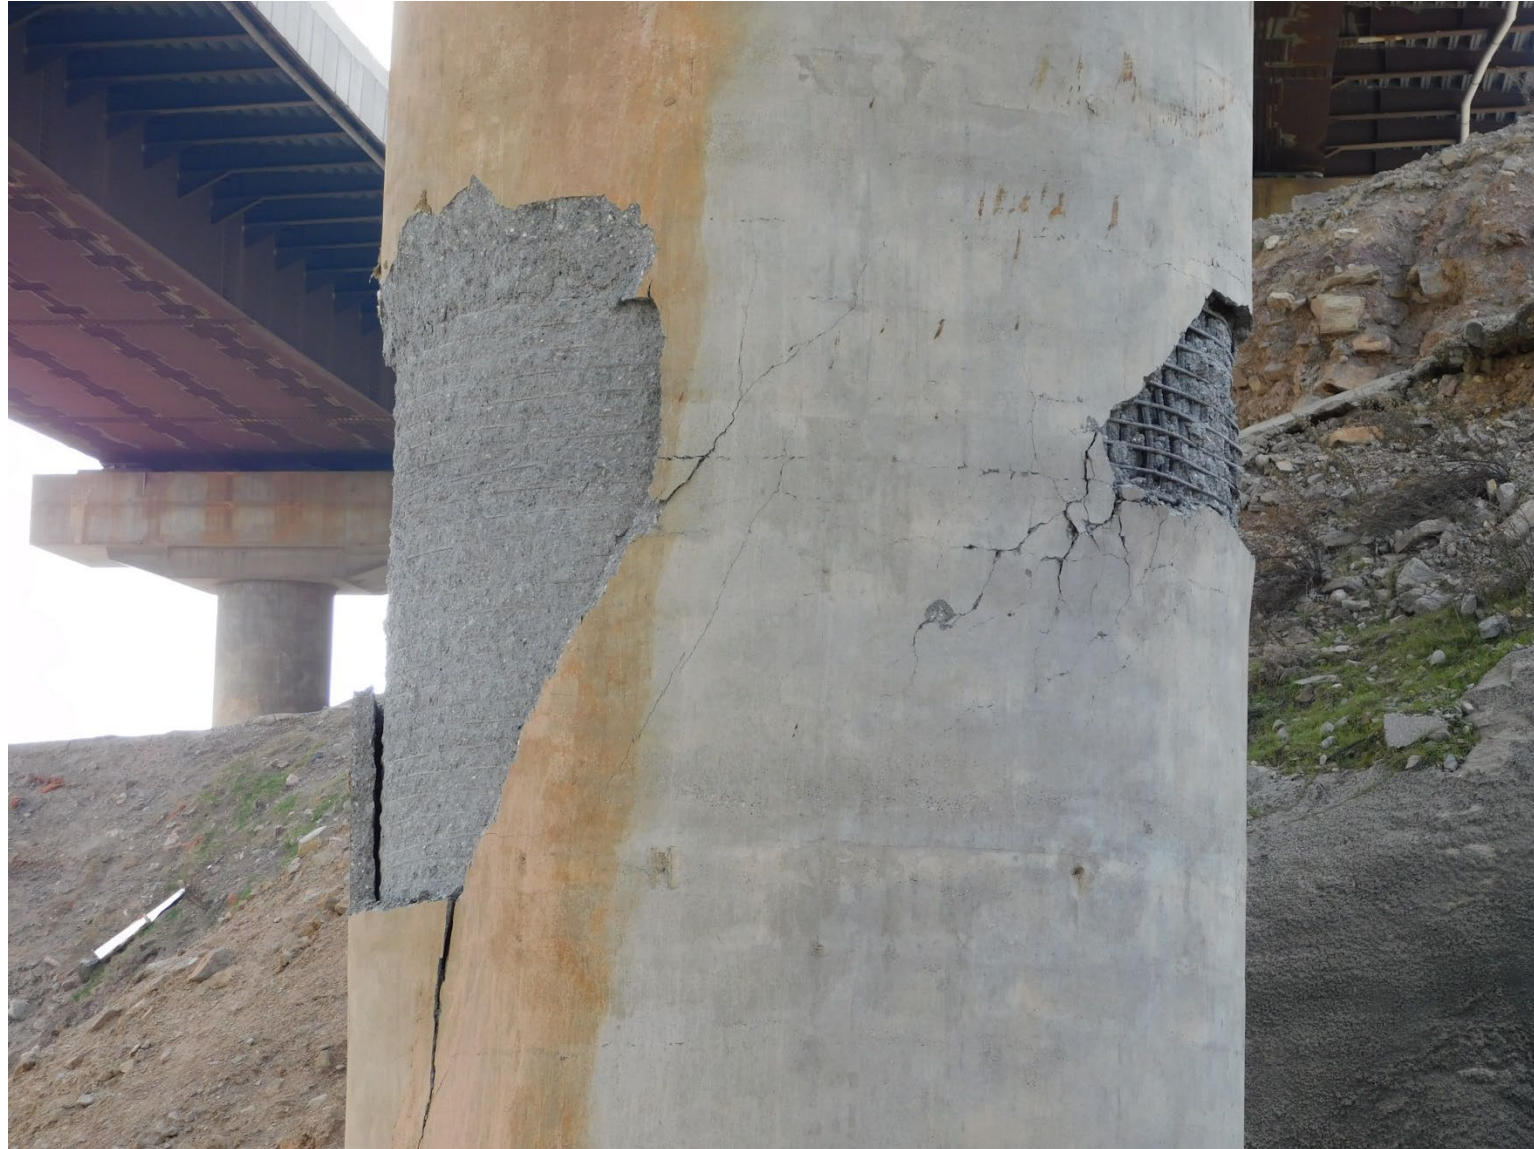
Bridge 1, Side View of Plastic Hinge

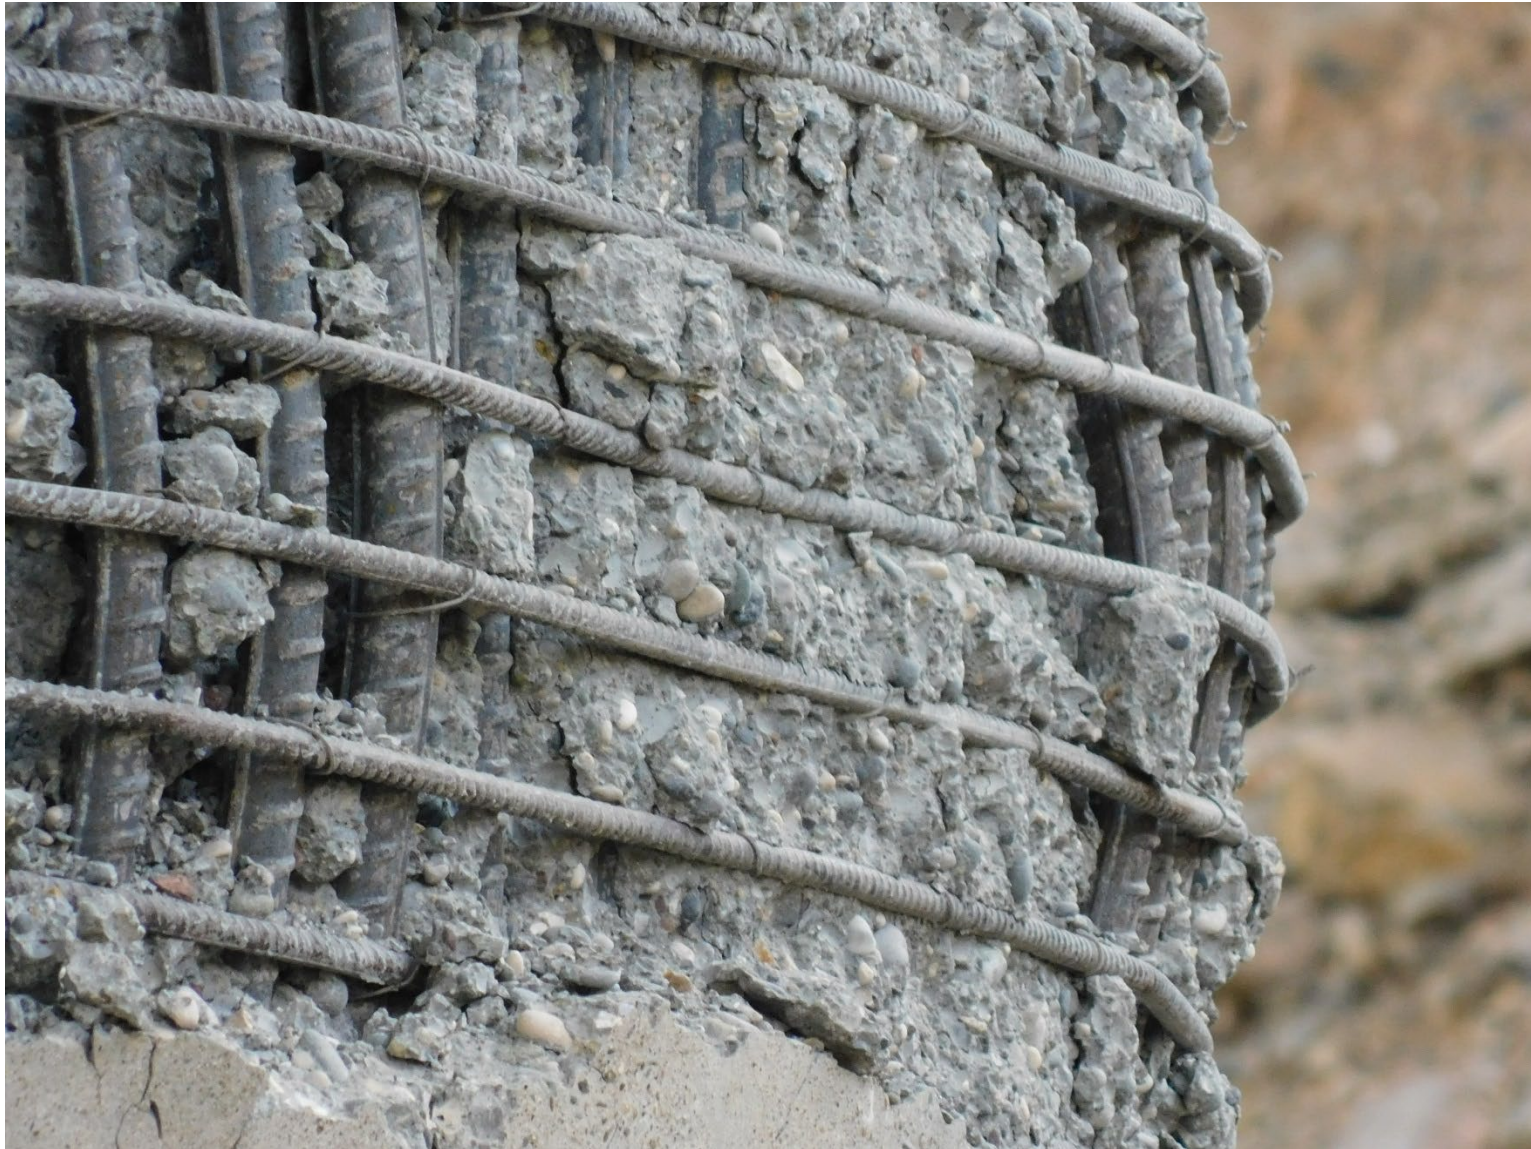
Bridge 1, Close-Up of one side of Plastic Hinge

***Vertical Rebar Buckled,
Transverse Rebar
Yielded and Deformed***

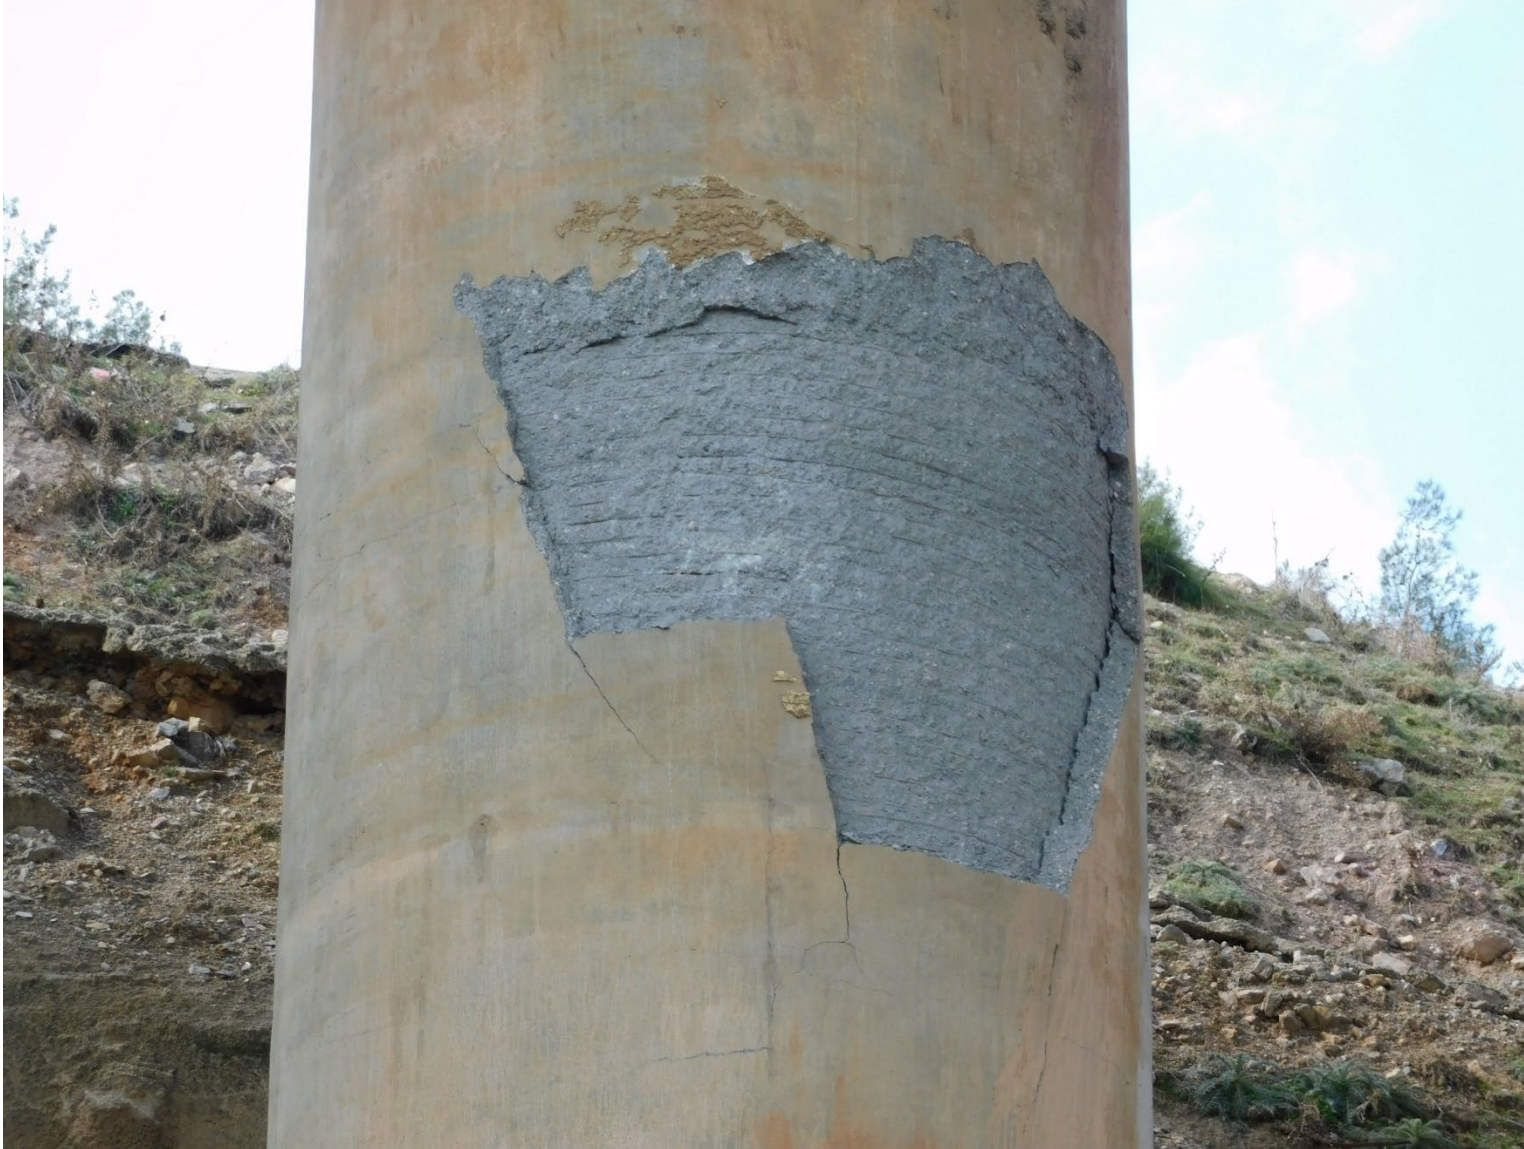
Bridge 1, Opposite side of Plastic Hinge, Spalled Concrete only

***No Rebar Buckled, and
Transverse Rebar not
Deformed***

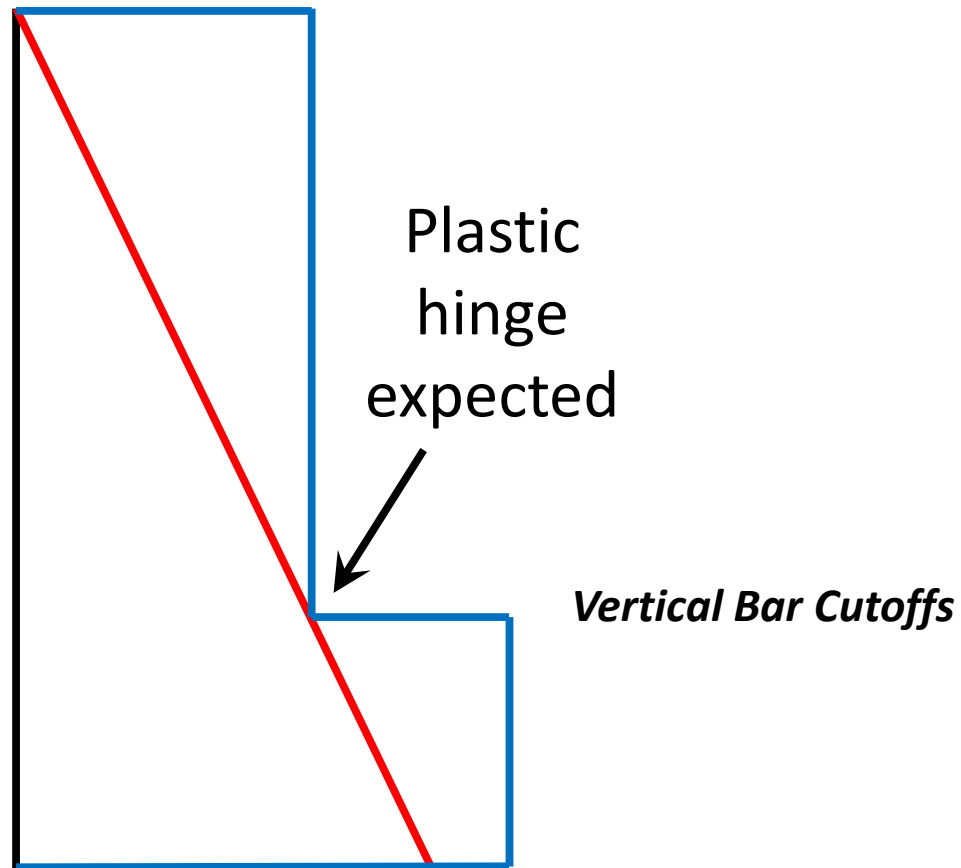
Bridge 1, Plastic Hinge not at Base of Column

- Moment Capacity
- Moment Demand

- Unusual bridge damage of column plastic hinge part-way up cantilever column and degradation at precast girder ends
- On-going nonlinear bridge analysis – with model as shown. Based on results from this global beam and shell model, a detailed 3D Finite Element model will be developed of just the girder end region
- Recommend physical testing in the laboratory of precast girder ends, including impact forces (dynamic) in all three directions
- Recommend physical testing in the laboratory of columns with different bar cutoffs

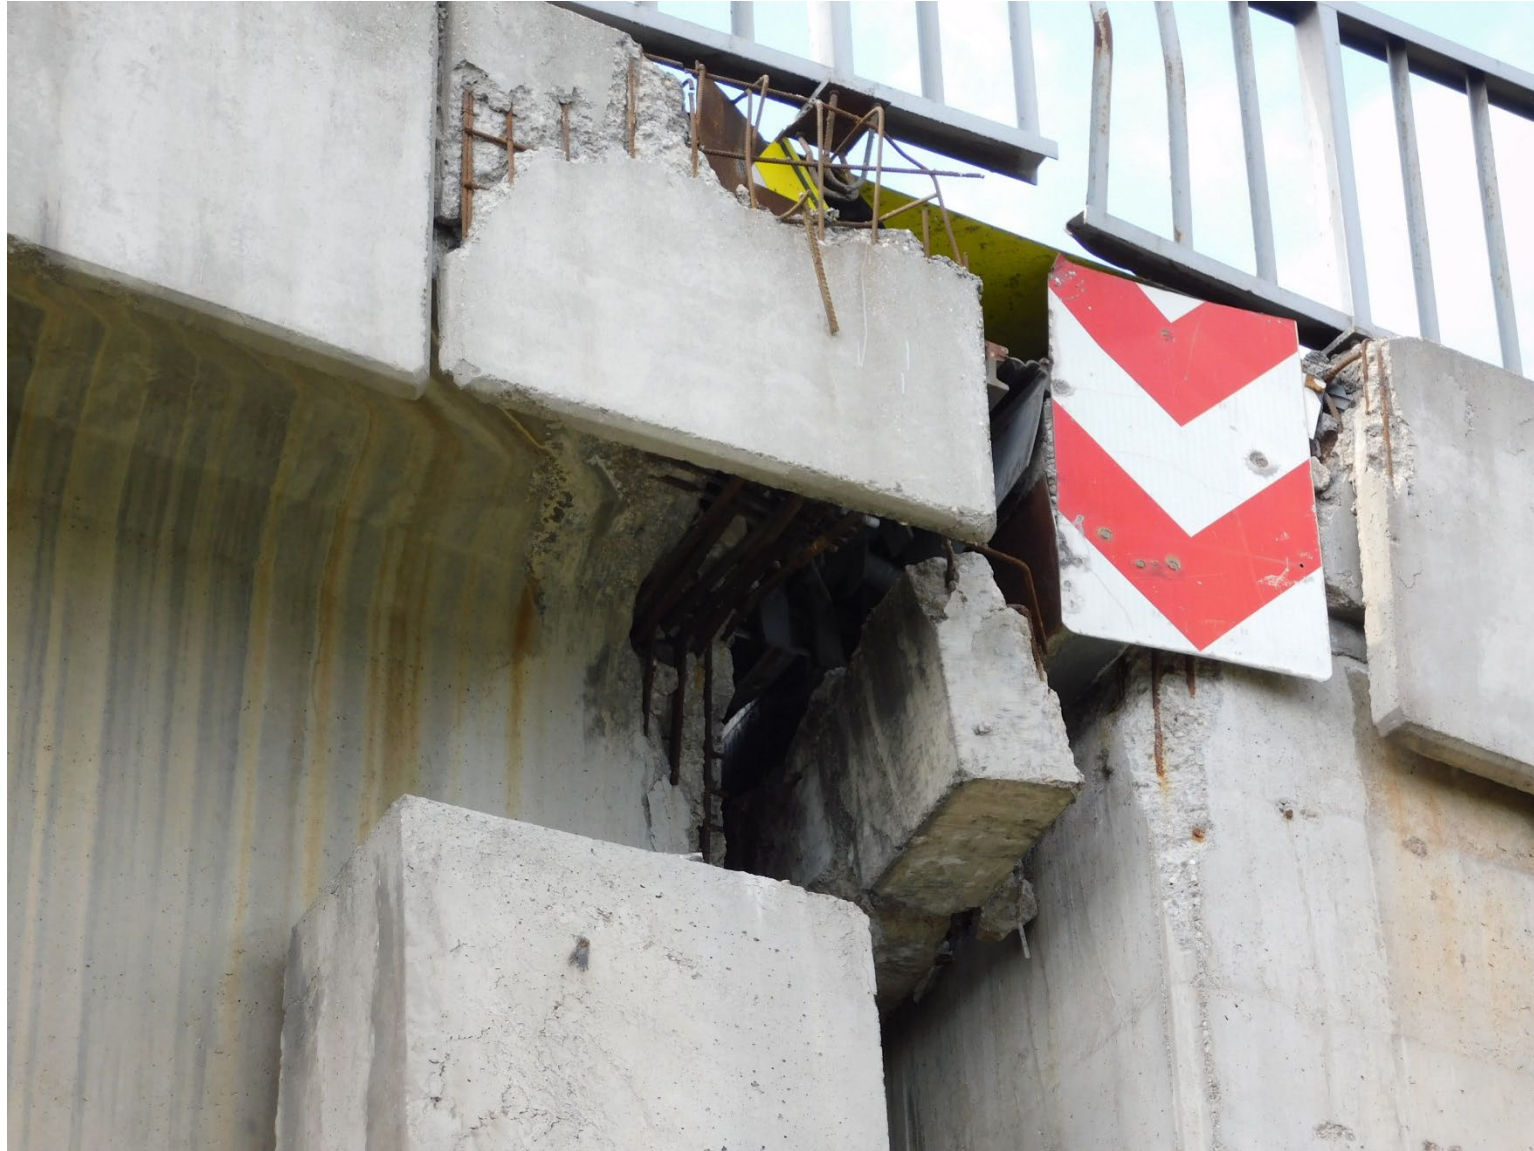
Bridge 1, Abutment Damage

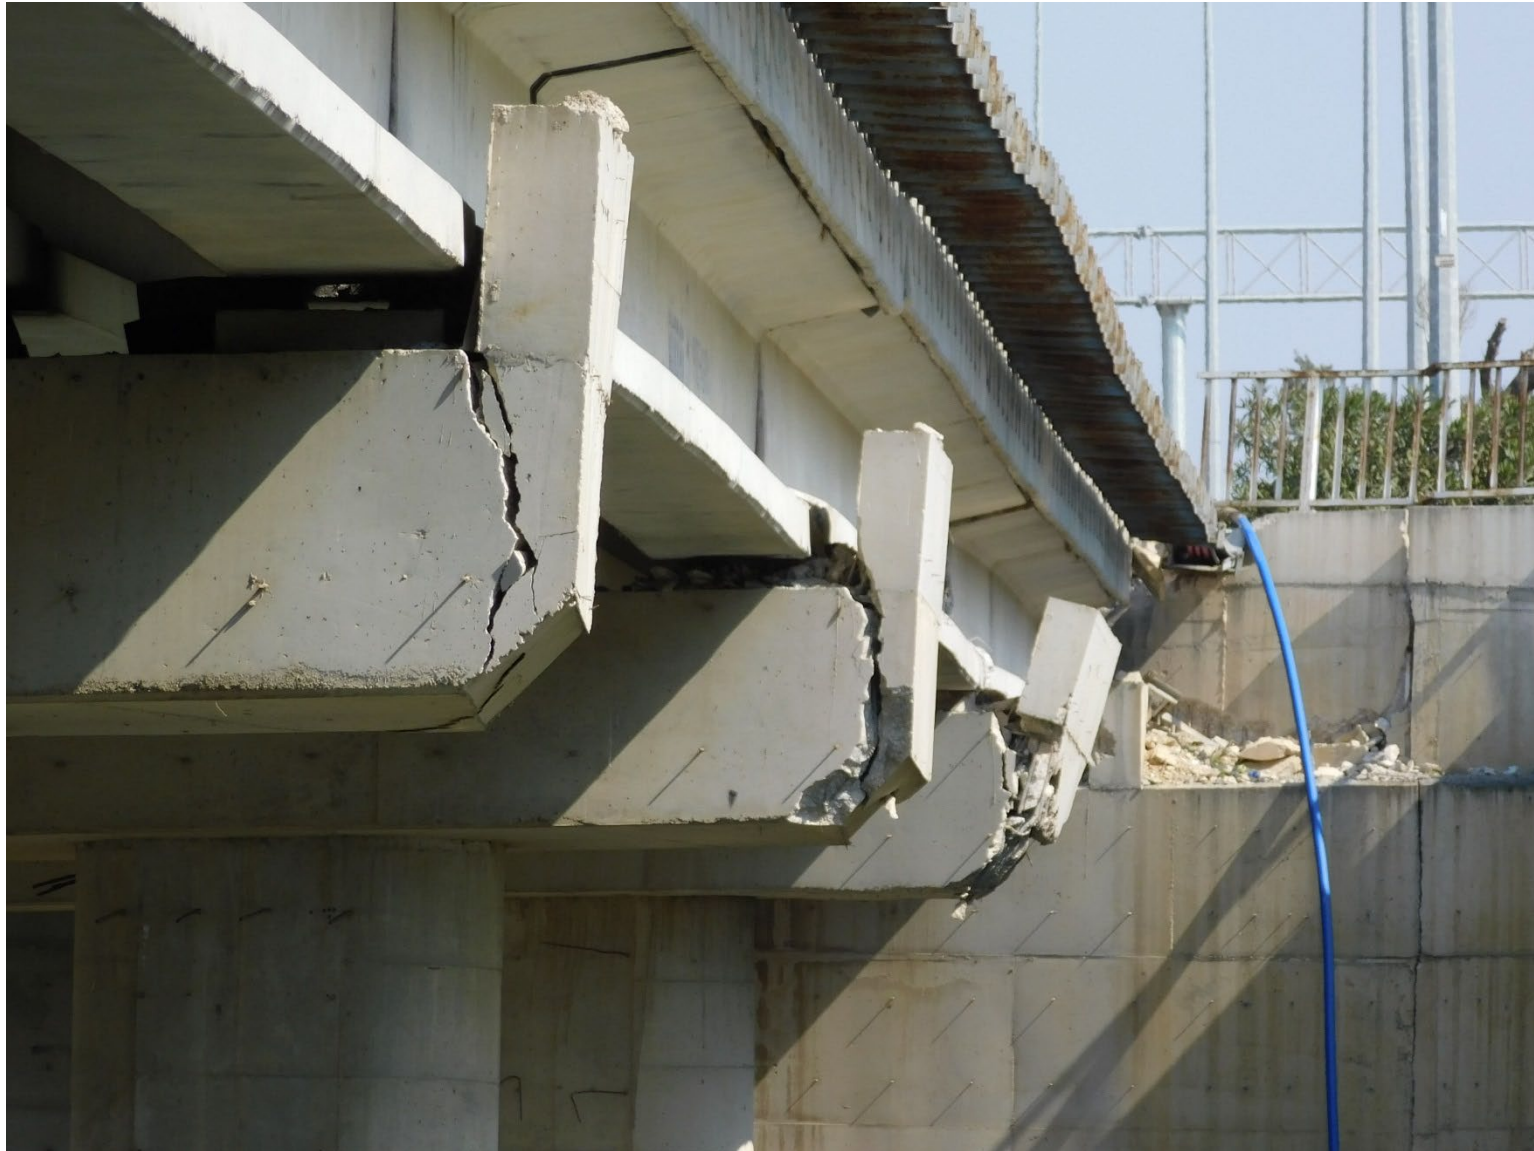
Bridge 2, Exterior Shear Key Failures

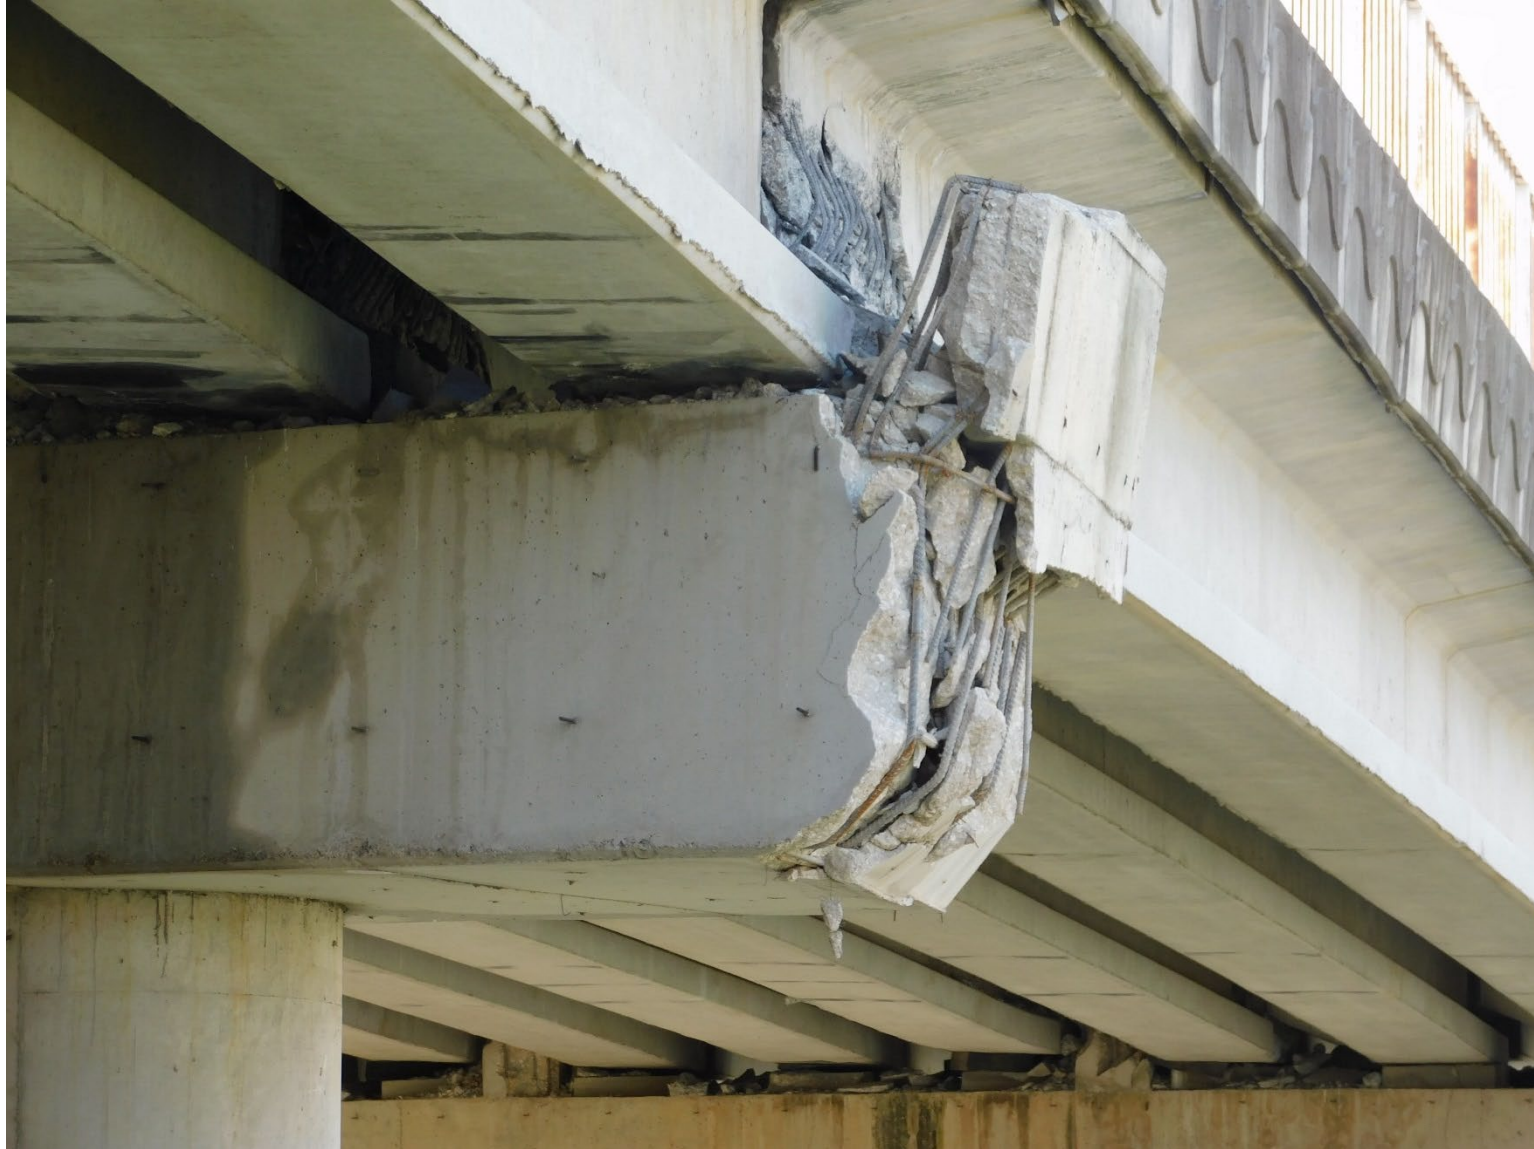
Bridge 2, Close-Up of Exterior Shear Key Failure

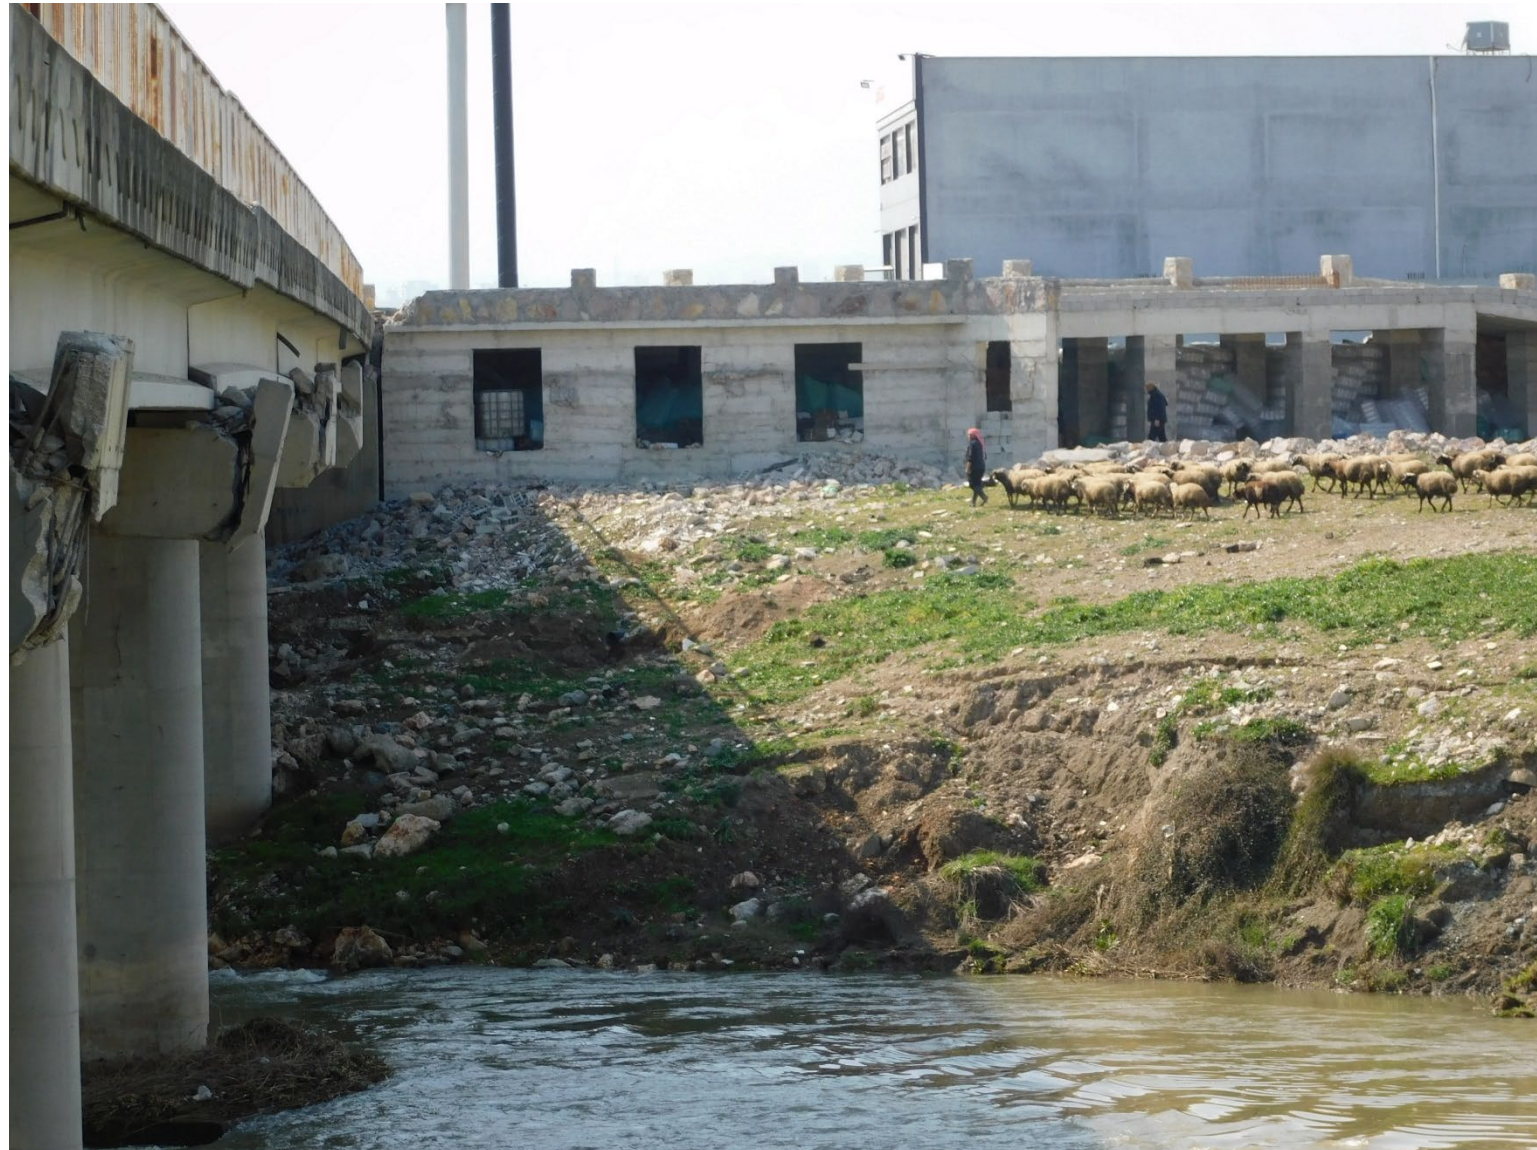
Bridge 2, Exterior Shear Key Damage, Looking Along Bridge

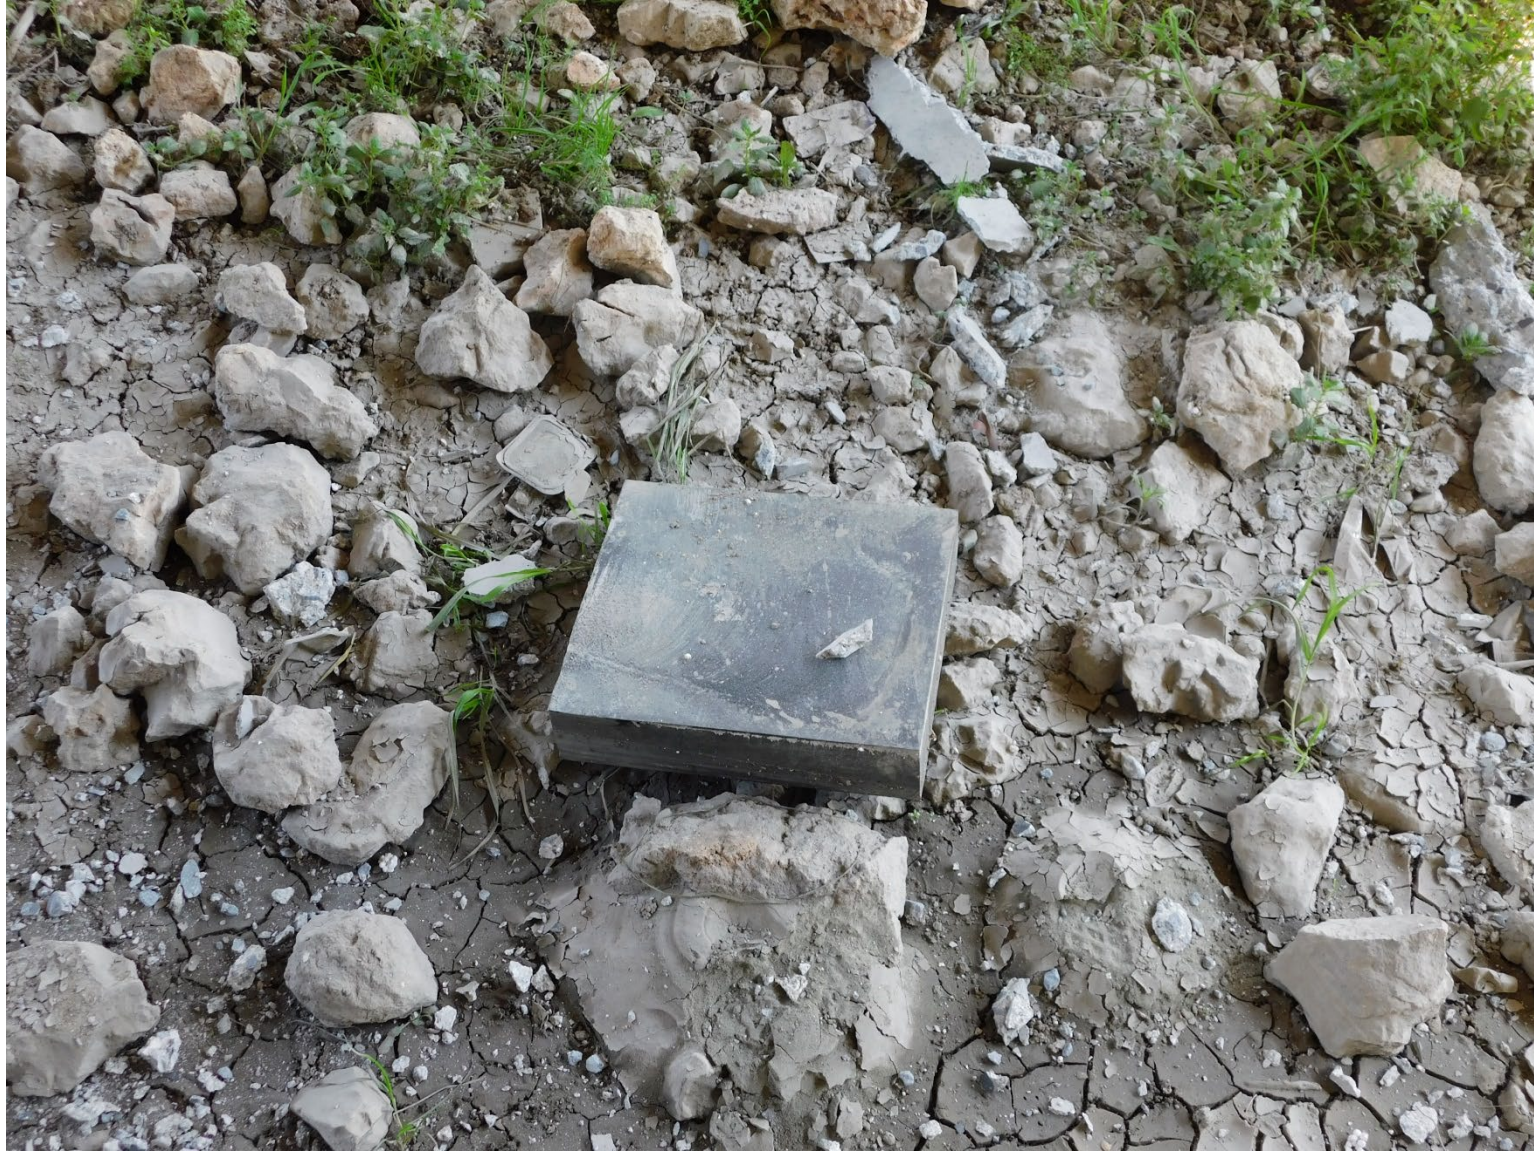
Bridge 2, Rubber Bearing Pads on Ground

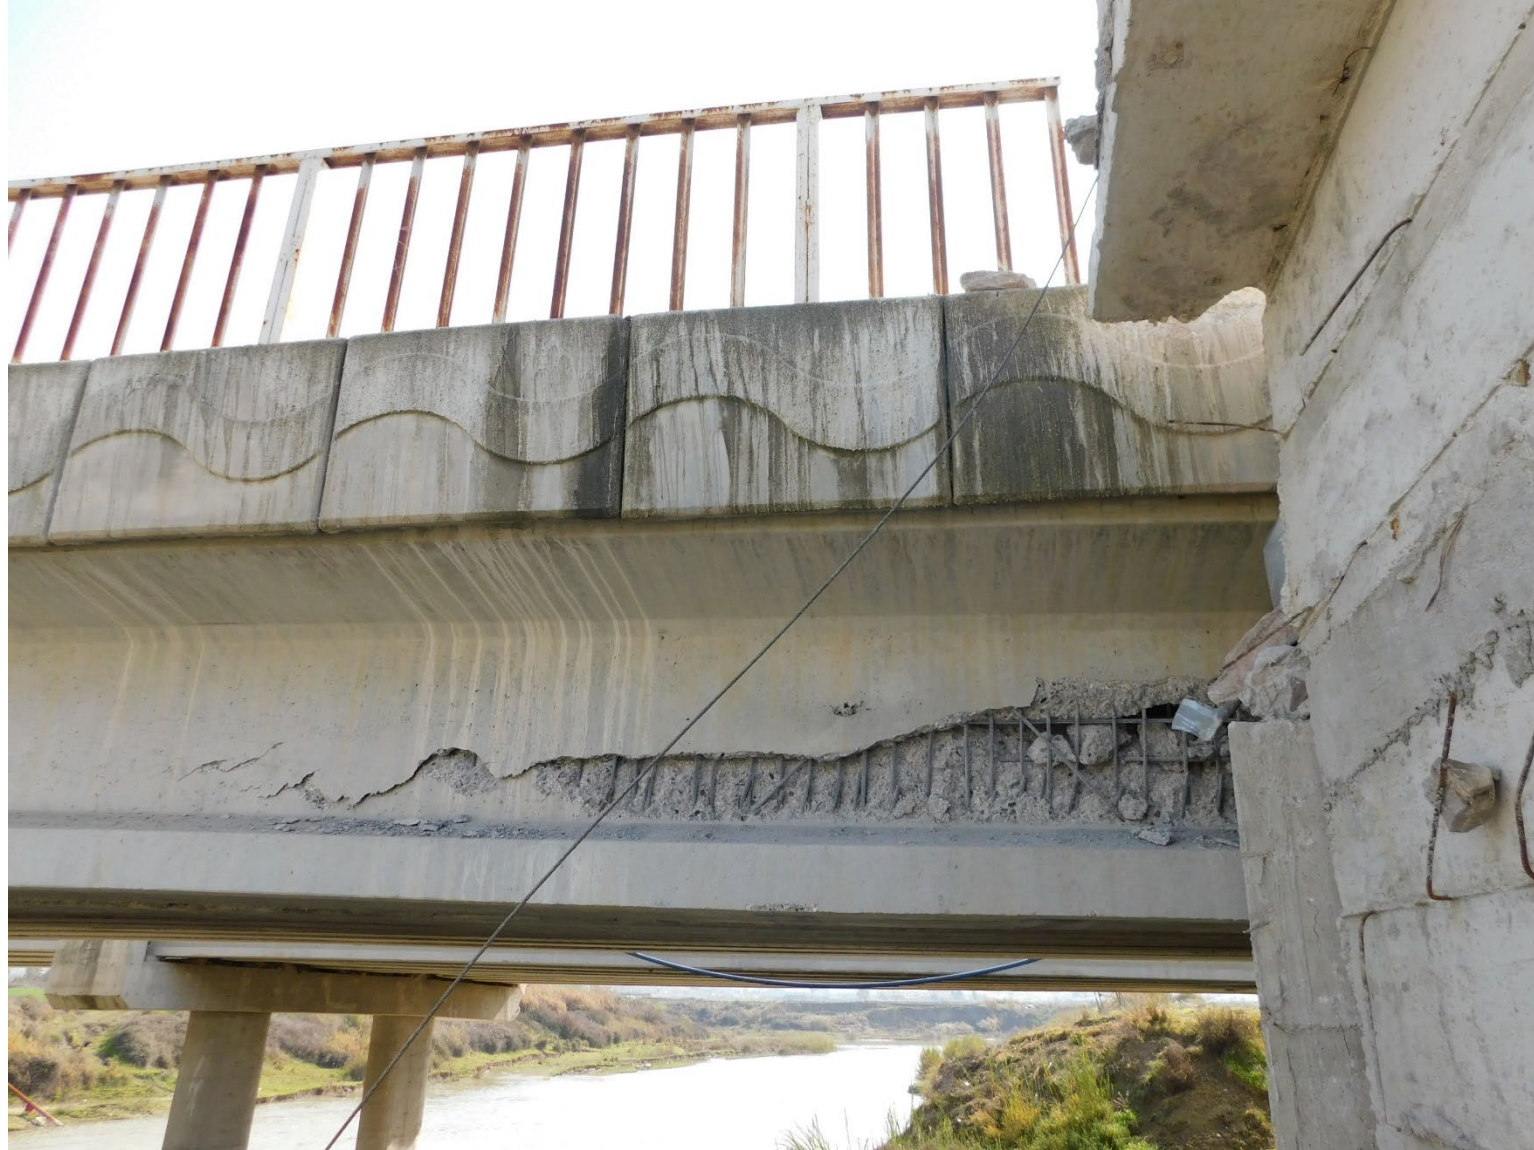
Bridge 2, End-of-Girder Damage, Exterior Girder

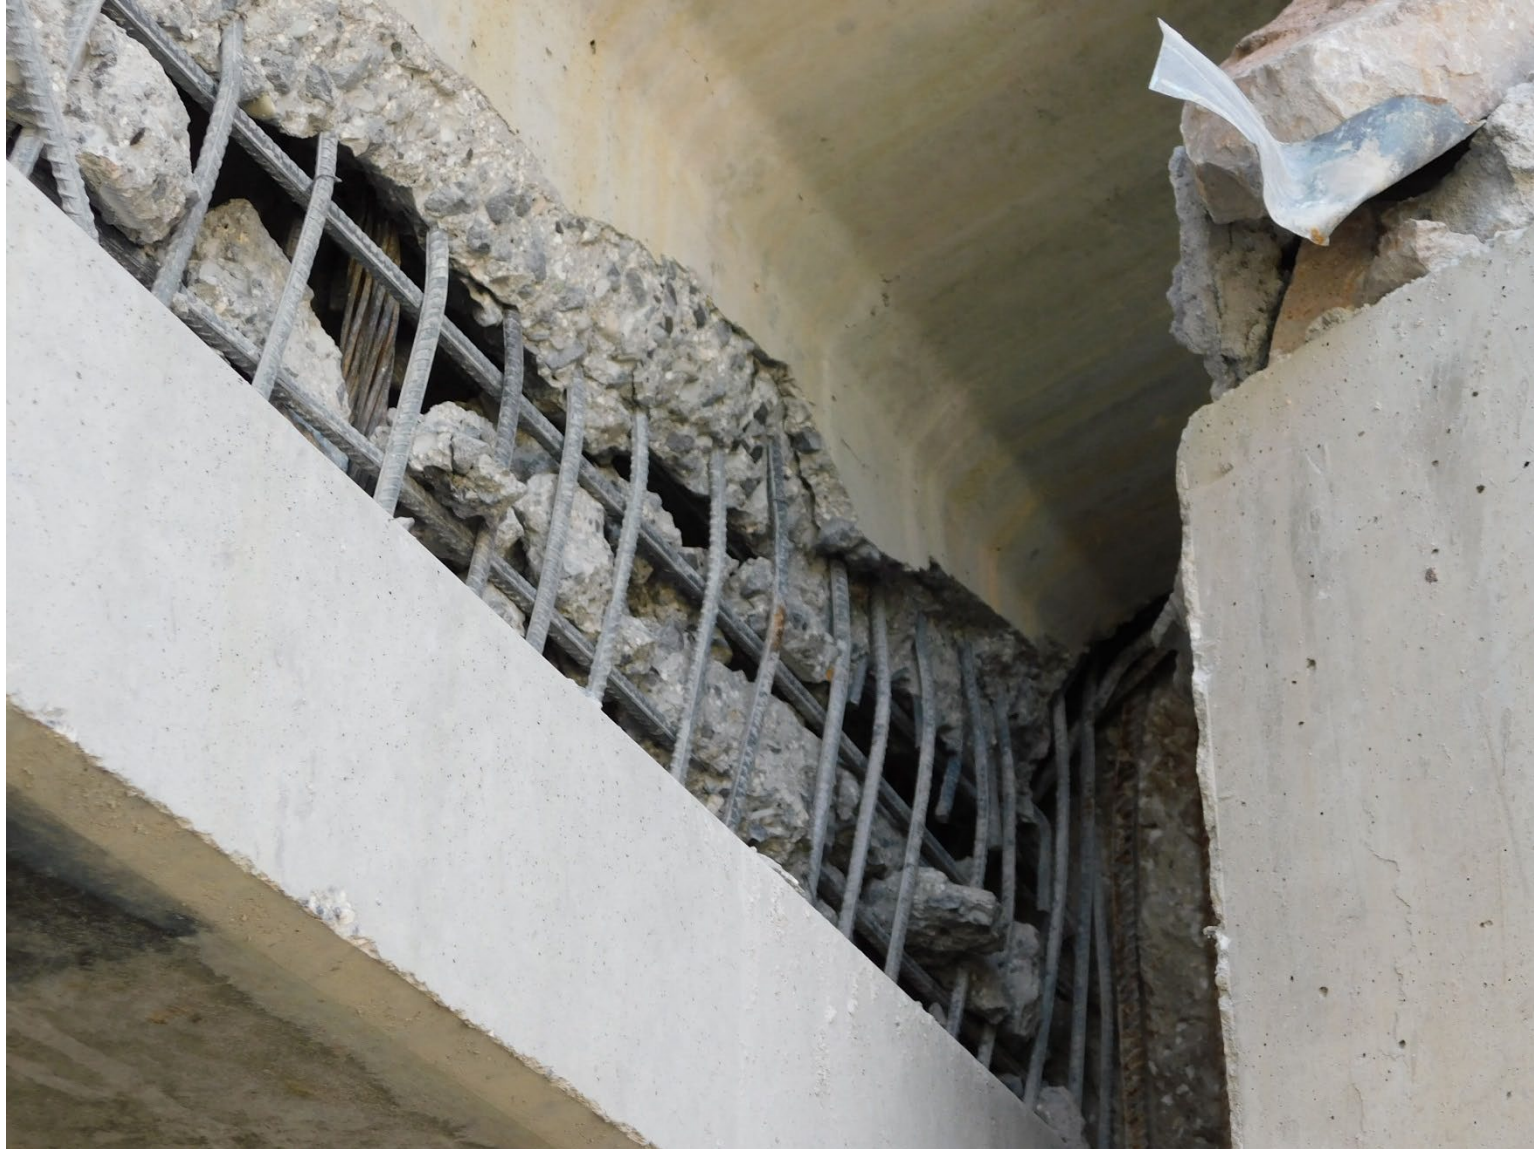
Bridge 2, no Concrete left at End-of-Girder, Exterior Girder

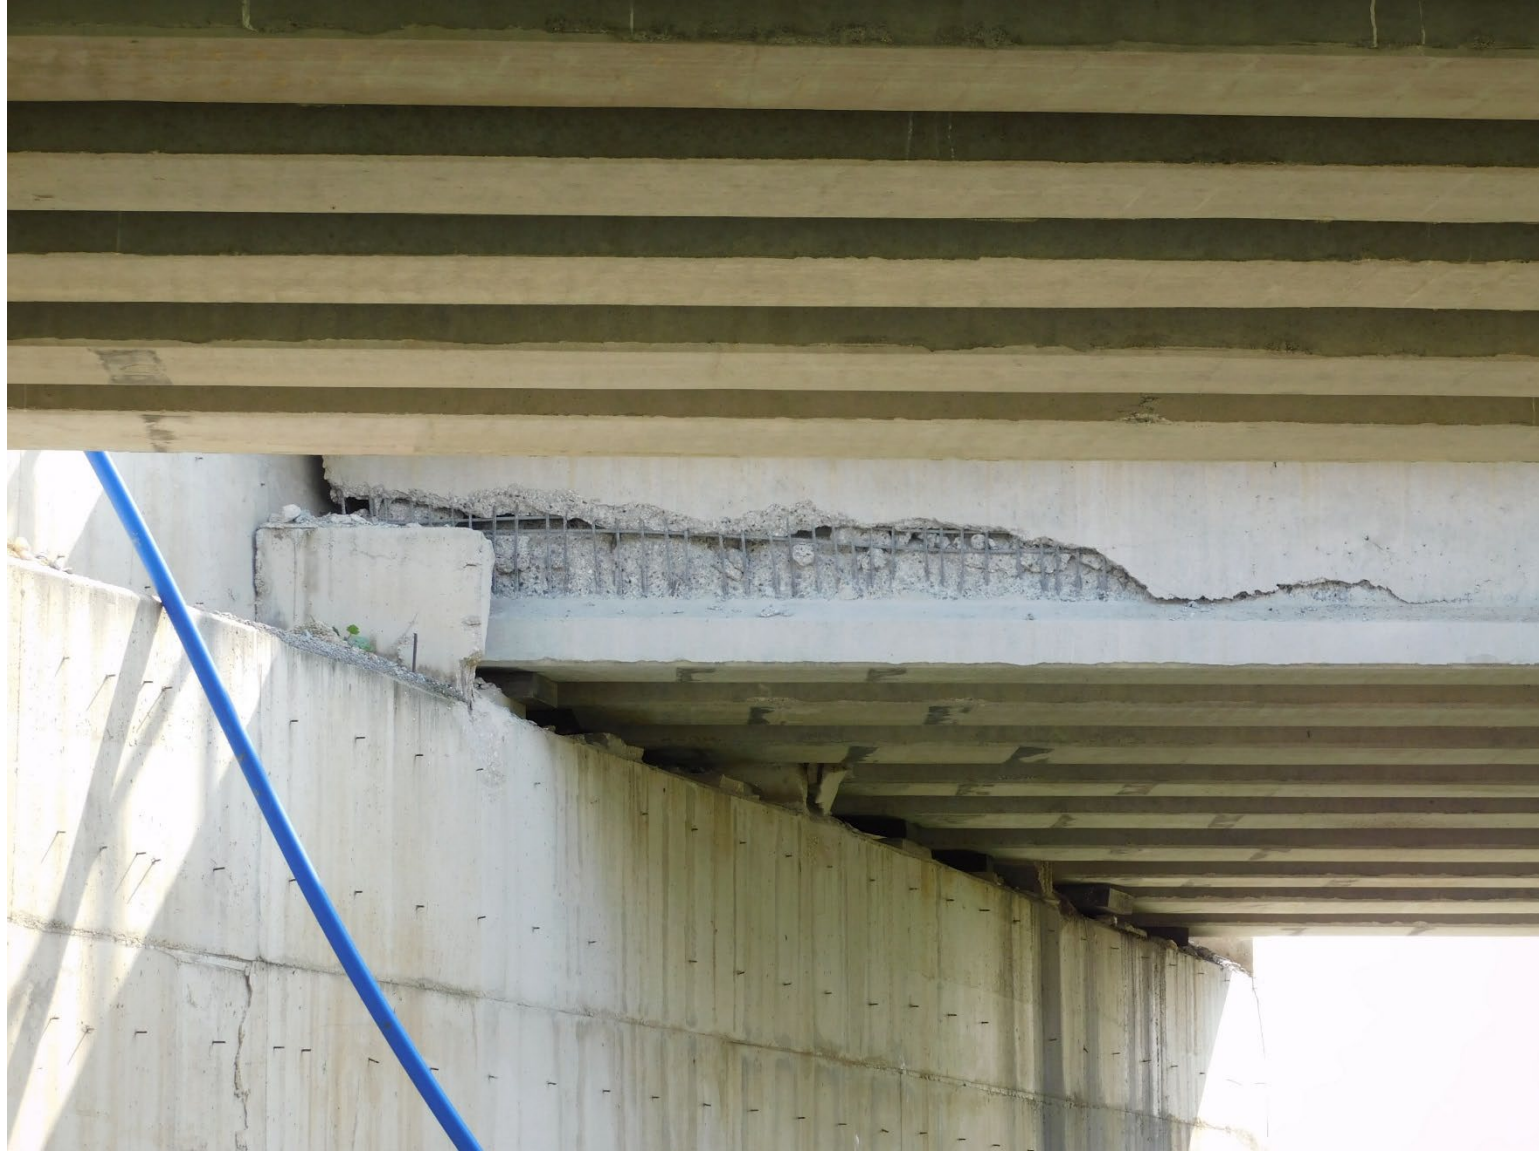
Bridge 2, Overall Exterior Girder Damage
