Observed Structural Bridge Damage from M_w 7.8 Earthquake in Southern Turkiye (Turkey) and Model for Nonlinear Time-History Analysis

Prof. Robert K. Dowell, Ph.D., P.E.
Director, Structural Engineering Laboratory

Structural Engineering Reconnaissance Team (Mountain Goats)

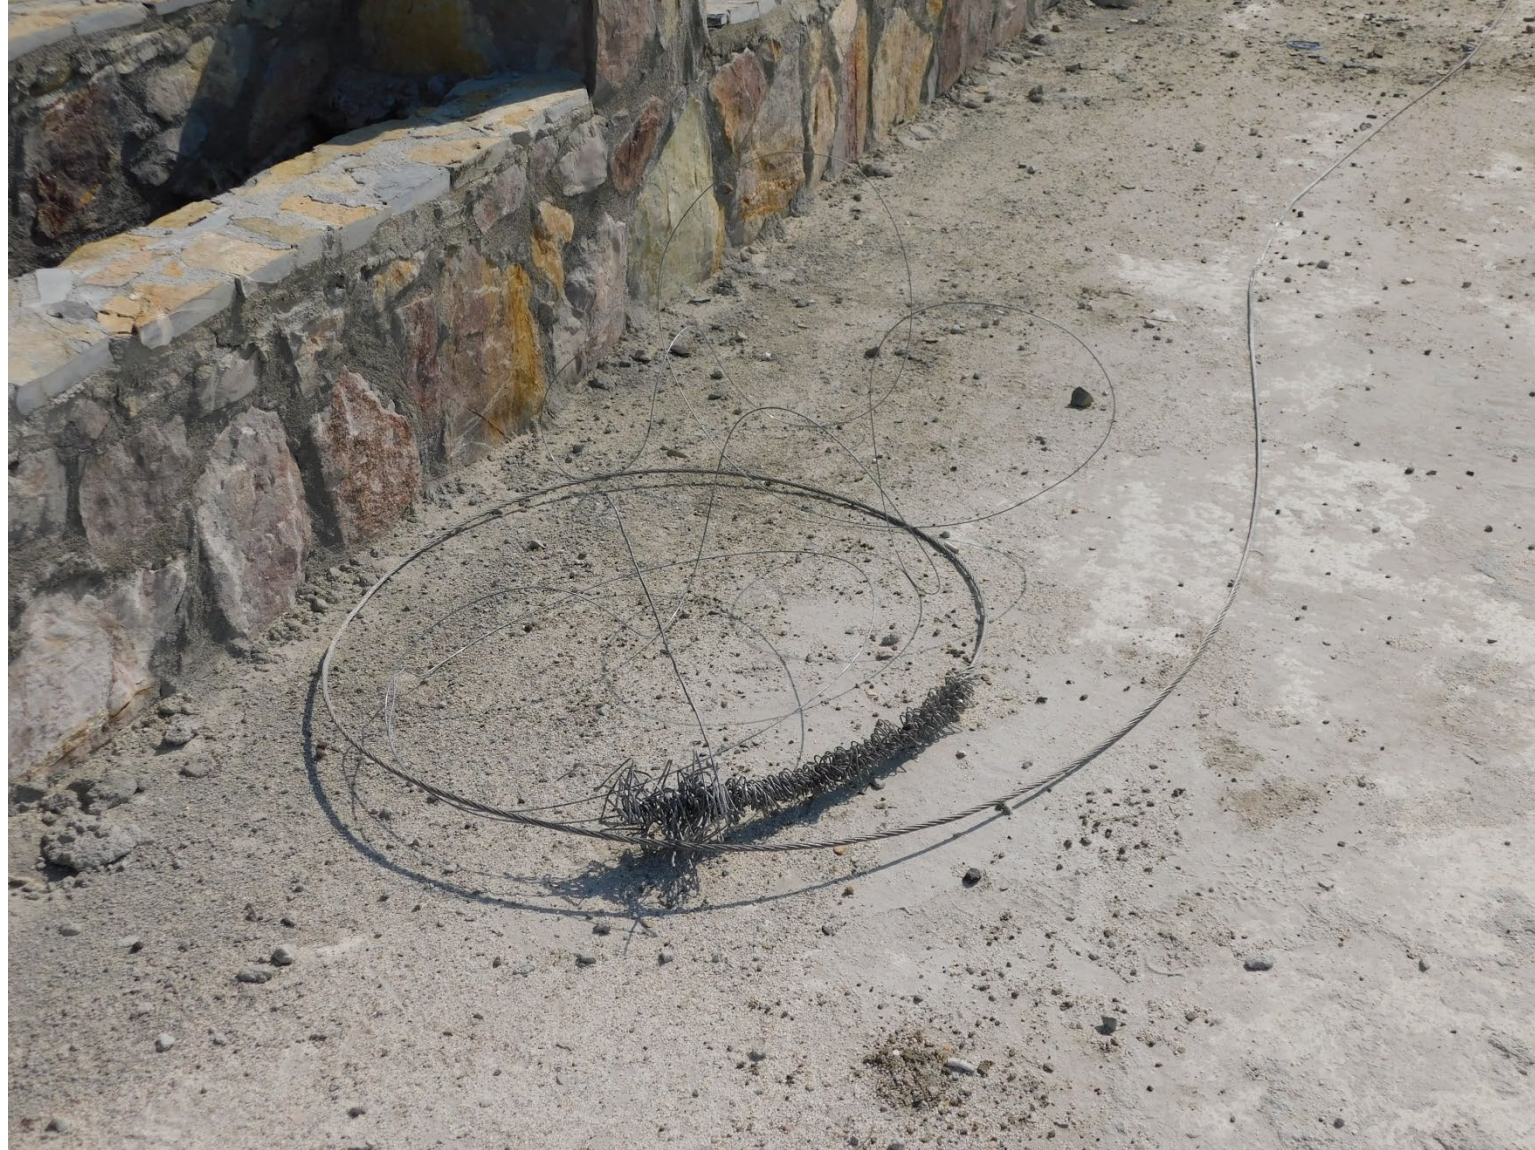
Bridge 2, Prestress Stand from Precast Girder

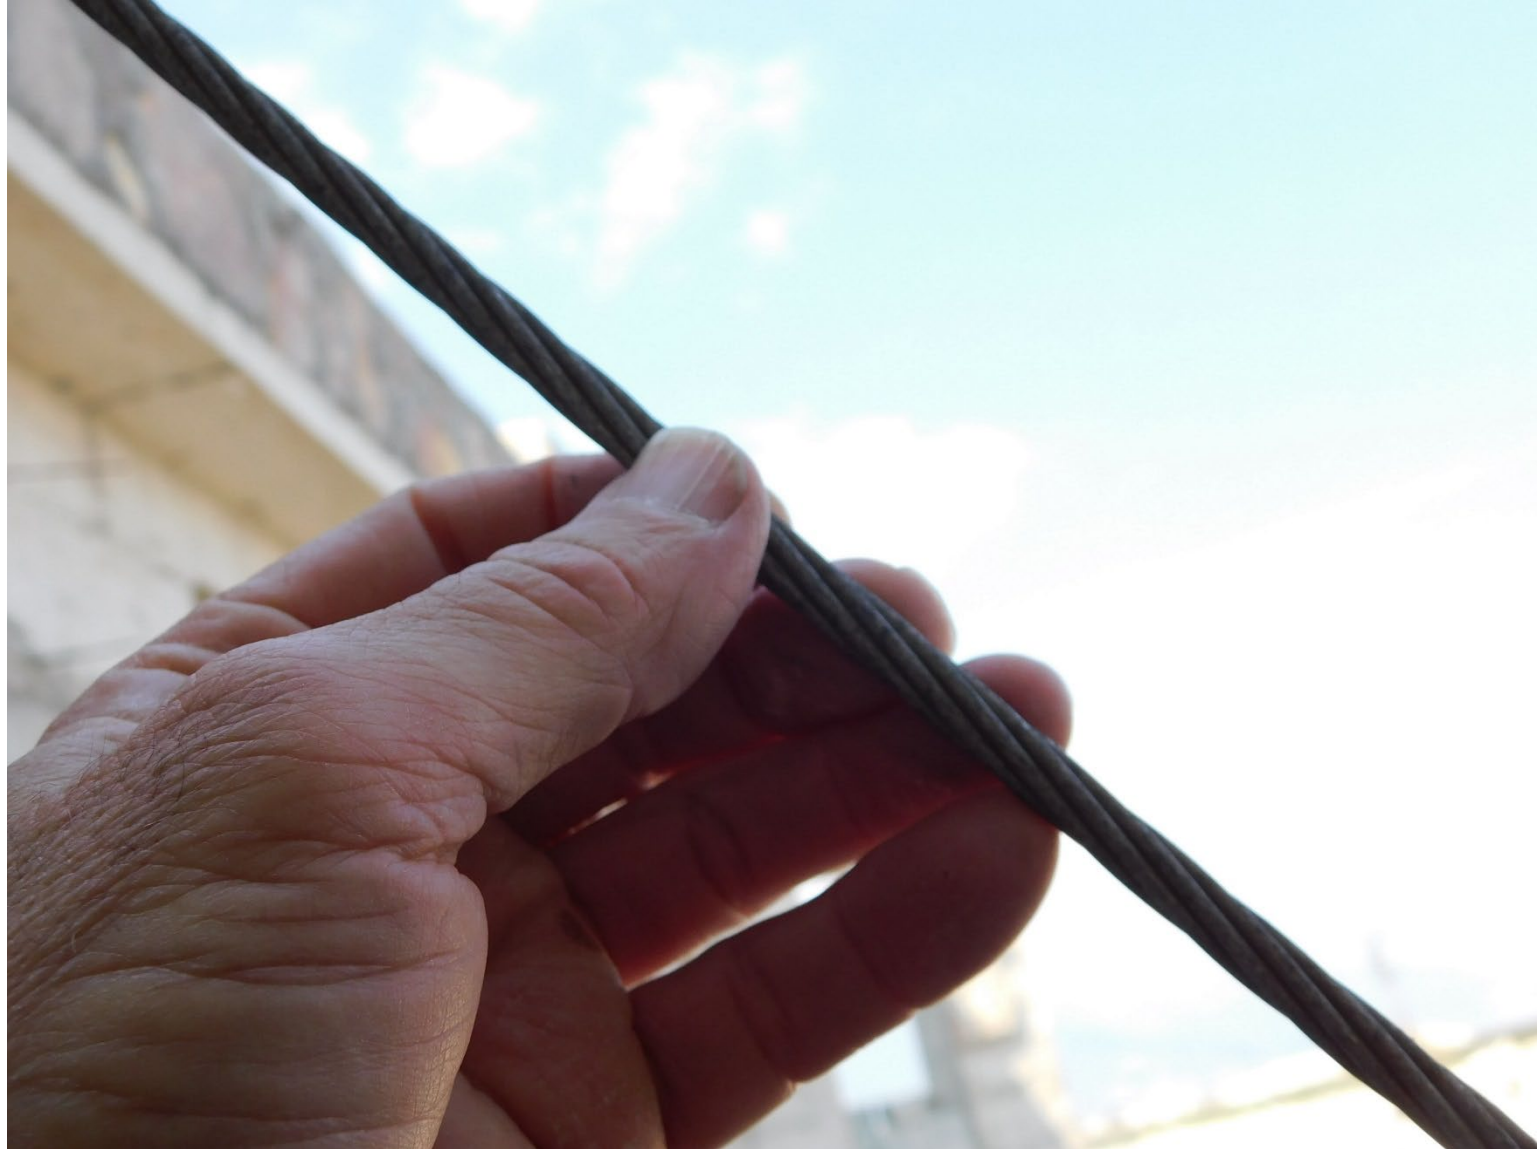
Bridge 2, Close-Up of Prestress Strand

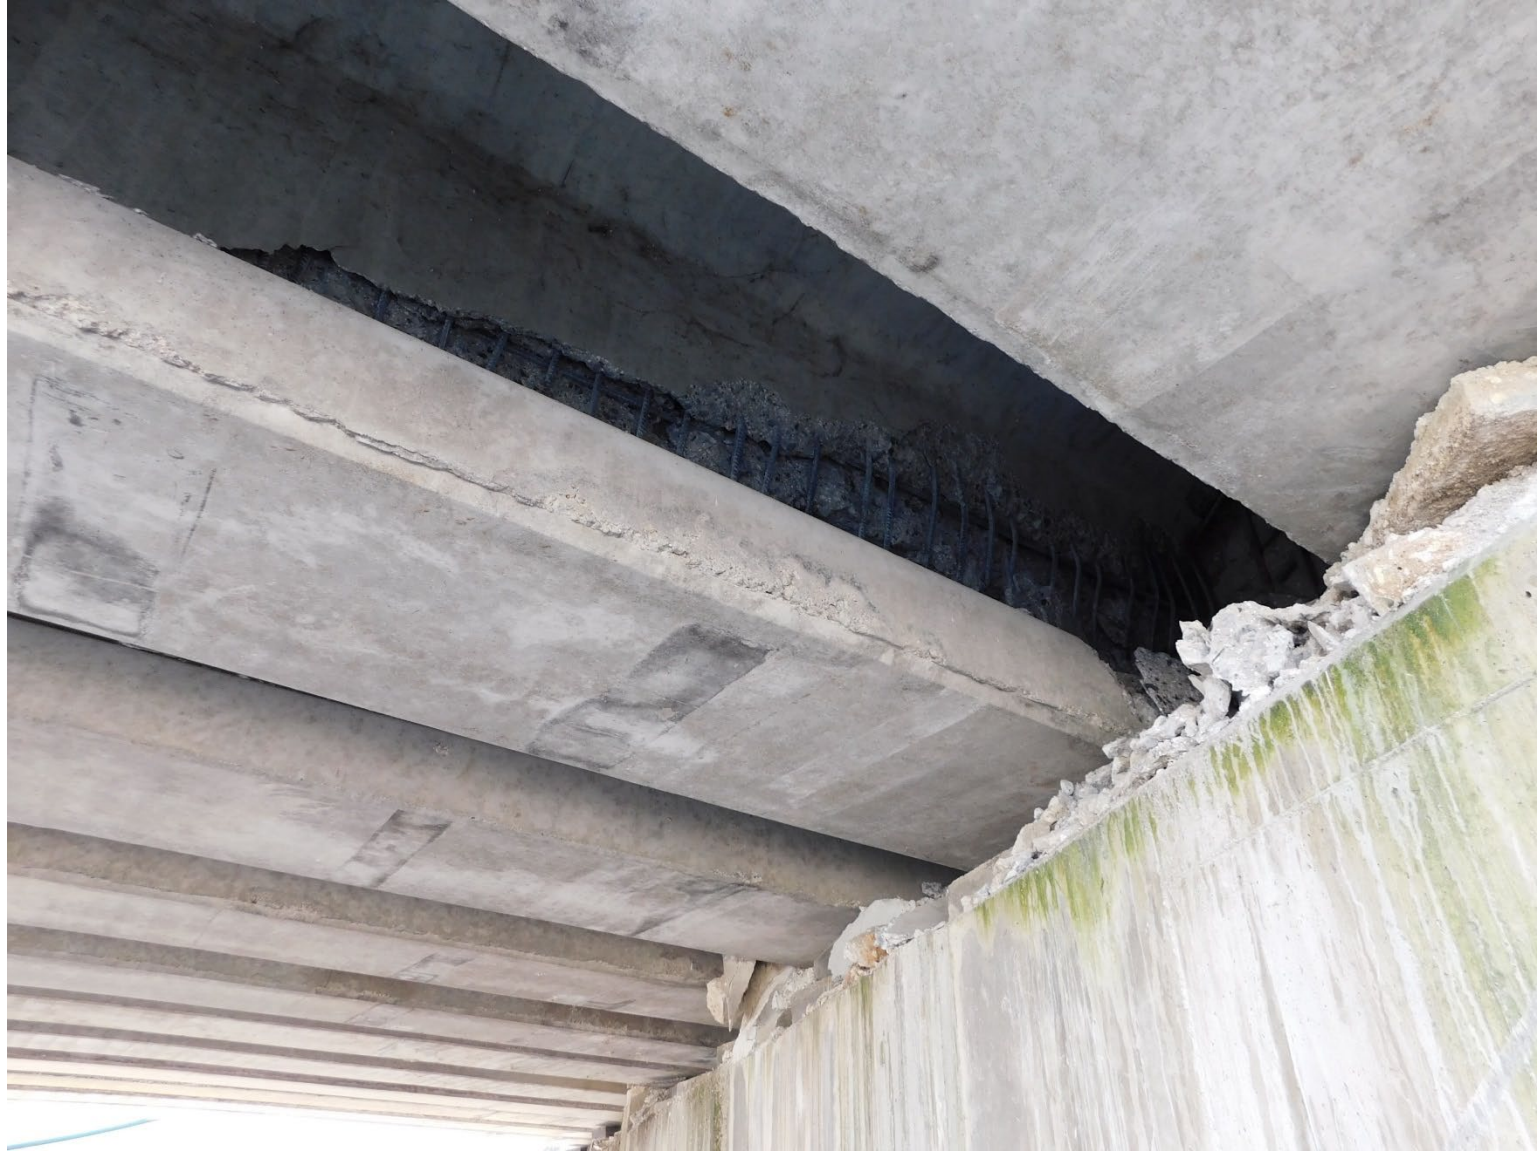
Bridge 2, Interior Girder Damage

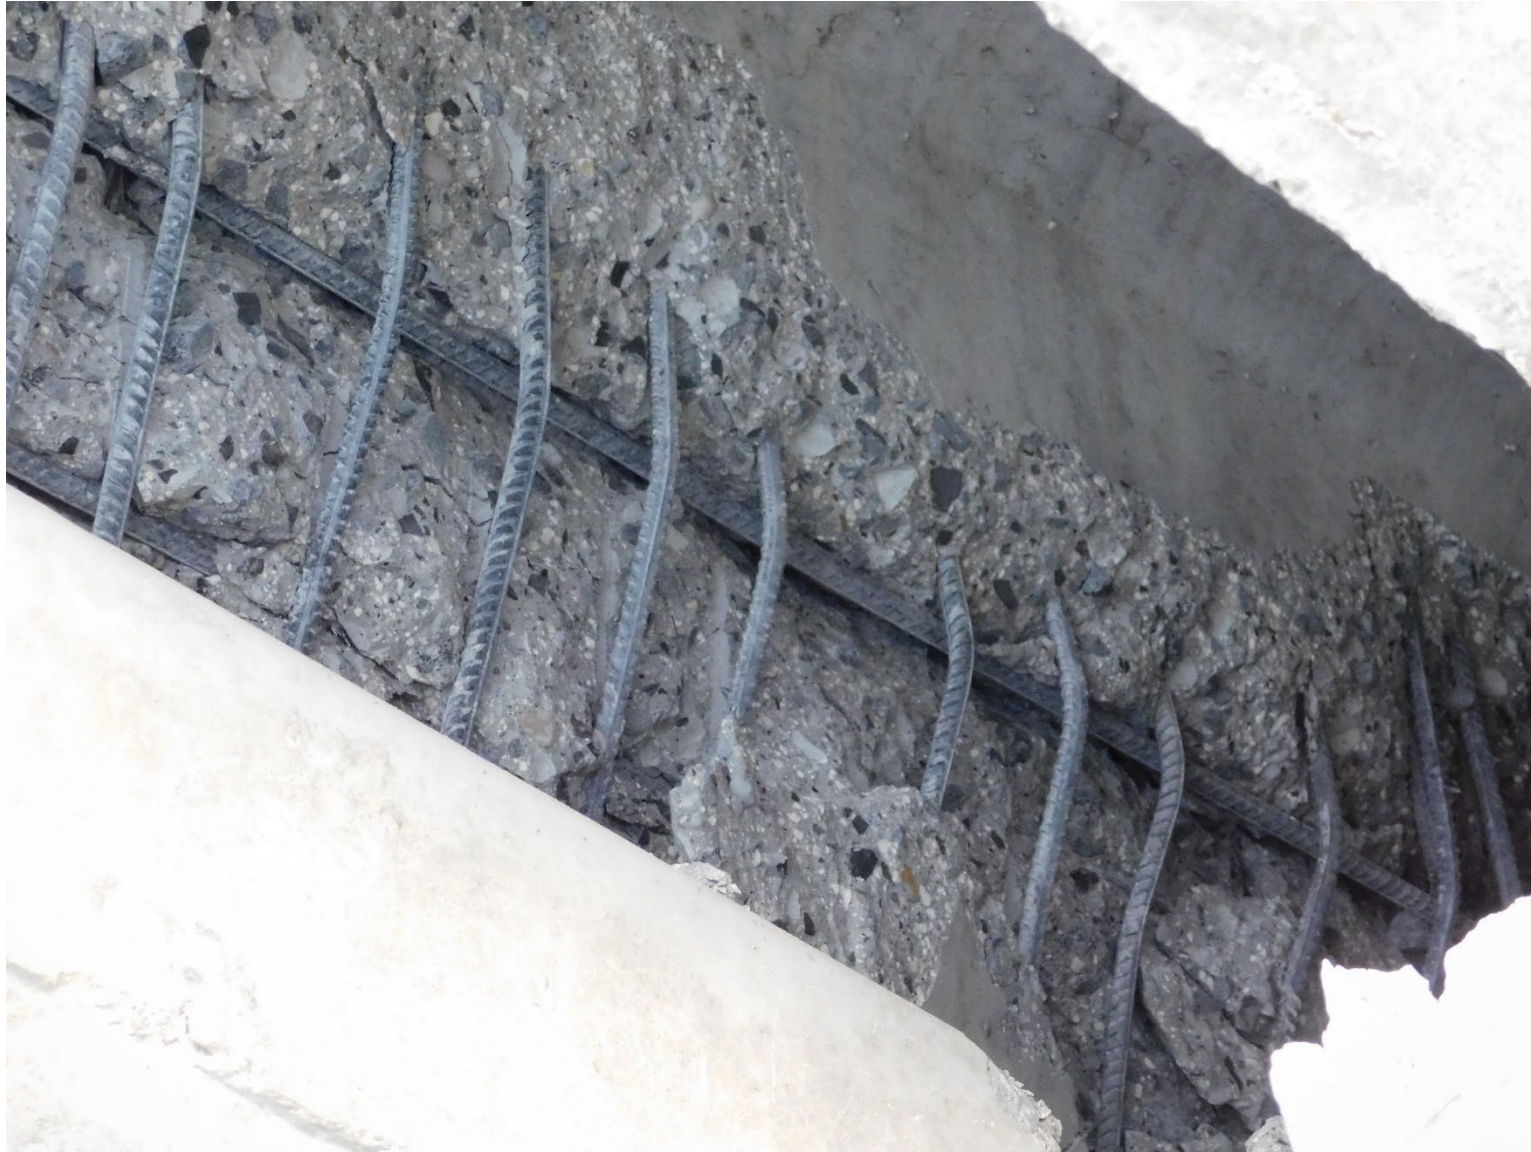
Bridge 2, Close-Up of Interior Girder Damage

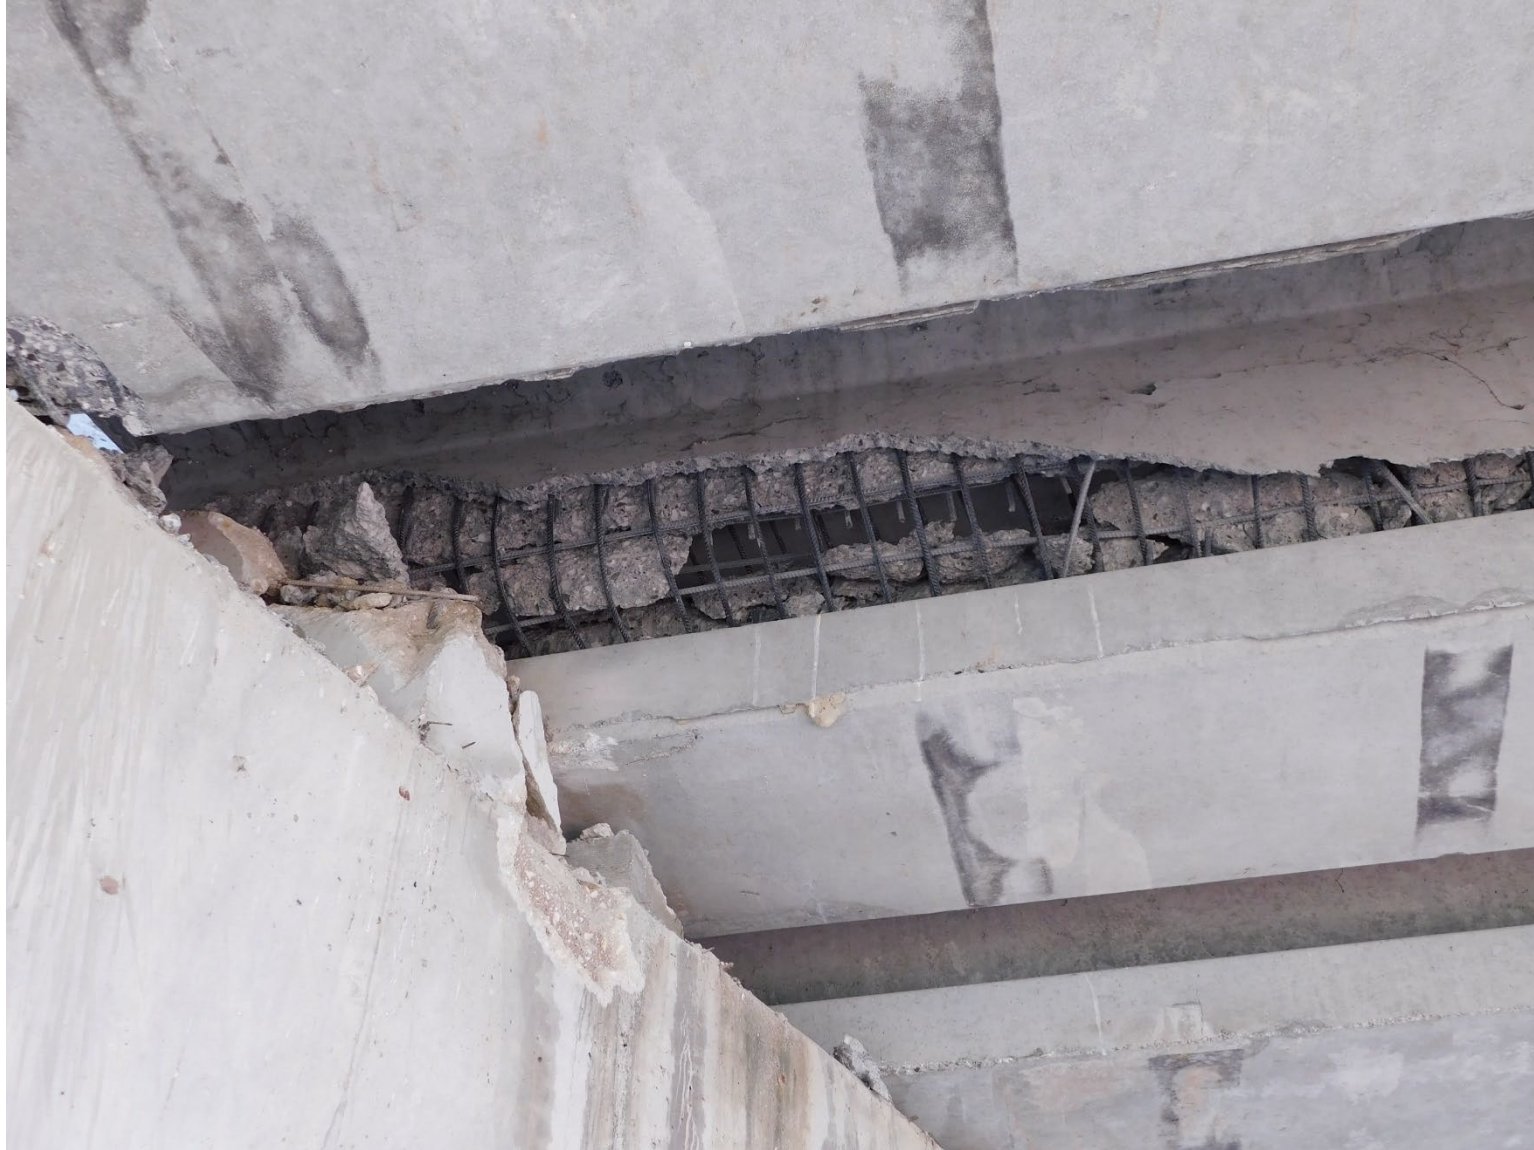
Bridge 2, Interior Girder Damage – no concrete left

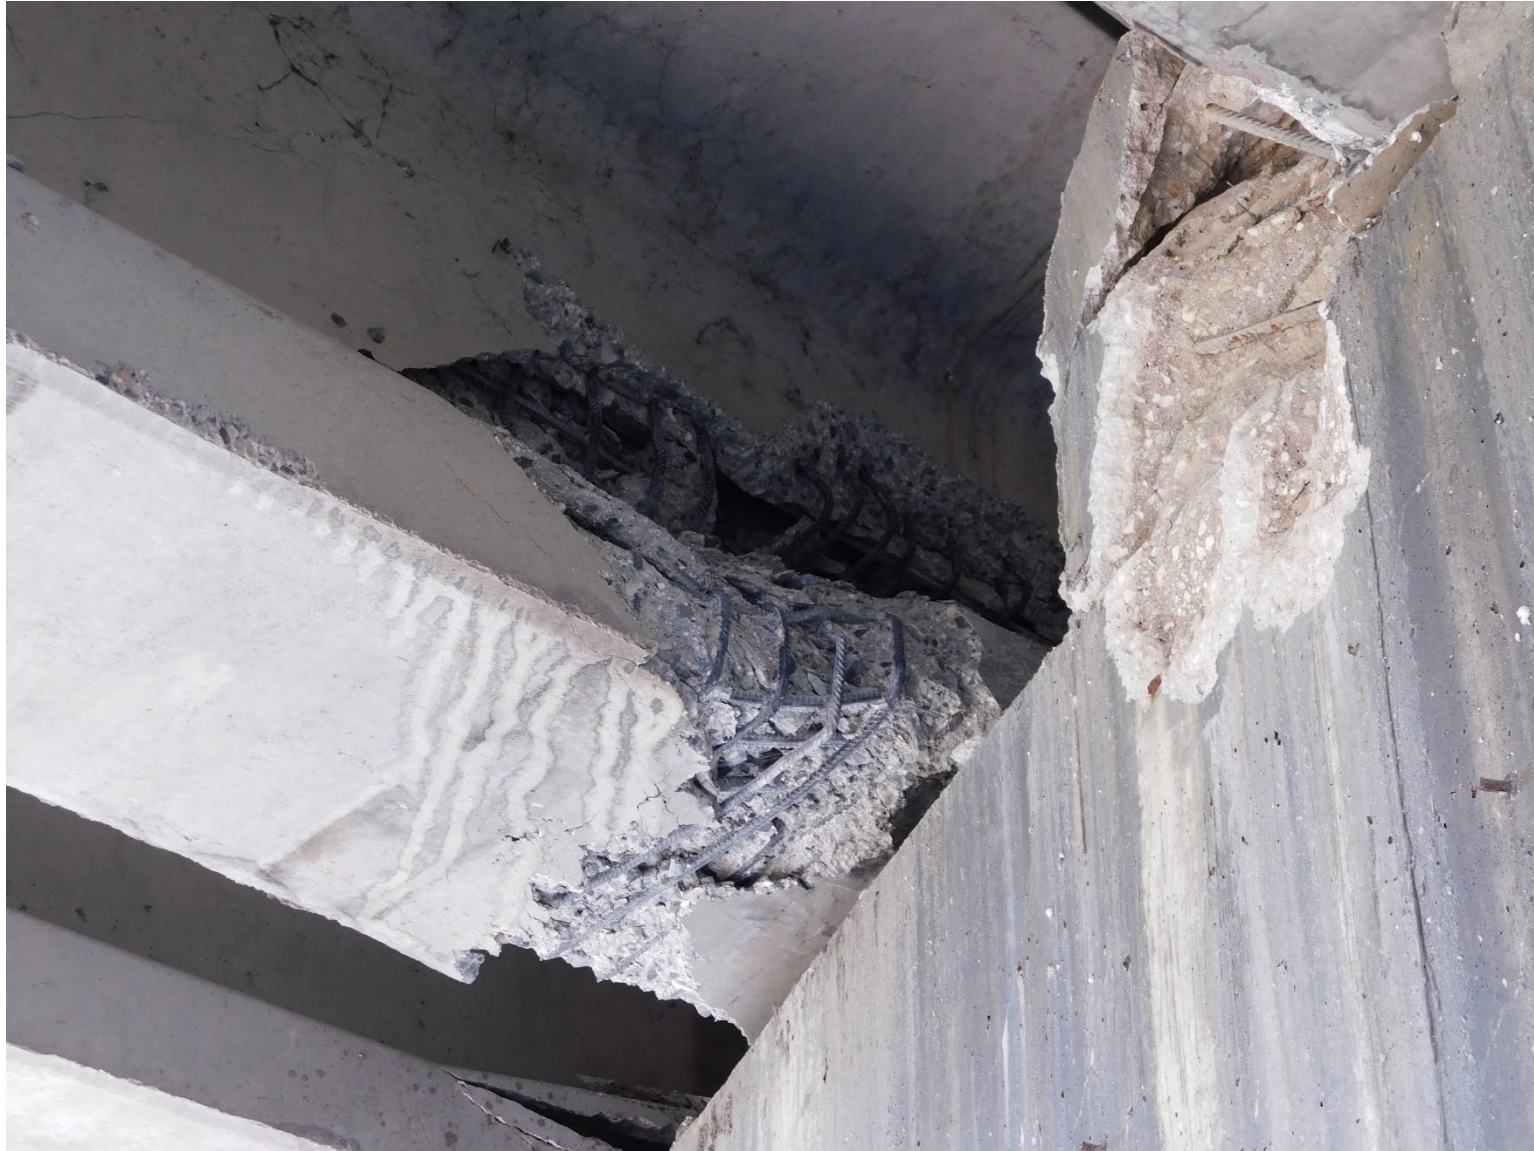
Bridge 2, Damage and Twisting of Girder End

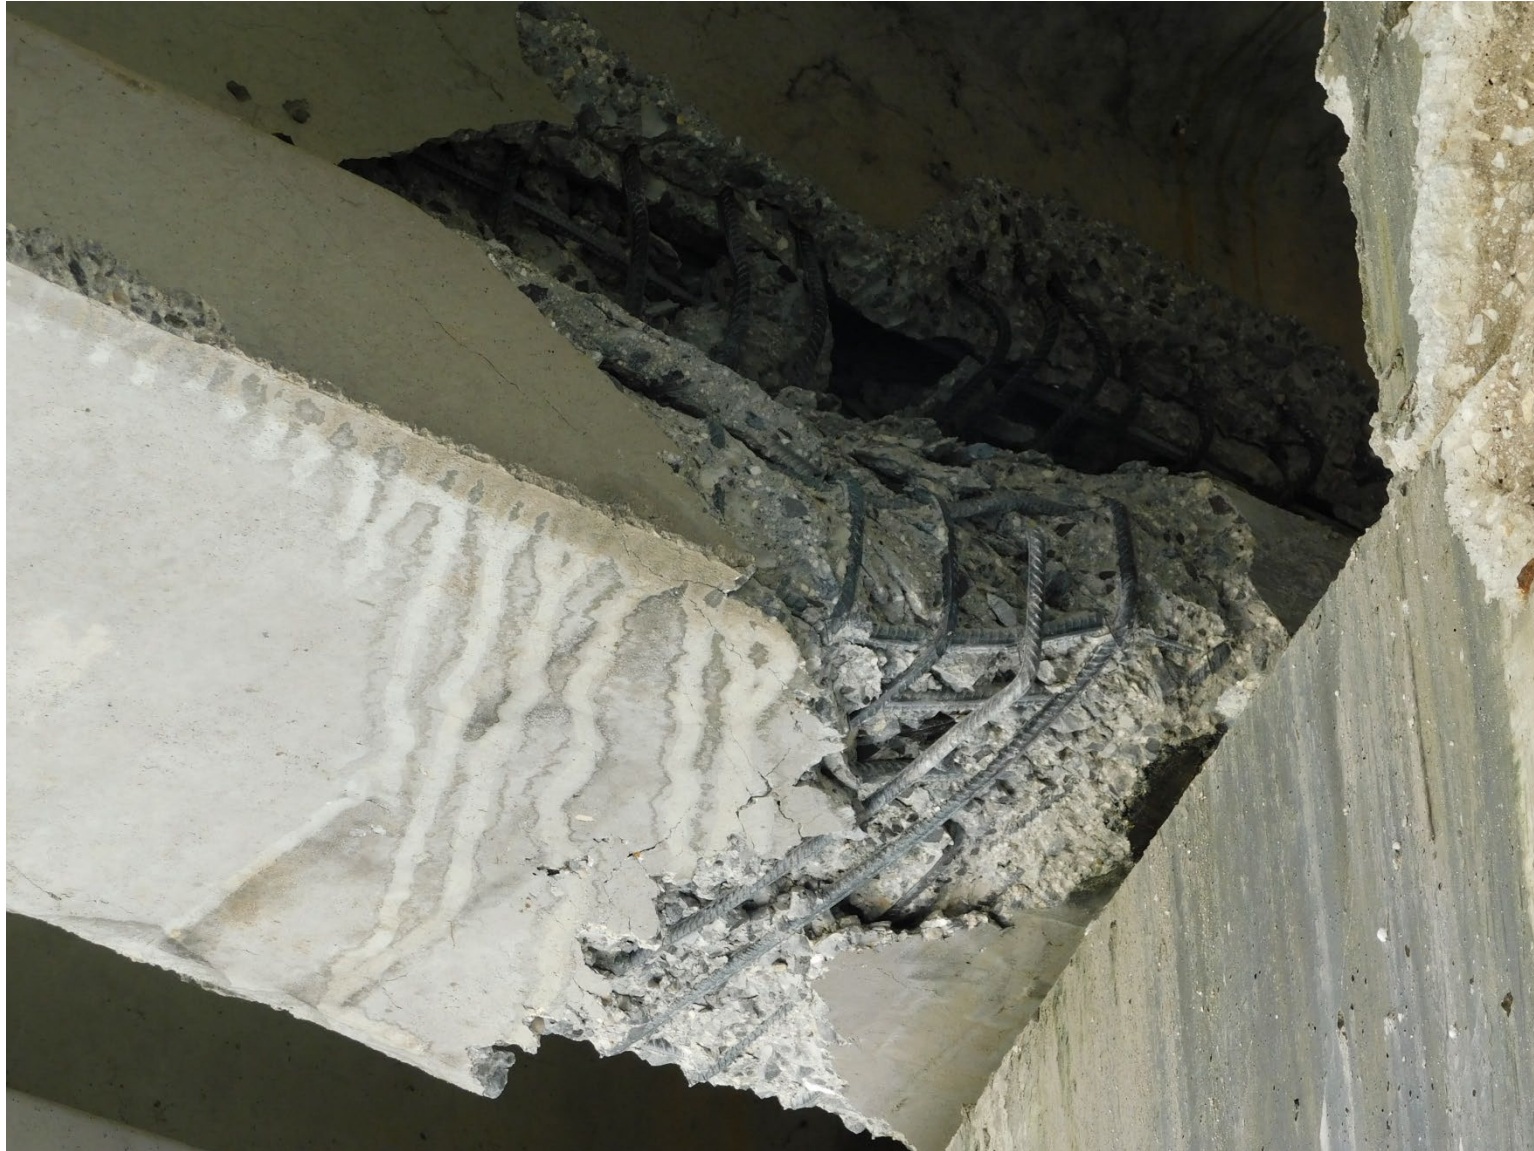
Bridge 2, Close-Up of Damage and Twisting of Girder End

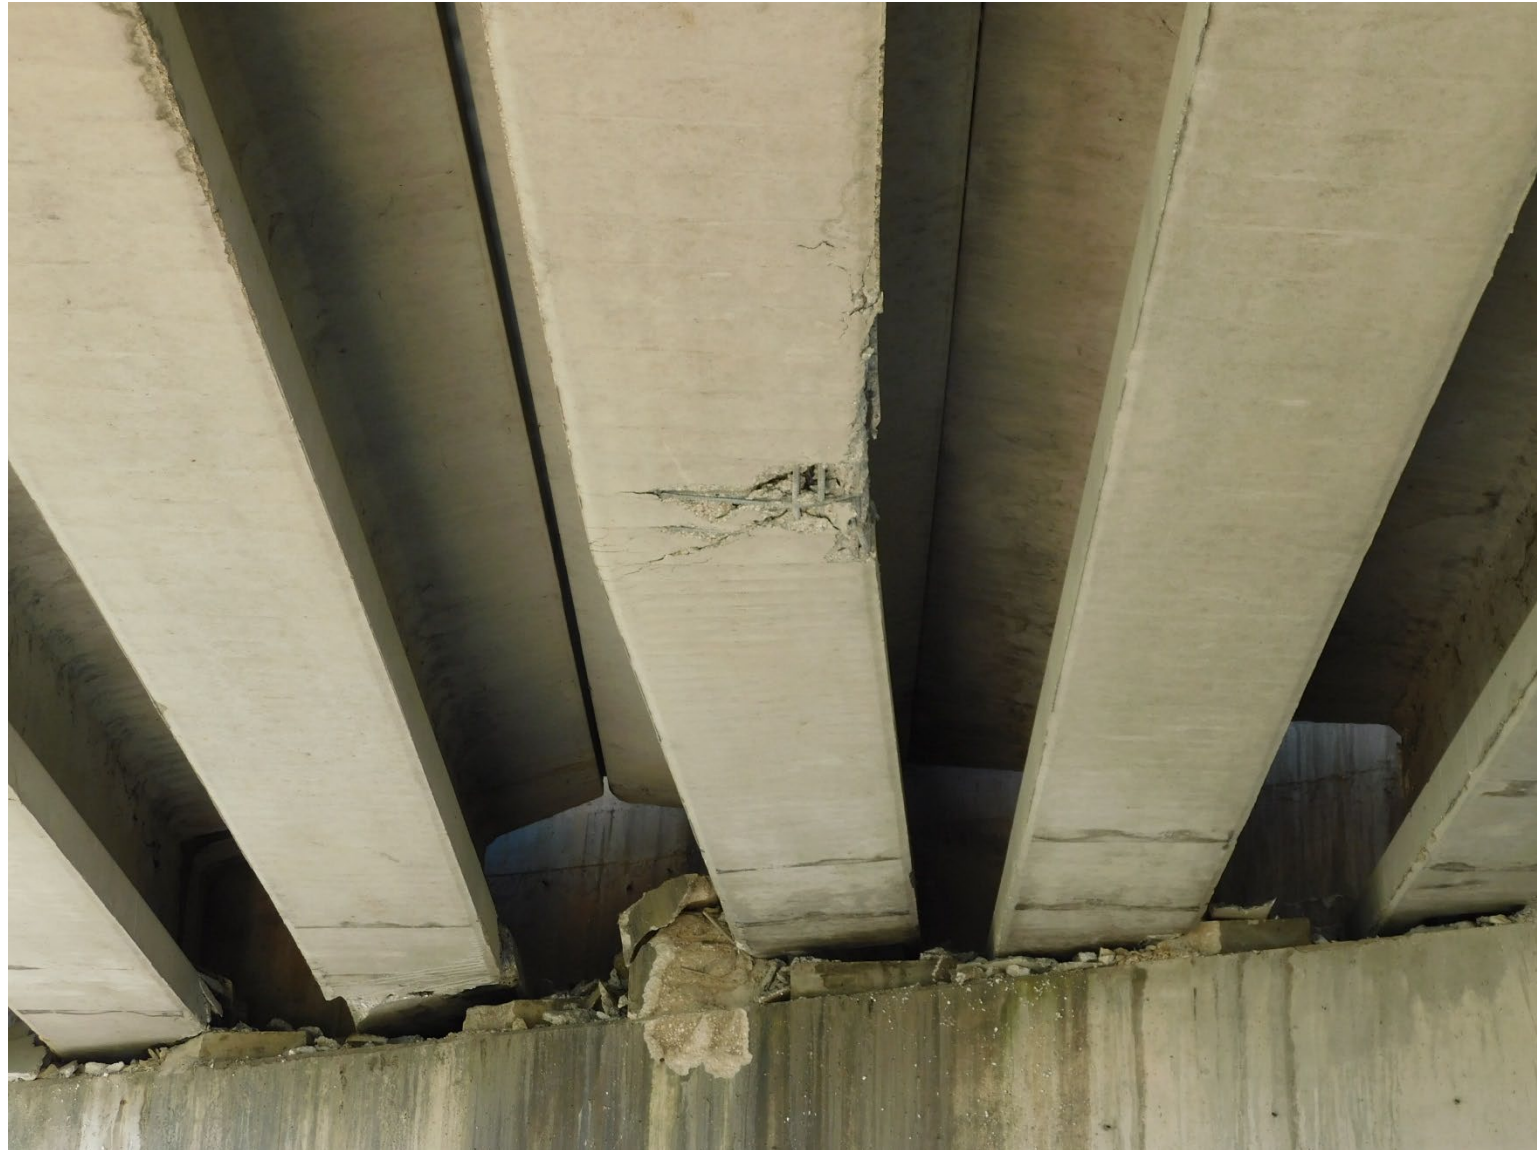
Bridge 2, Bent Vertically/Horizontally Precast Girder

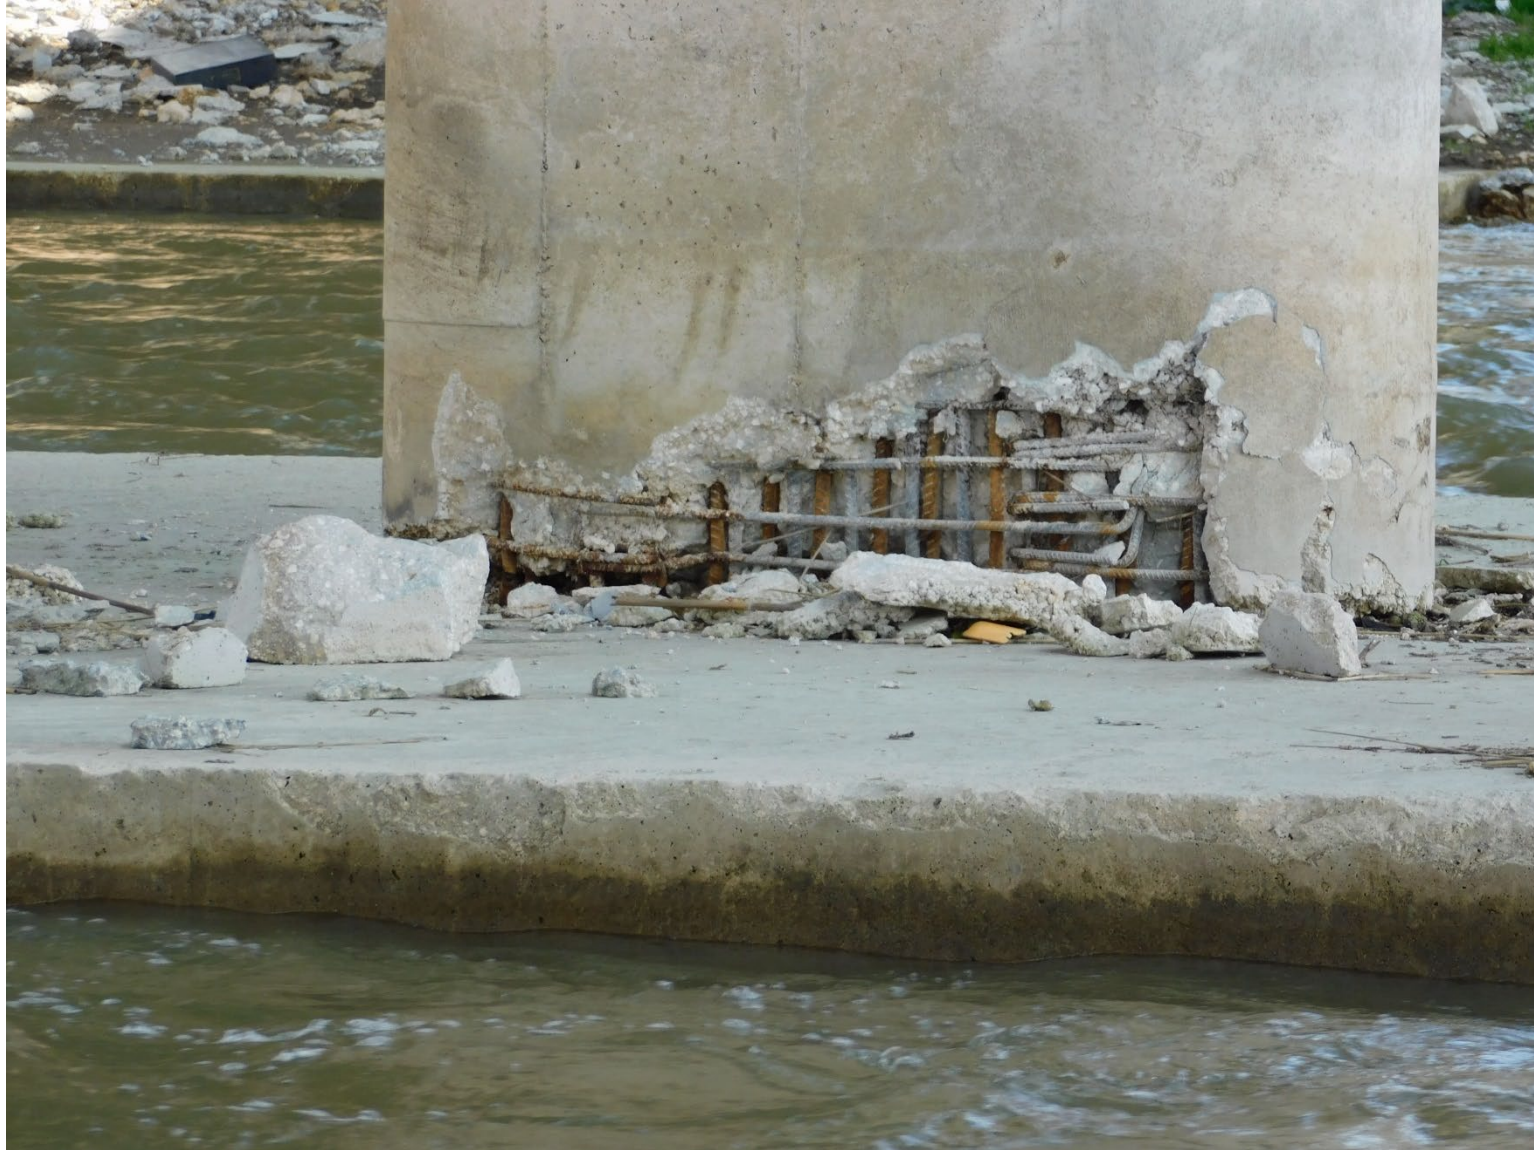
Bridge 2, Plastic Hinge at Base of Column in Weak Direction

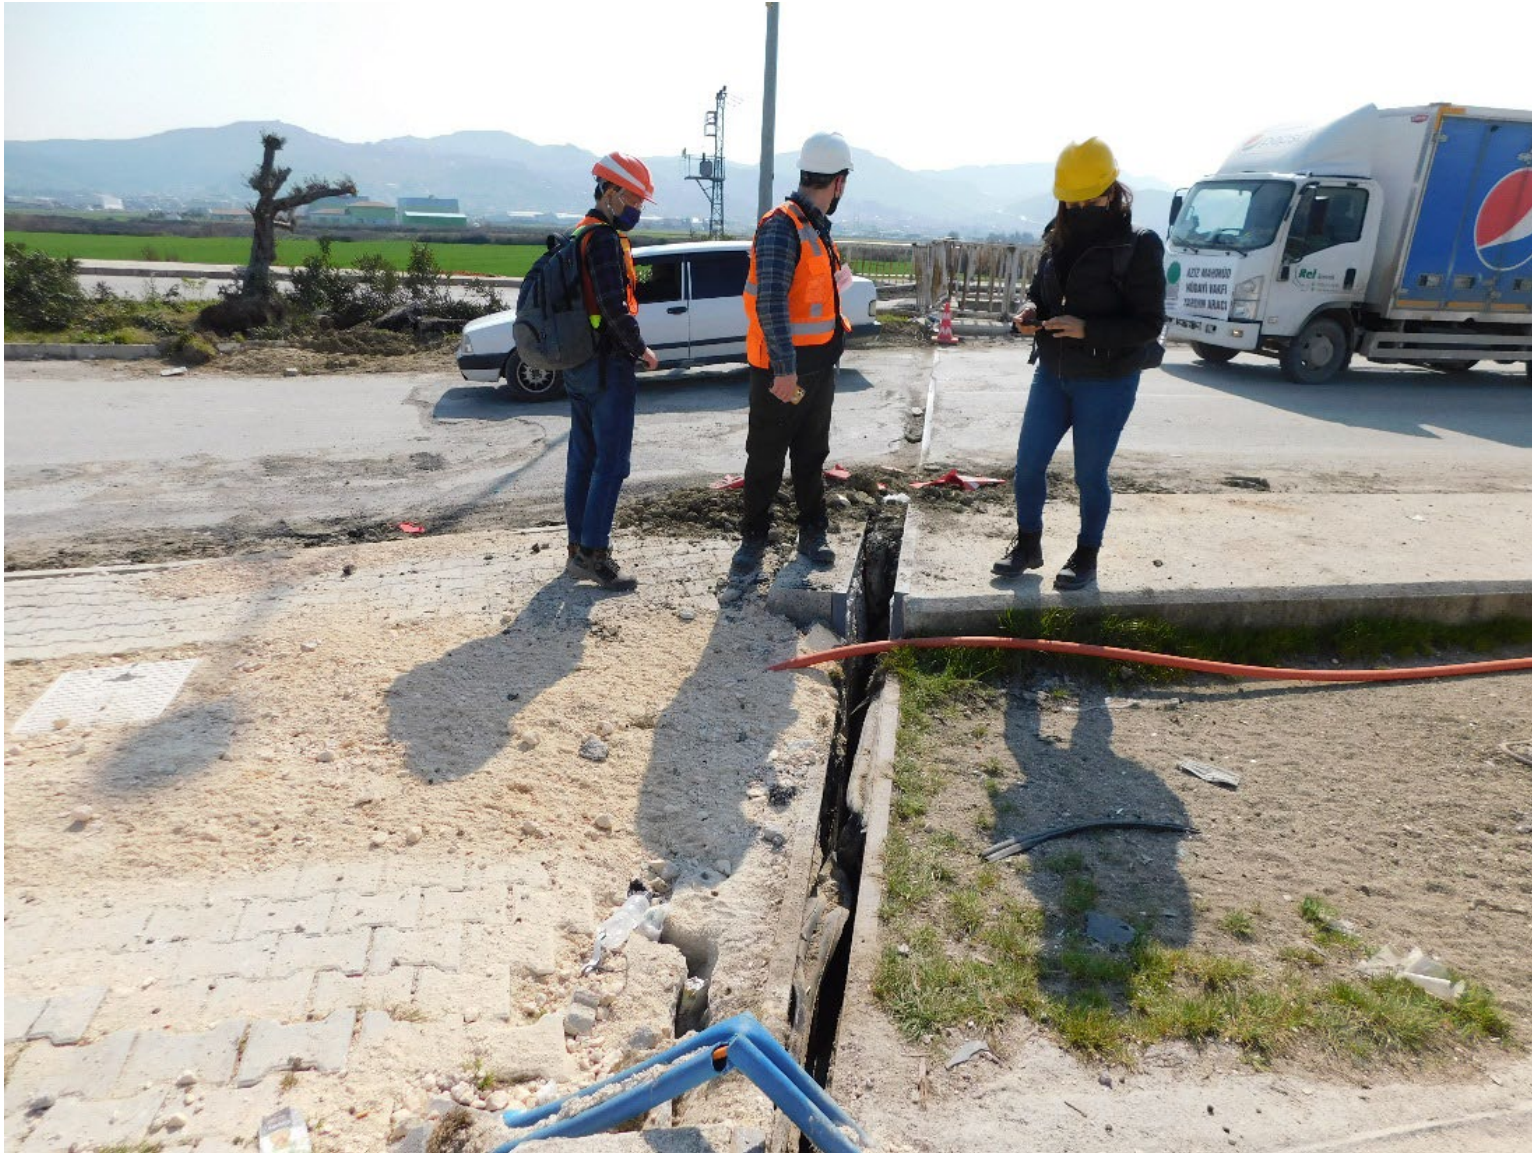
Bridge 2, Approach Settlement

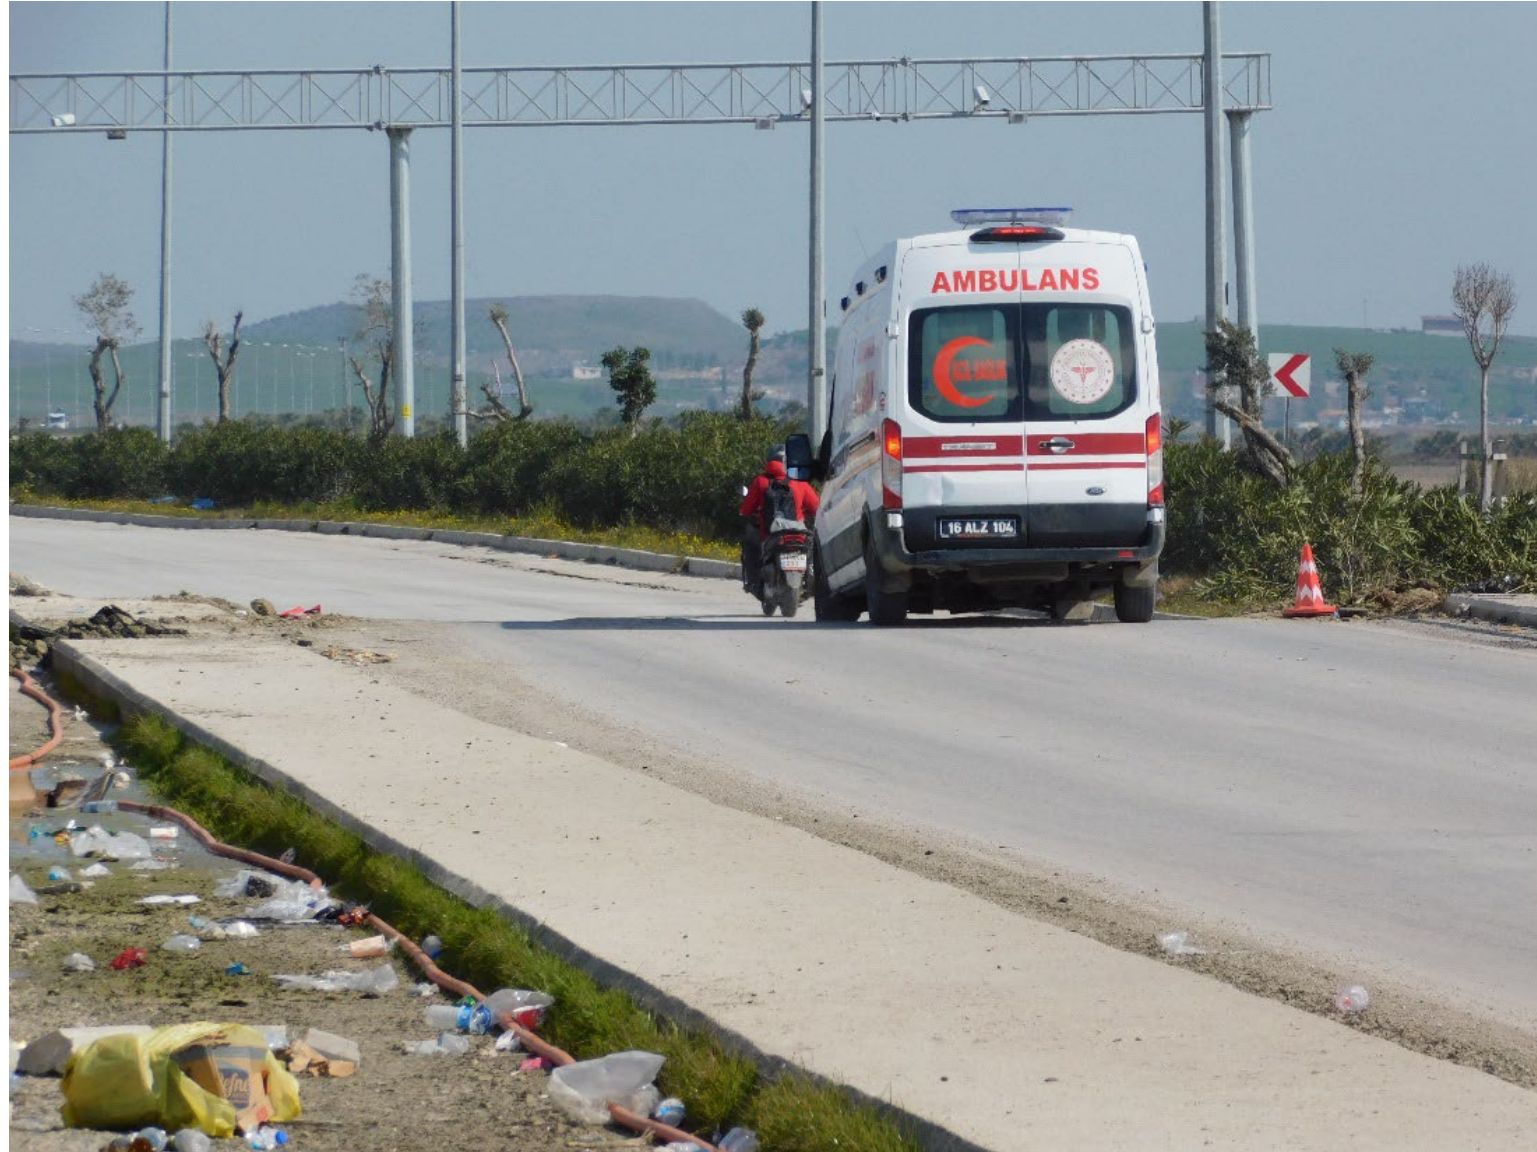
Bridge 2, Approach Settlement

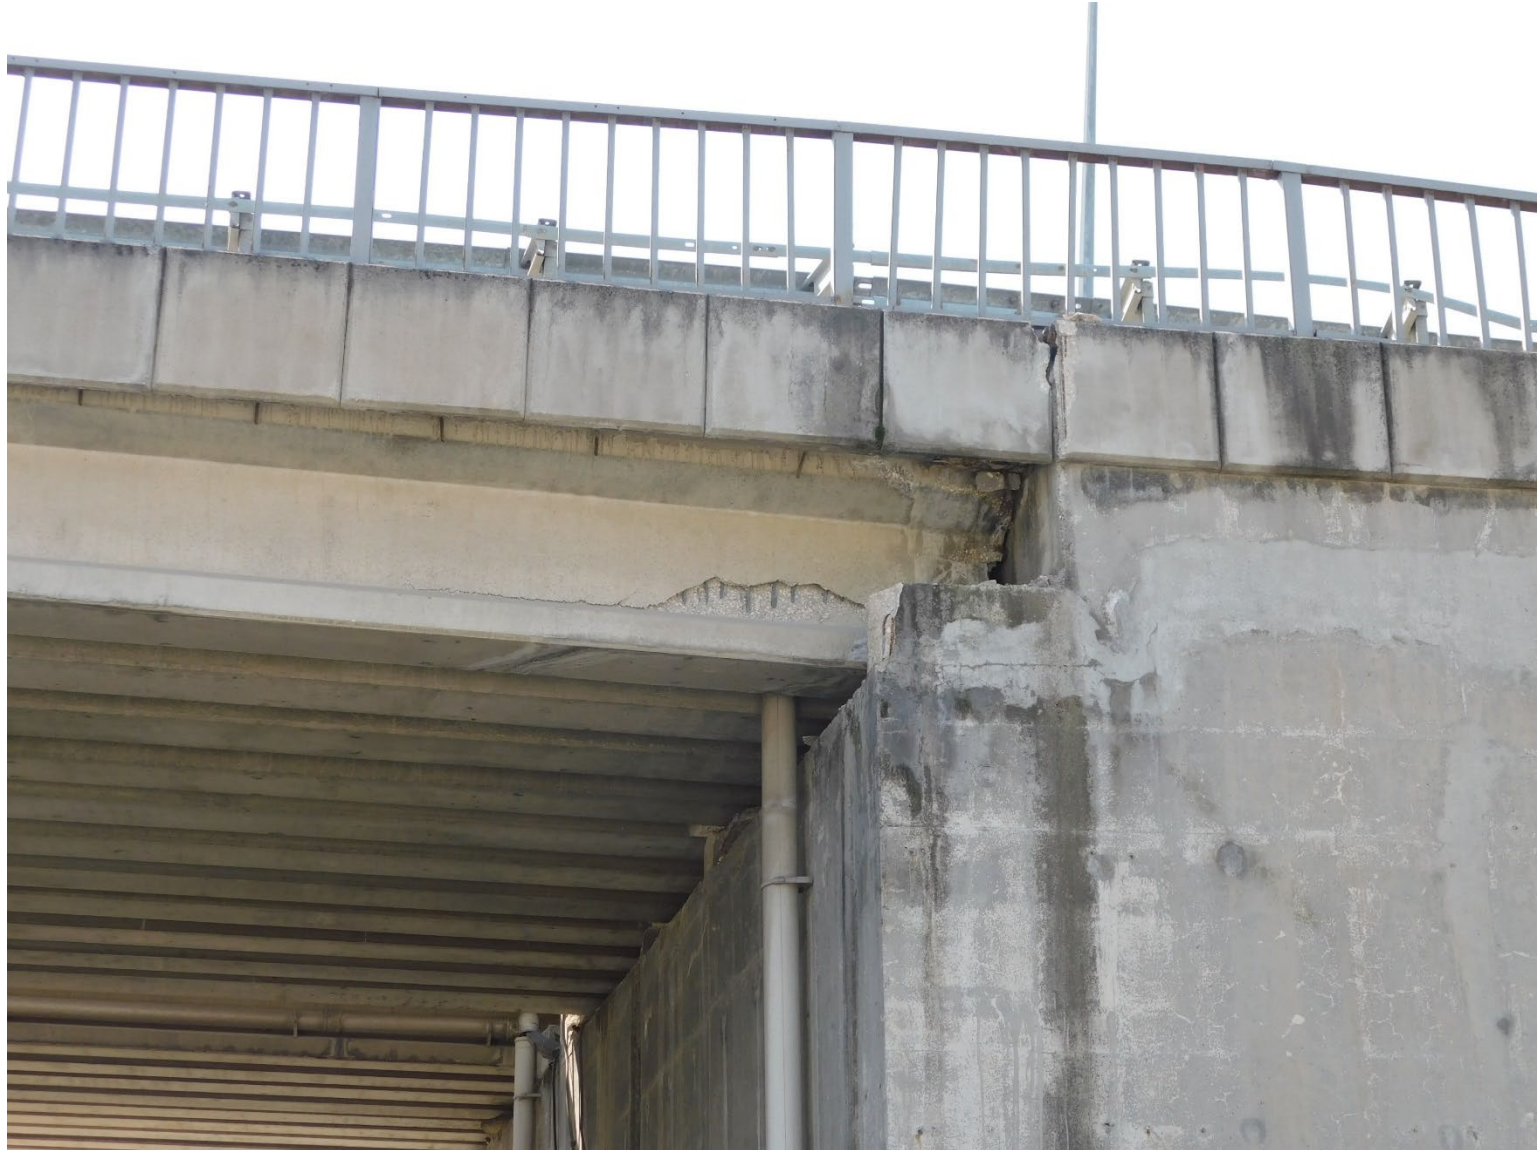
Bridge 3, End-of-Girder Damage

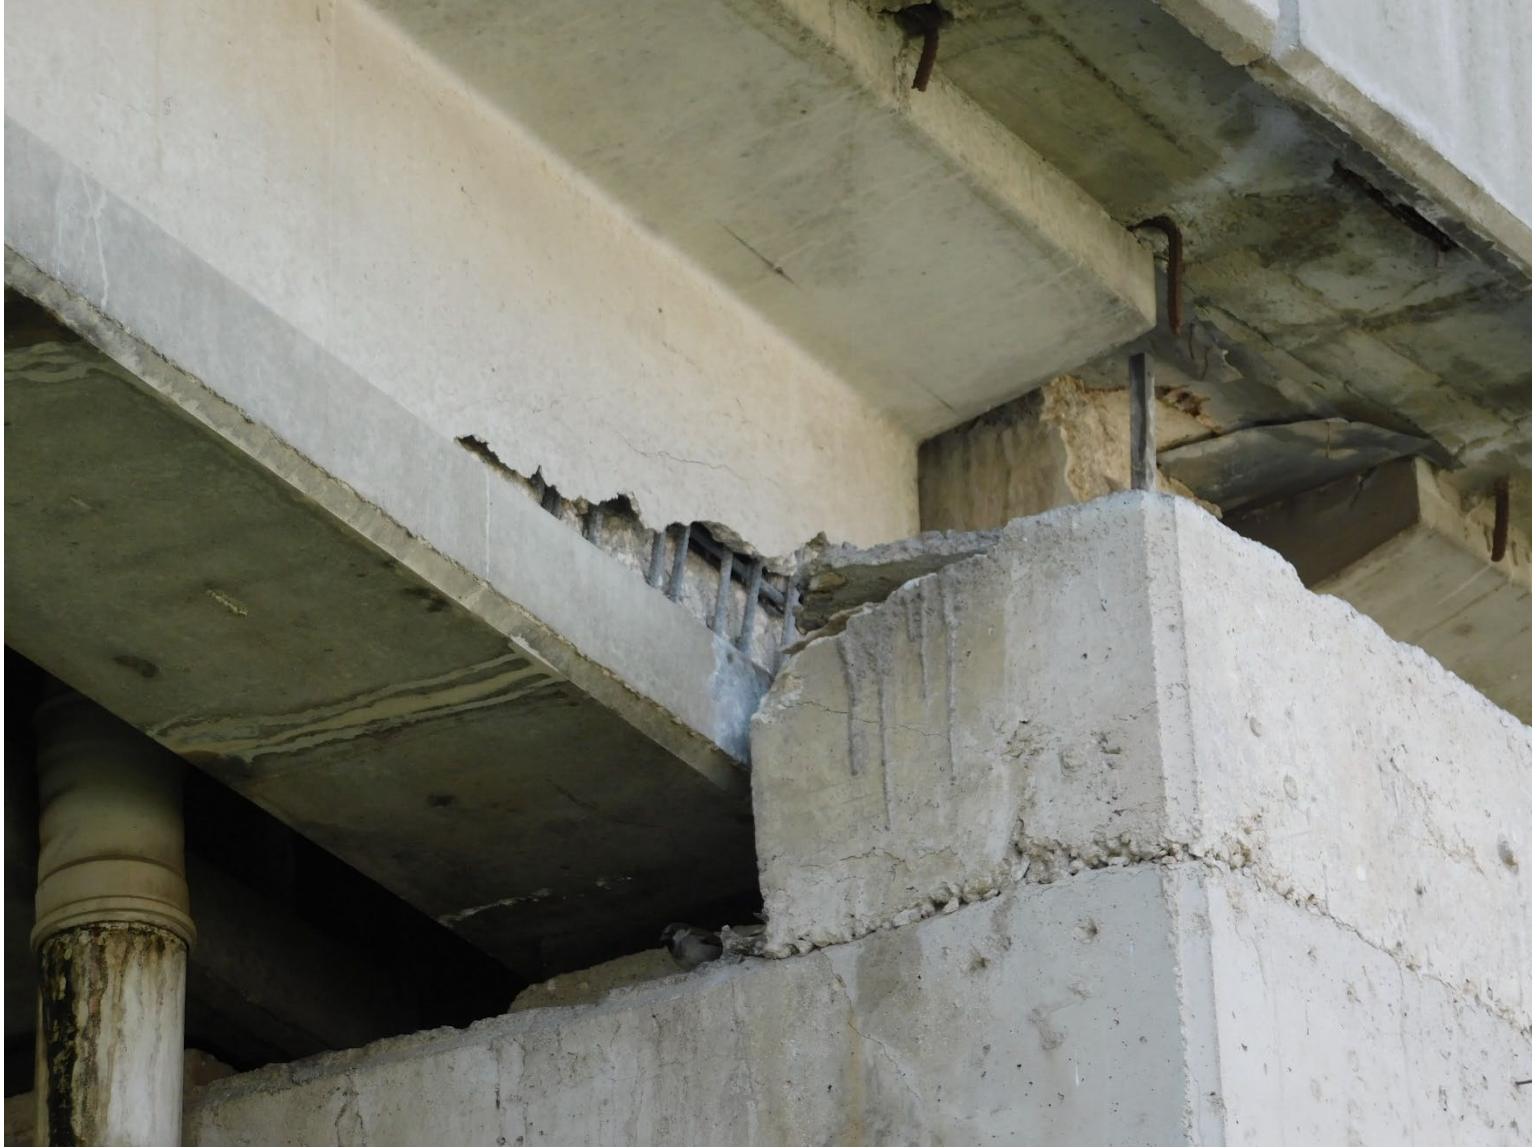
Bridge 3, Close-Up of End-of-Girder Damage
