Observed Structural Bridge Damage from M_w 7.8 Earthquake in Southern Turkiye (Turkey) and Model for Nonlinear Time-History Analysis

Prof. Robert K. Dowell, Ph.D., P.E.
Director, Structural Engineering Laboratory

Structural Engineering Reconnaissance Team (Mountain Goats)

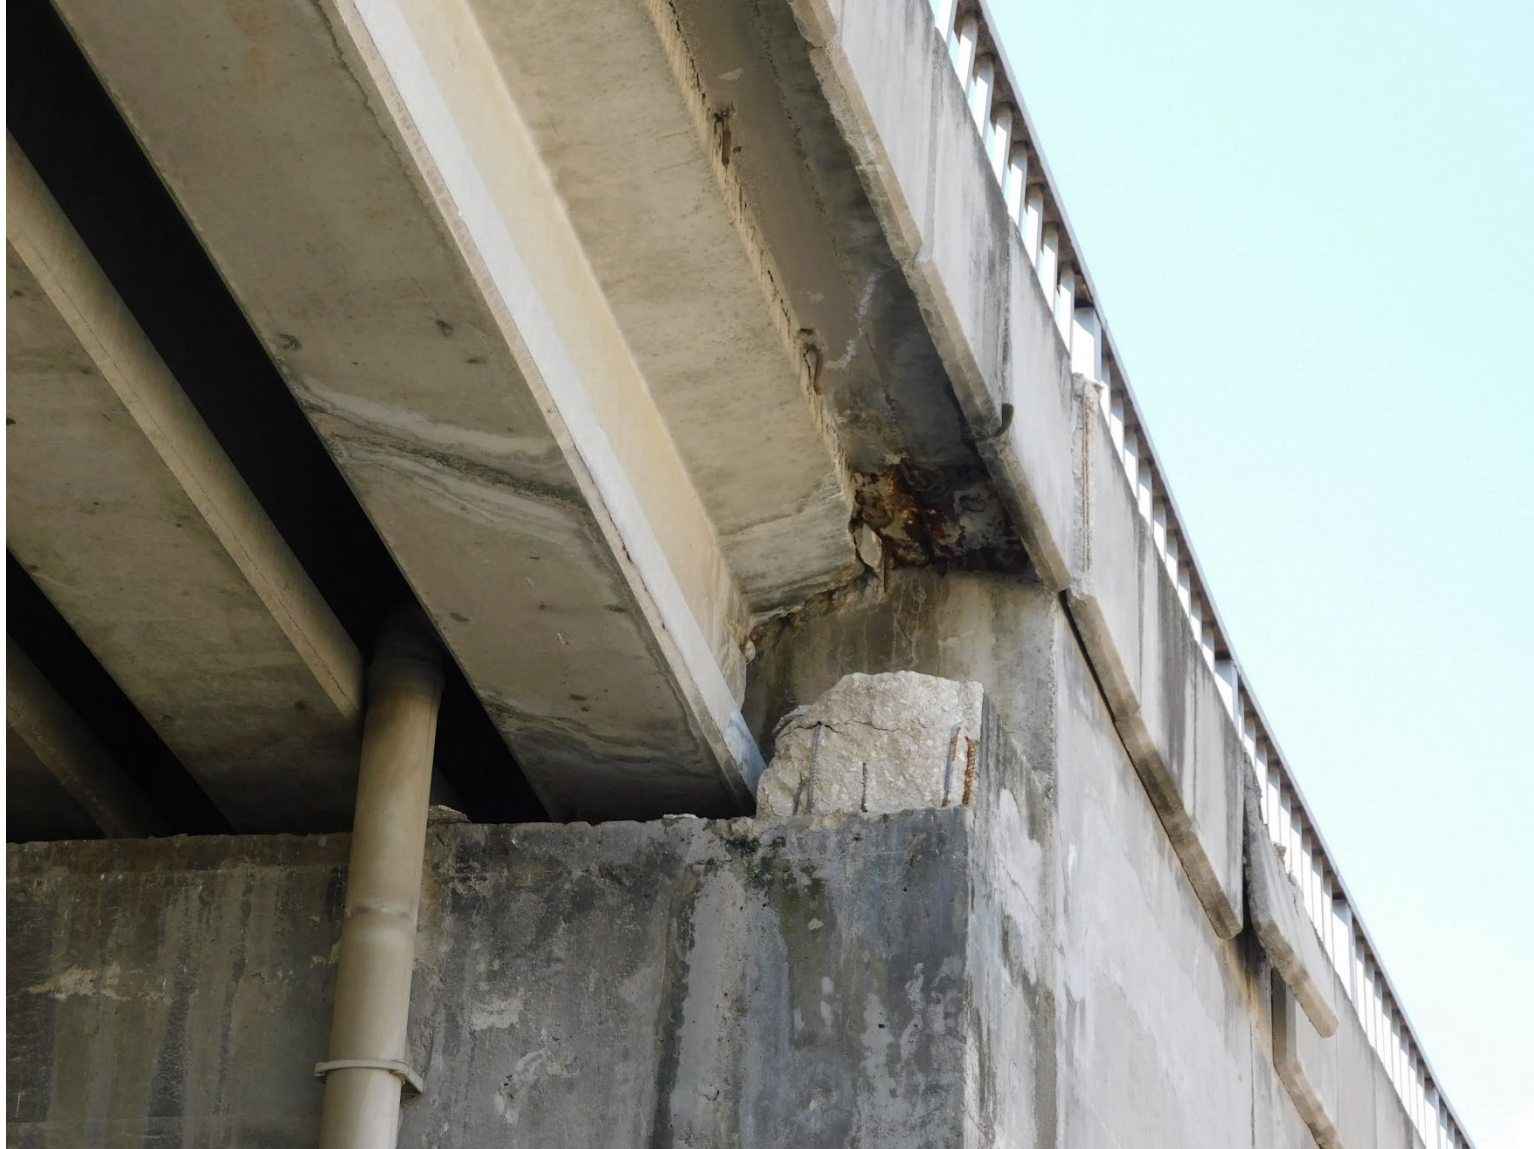
Bridge 3, Exterior Shear Key Damage

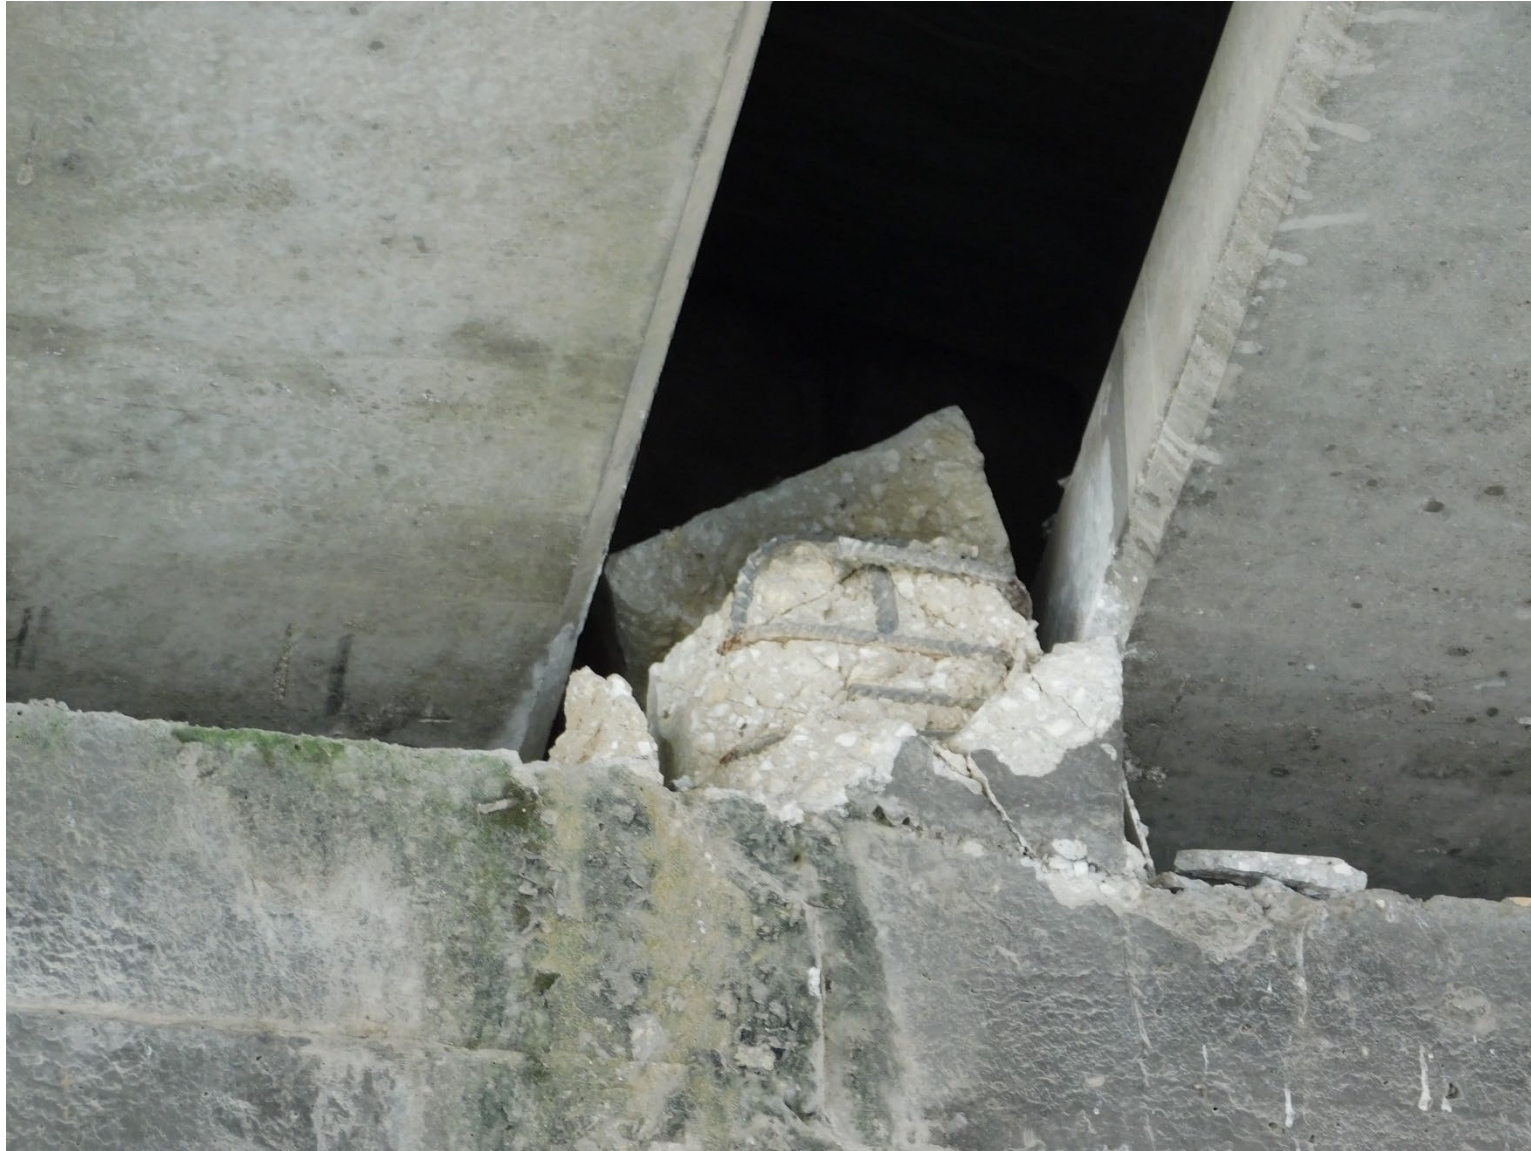
Bridge 3, Interior Shear Key Failure
