Replacement of Ductile Iron Pipes in Early Days

The 6th Taiwan-US-Japan Workshop on Water System Seismic Practices October 15, 2009 TAIPEI

Kazuhiko Fujimura Tokyo Waterworks Service Co., Ltd., Japan (TSS)

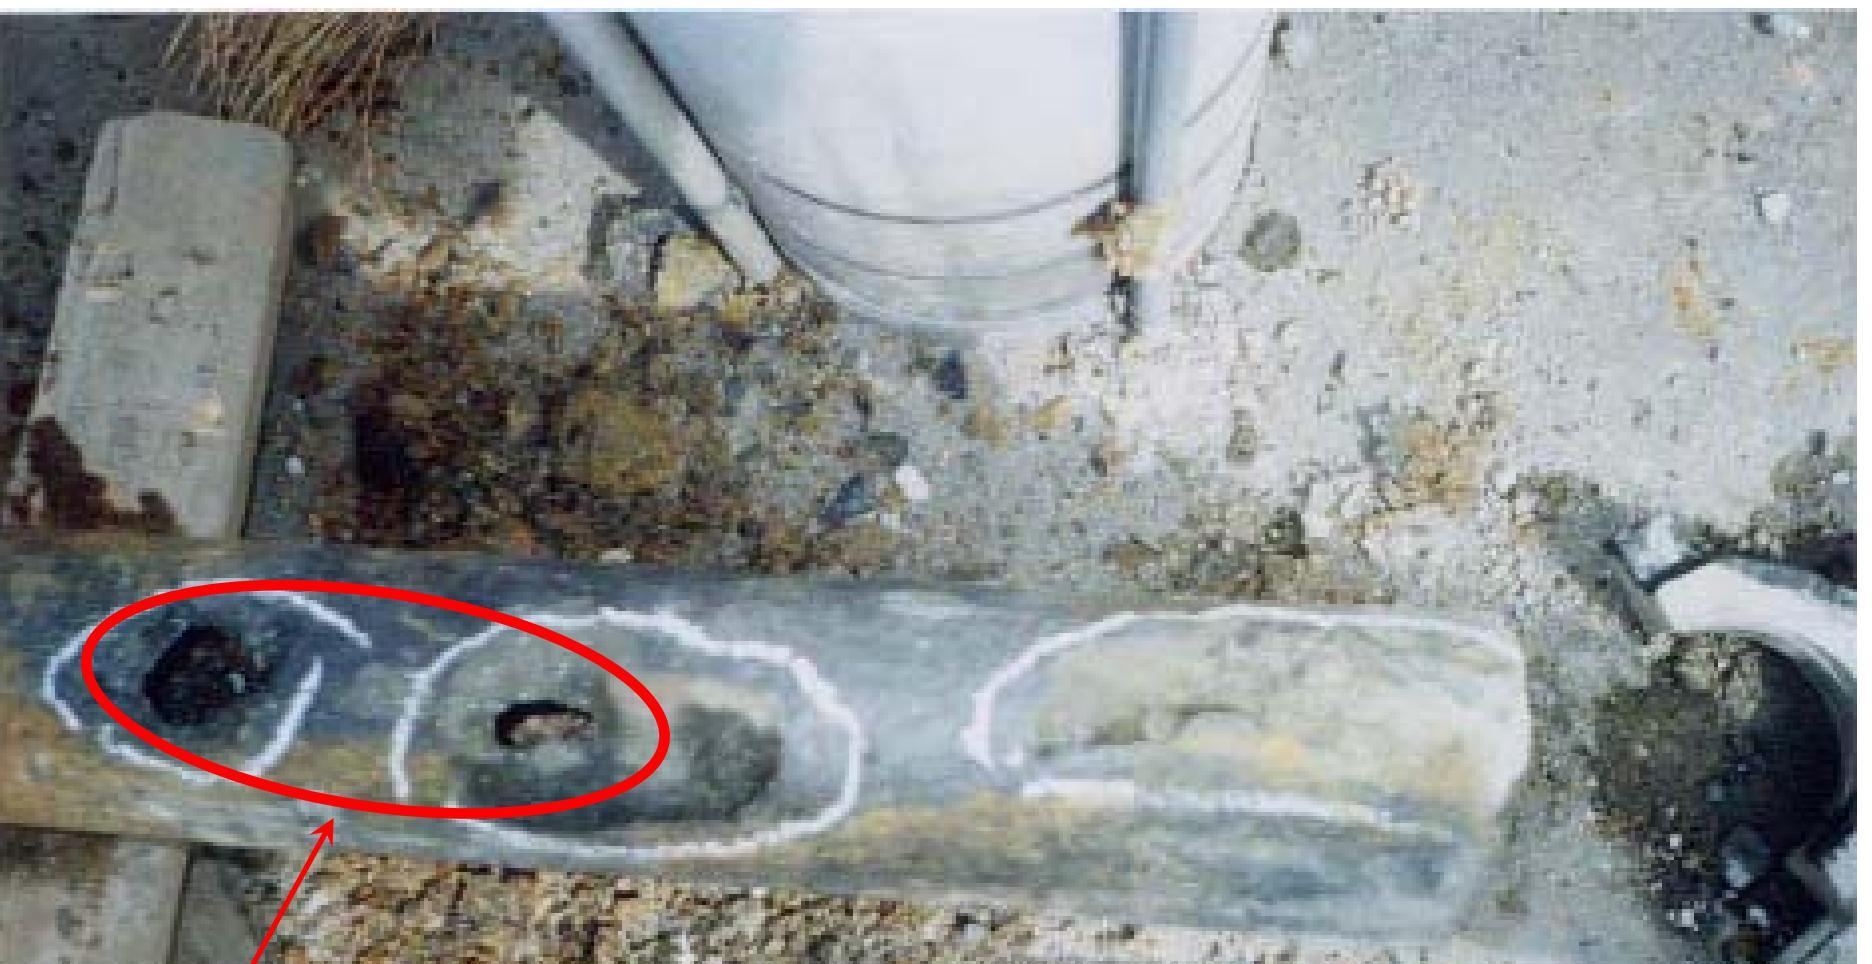
Straight Pipe \$\$\phi150\$
Maximum Depth of Pitting: 8.2mm (Bored through) *Condition of Corrosion (Pitting) outside Pipes*

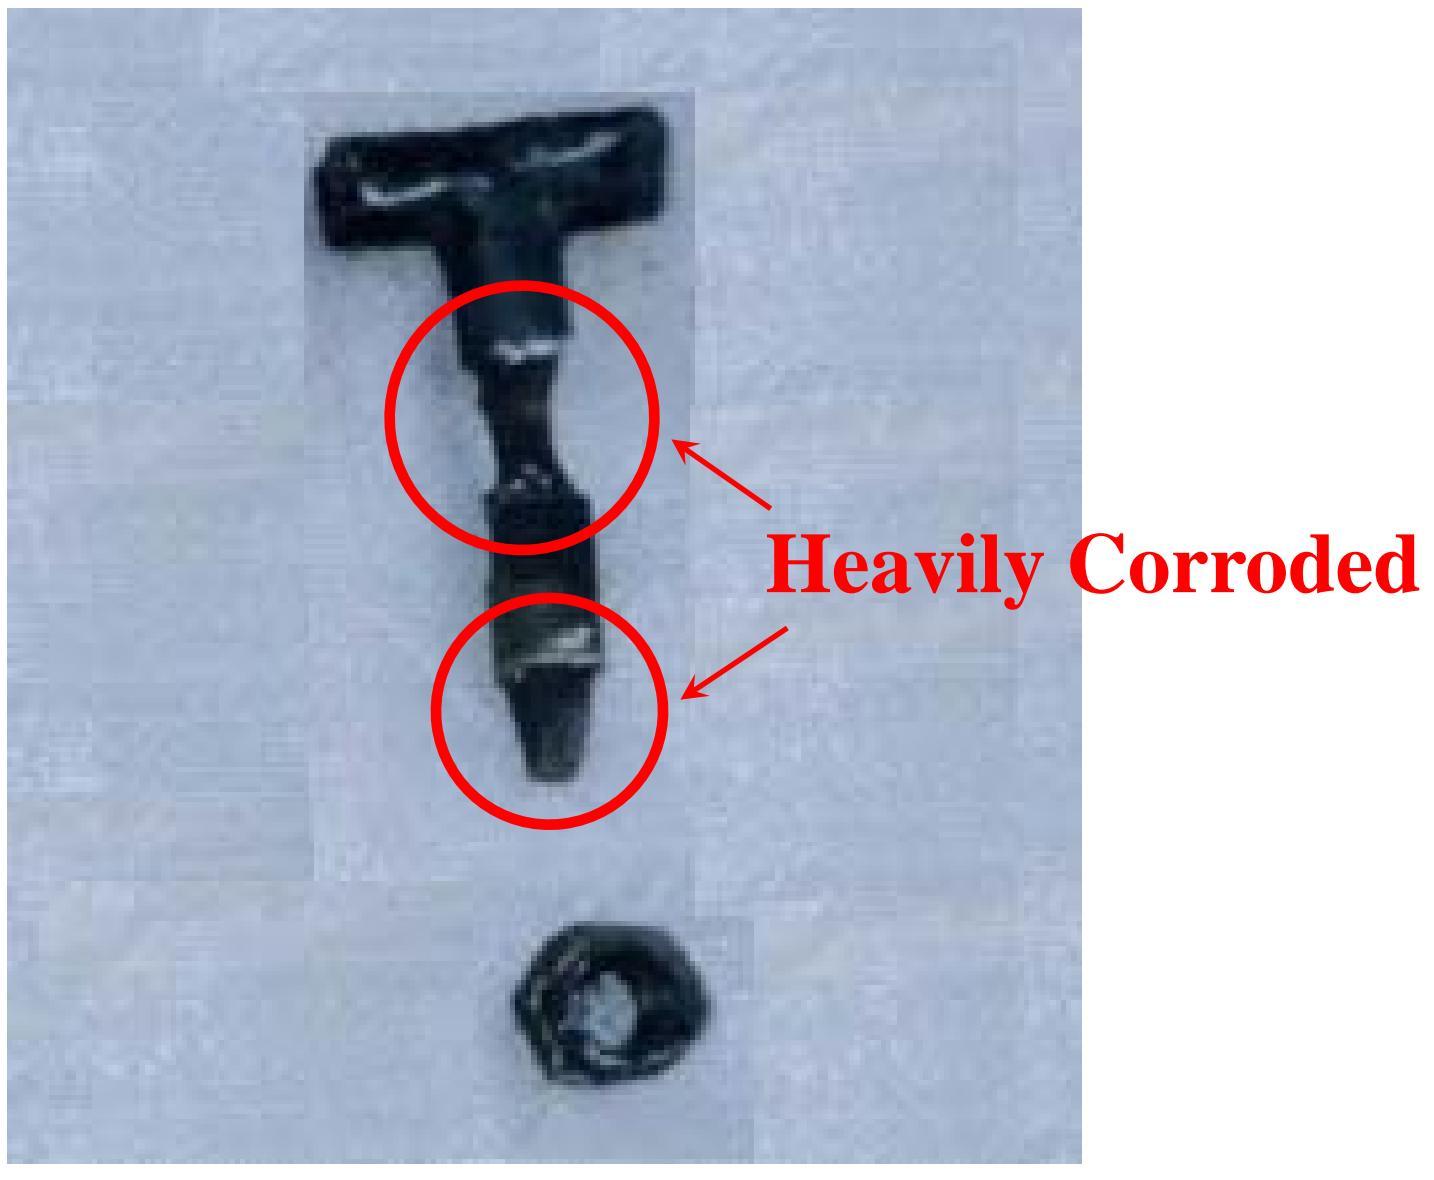
Corroding Condition of Bolts

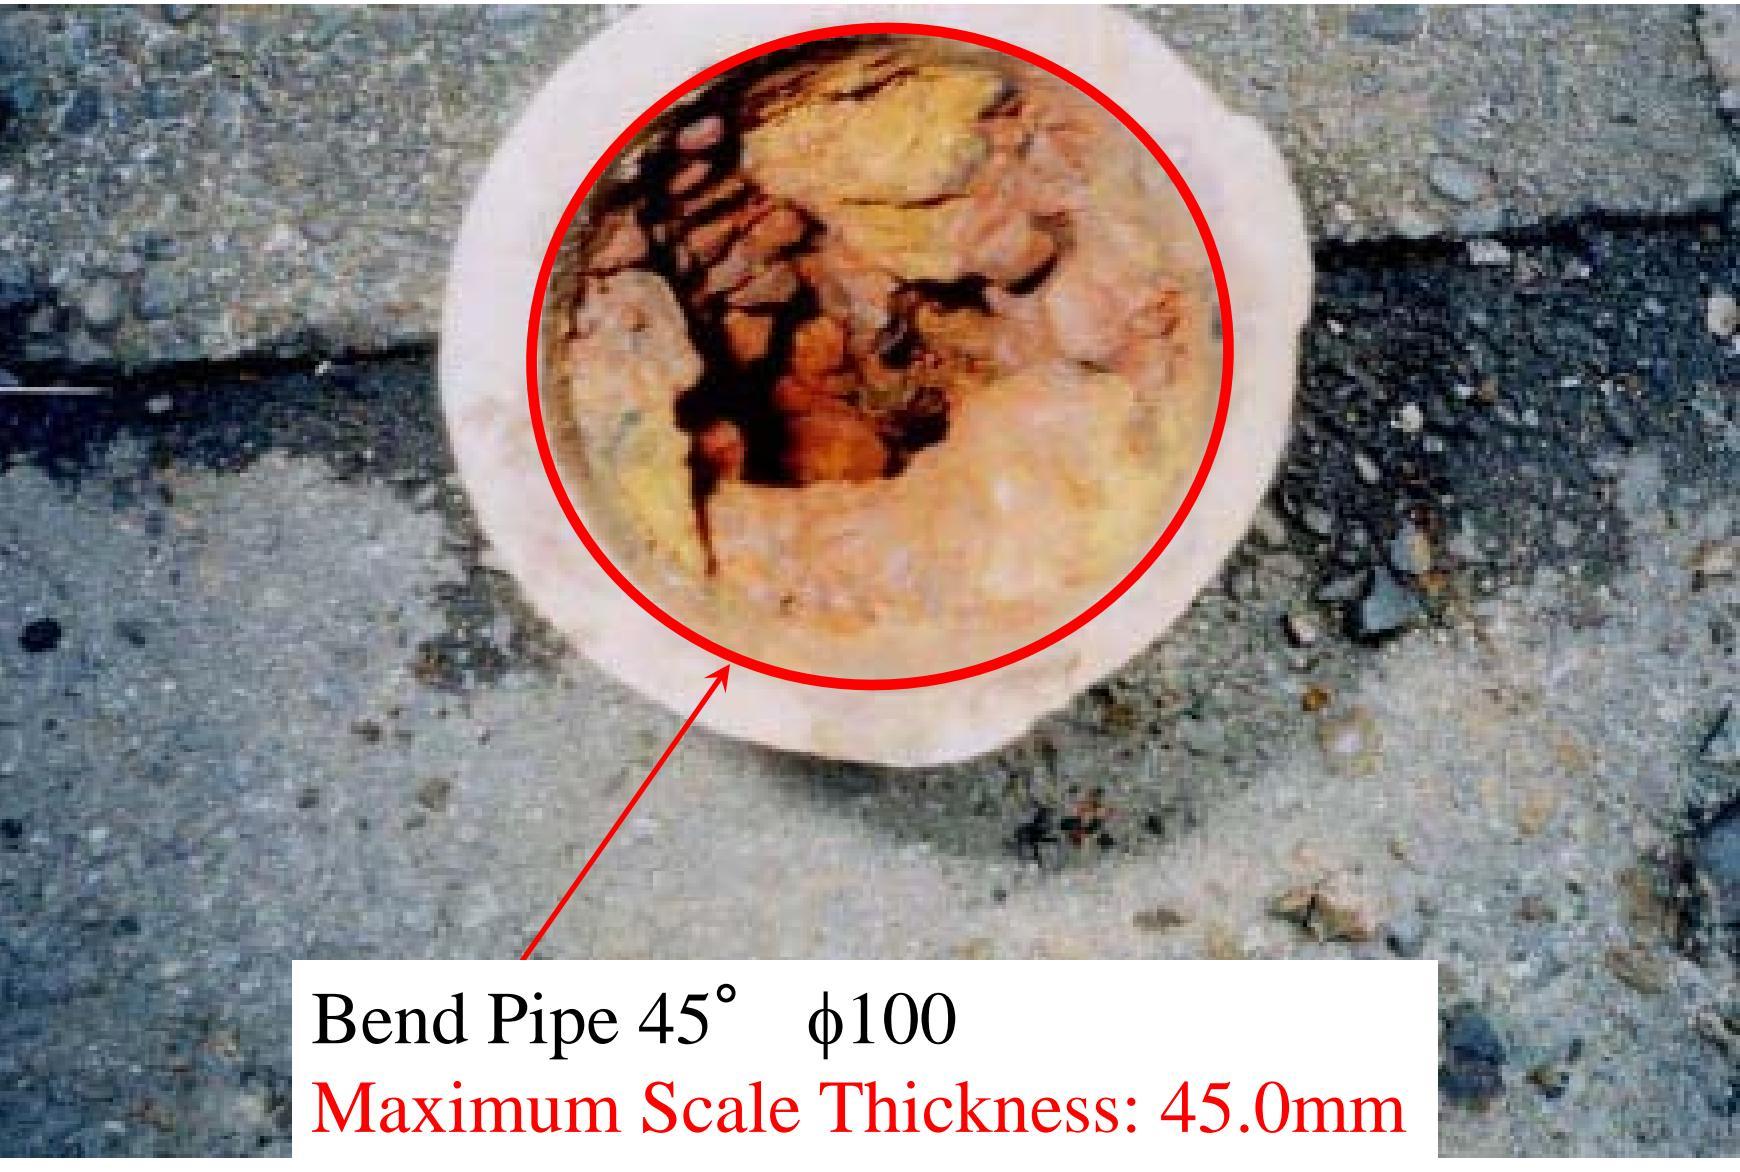
Sticking Condition of Scale inside a Pipe
