WATER SUPPLY FACILITIES DAMAGES BY THE 1999 CHI-CHI EARTHQUAKE AND THE AFTERSHOCK RESTORATION WORKS

Dr. LIAO, Tsung-Shen Chairman

Chinese Taiwan Water Work Association

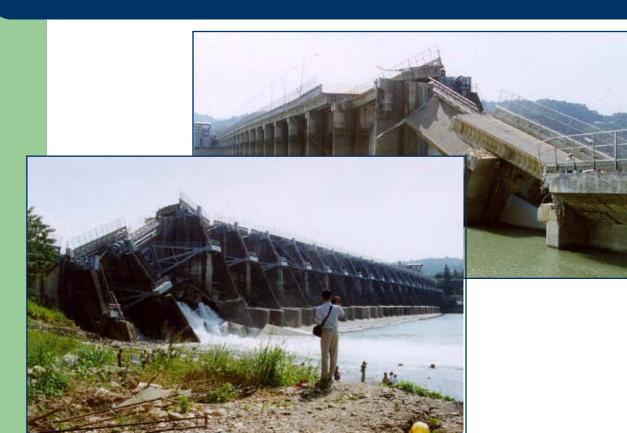
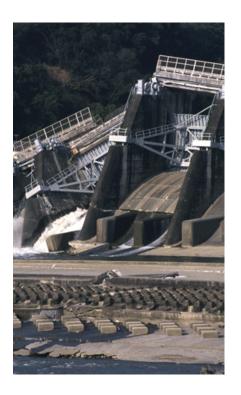
DAMAGE TO THE SHIGARNG DAM IN THE CHI-CHI EARTHQUAKE

9.8 m offset fault in vertical direction

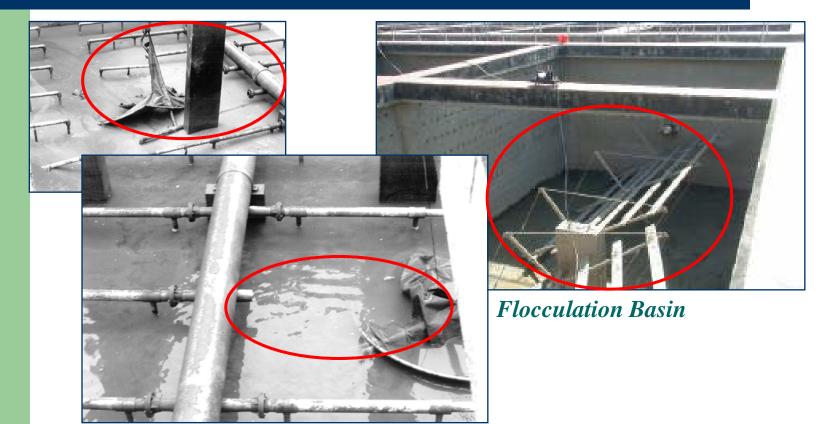
DAMAGE TO THE FONGYUAN PURIFICATION PLANT IN THE CHI-CHI EARTHQUAKE -1

Flocculation and Sedimentation Basin

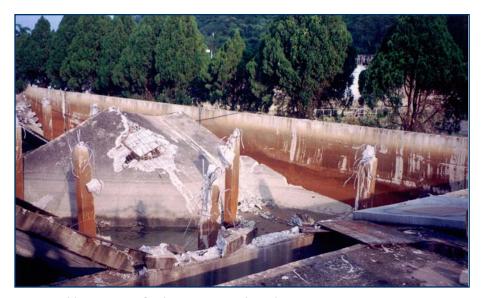
DAMAGE TO THE FONGYUAN PURIFICATION PLANT IN THE CHI-CHI EARTHQUAKE – 2

Finished Water Reservoir

Collapse of the Finished Water Reservoir

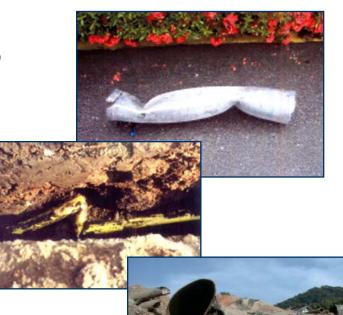
DAMAGE TO THE WATER PIPELINES

• In the Chi-Chi earthquake, the area of the subsurface damage to water pipelines is much larger in size than the area of abovesurface structural damage.

• The site investigations approximate a total length of damaged water pipelines of around 16,000 km, including 12,000 km of primary water supply lines (≥300 mm).

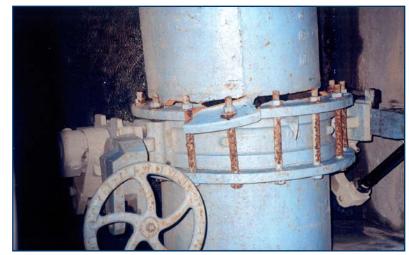
- SP, CIP, DIP, PE and PVC, are used for the pipelines of the TWC water supply system.
- The steel pipes (SP) and the polyethylene (PE) pipes were both received only small damage in the Chi-Chi earthquake.
- The joint of the PVC pipe seems very vulnerable in the earthquake. For other types of pipe, such as the DIP pipes, the damage to segmented pipes most often occurs at the joint too.

Damage to 600 mm Pipe in the Fongyuan Purification Plant
