## SEISMIC STRUCTURAL ASSESSMENT OF DAMAGED CHITTAGONG PUBLIC LIBRARY BUILDING DURING 27 JULY 2003 EARTHQUAKE

### ABSTRACT

Seismic structural damage assessment is a part of post earthquake disaster management program. During the Rangamati Earthquake of Chittagong Hill Tracts in July 27, 2003, the only Public Library located at Chittagong was severely affected and undergone various degrees of damages. This paper deals with the physical damages as well as structural strength assessment of the damaged Public Library building. A detailed overview of several seismic damage evaluation documents framed by FEMA 310 has been elaborated and incorporated for seismic structural strength assessment process. Finite element frame analysis is used incorporating Bangladesh National Building Code (BNBC) seismic provisions. The difficulties existing in the structural system planning of the damaged Chittagong Public Library building and design discrepancies are documented and probable suggestive measure are highlighted in this paper.

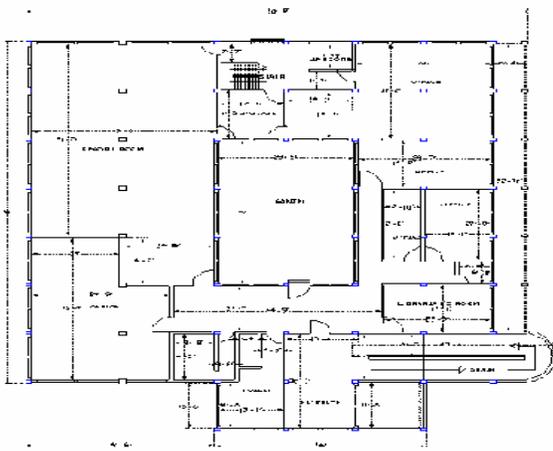
Figure 4. Typical Floor Plan

The structural member hasn't sudden change in stiffness along both horizontal & vertical direction, which yields better results to seismic resistance. This building has excessive openings (about 50%) at side masonry walls, which doesn't yield positive results. Hence the corner where the building changes its direction has become seismically vulnerable, as there is a possibility to occur a stress reentrant phenomenon during an earthquake. Although the length of the building is more than 100 ft, no expansion joint is provided in the building. This also makes the structure seismically vulnerable.
