Recent Topics related to Seismic Safety of Dams

Tatsuo OHMACHI

Professor, Tokyo Institute of Technology

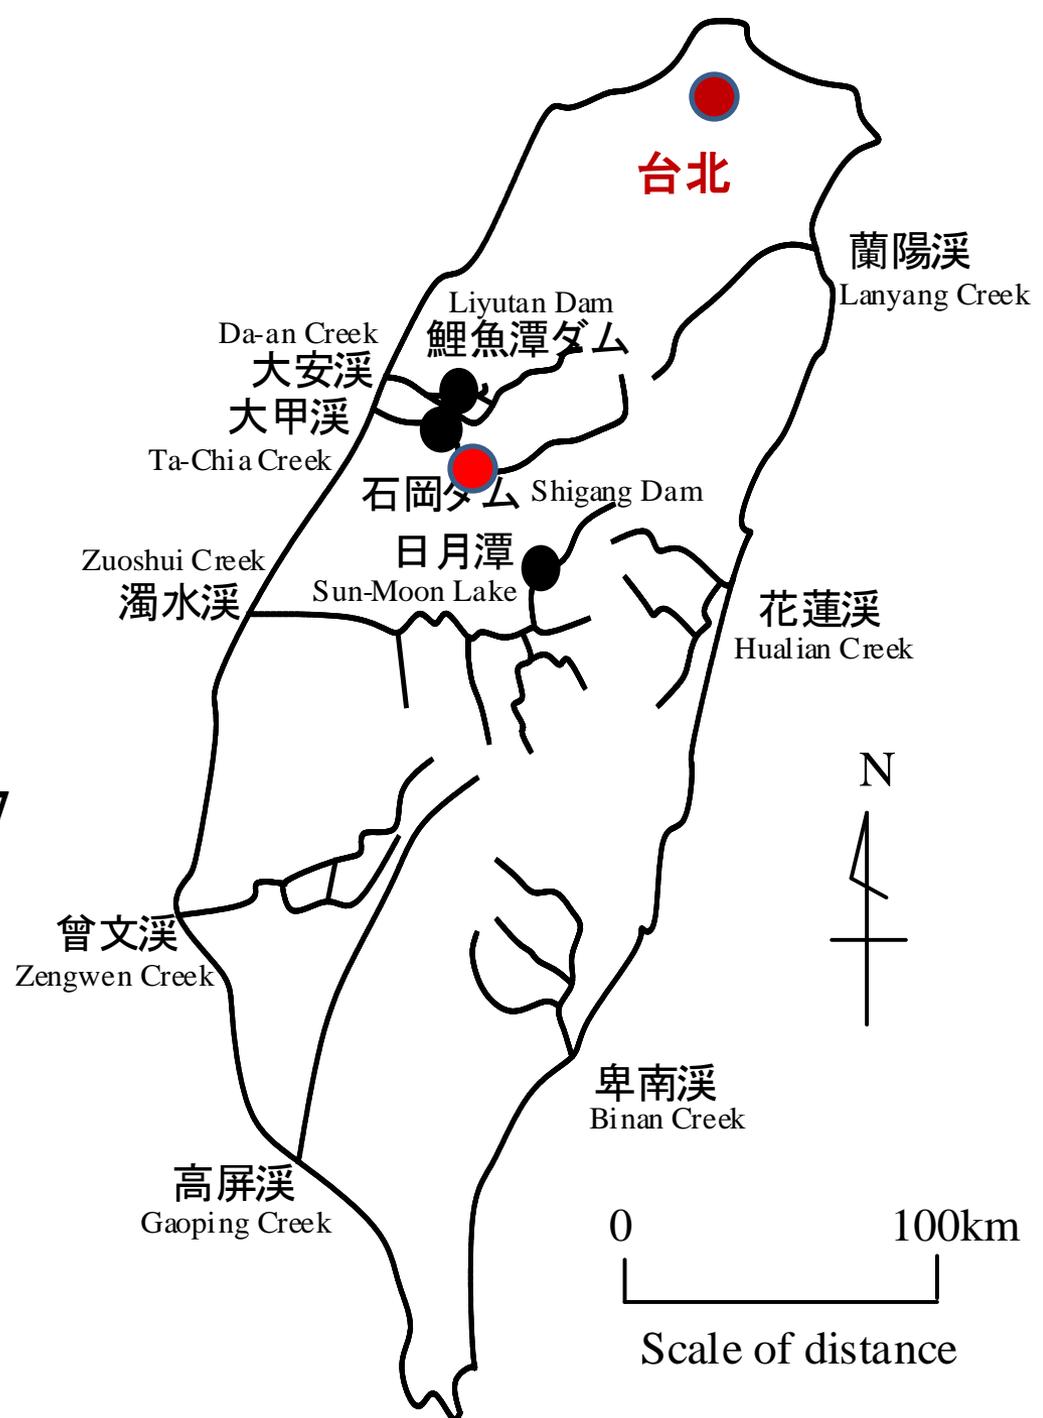
- The Earthquake struck Taiwan at 1:47 a.m. (local time) on Sept. 21,1999, causing the collapse of Shih-Kang Dam constructed in 1977.

- The dam was a 357 m long concrete gravity dam, equipped with 18 spillway gates and 2 sediment flushing gates.
- **Mainly due to seismic faulting crossing the dam foundation, the right half of the dam was crushed to pieces, and offset about 8.5m**
- No casualty was reported, as a result of the dam break.

Shih-kang Dam was restored and has been in use still now.

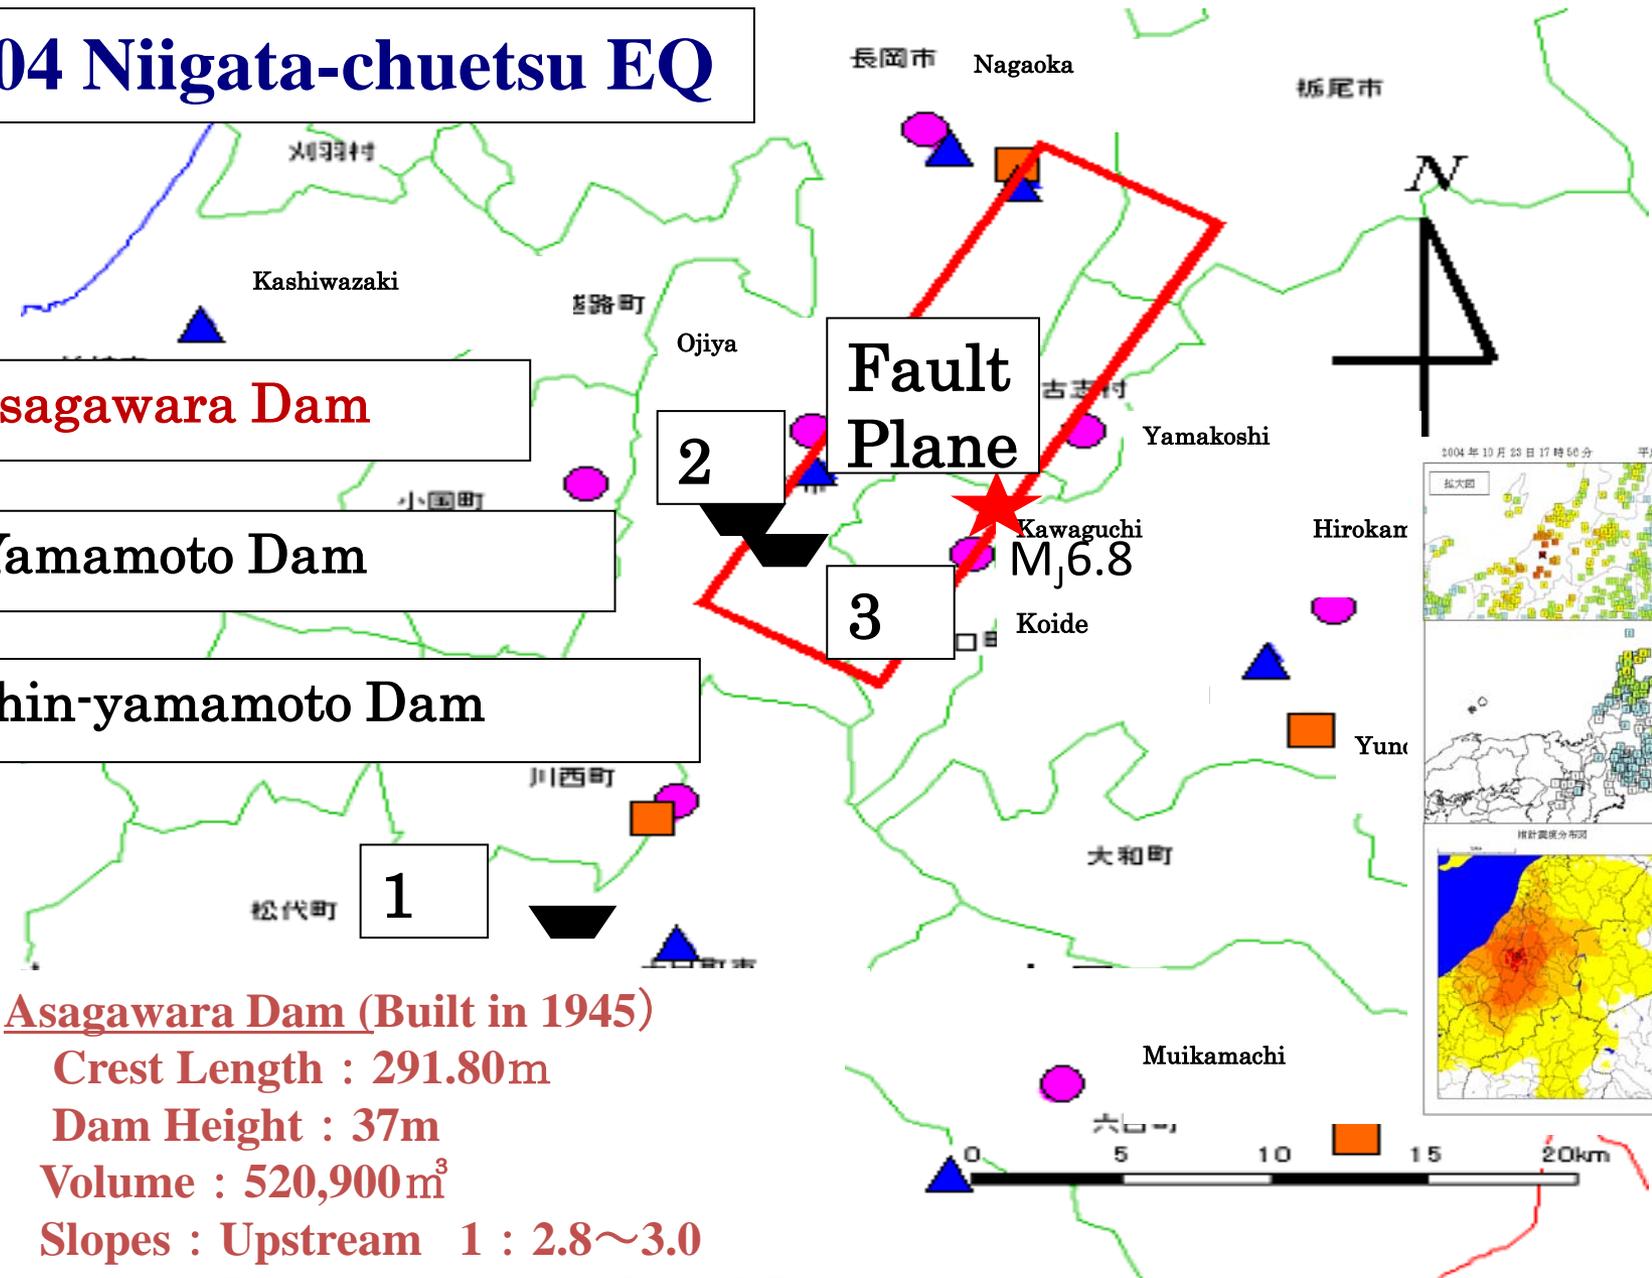
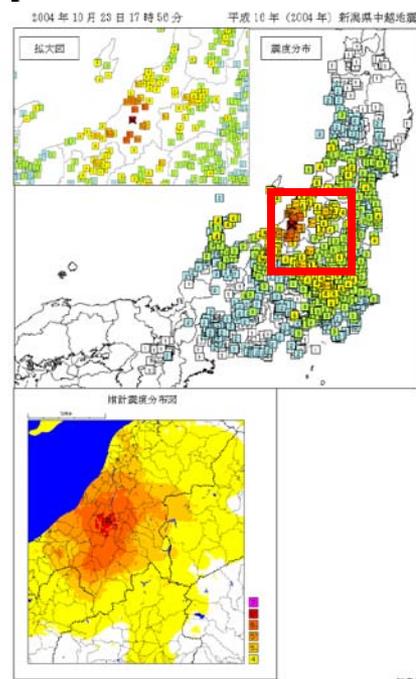
2004 Niigata-chuetsu EQ

Asagawara Dam (Built in 1945)
Crest Length : 291.80m
Dam Height : 37m
Volume : 520,900m³
Slopes : Upstream 1 : 2.8~3.0
Downstream 1 : 2.0~2.5

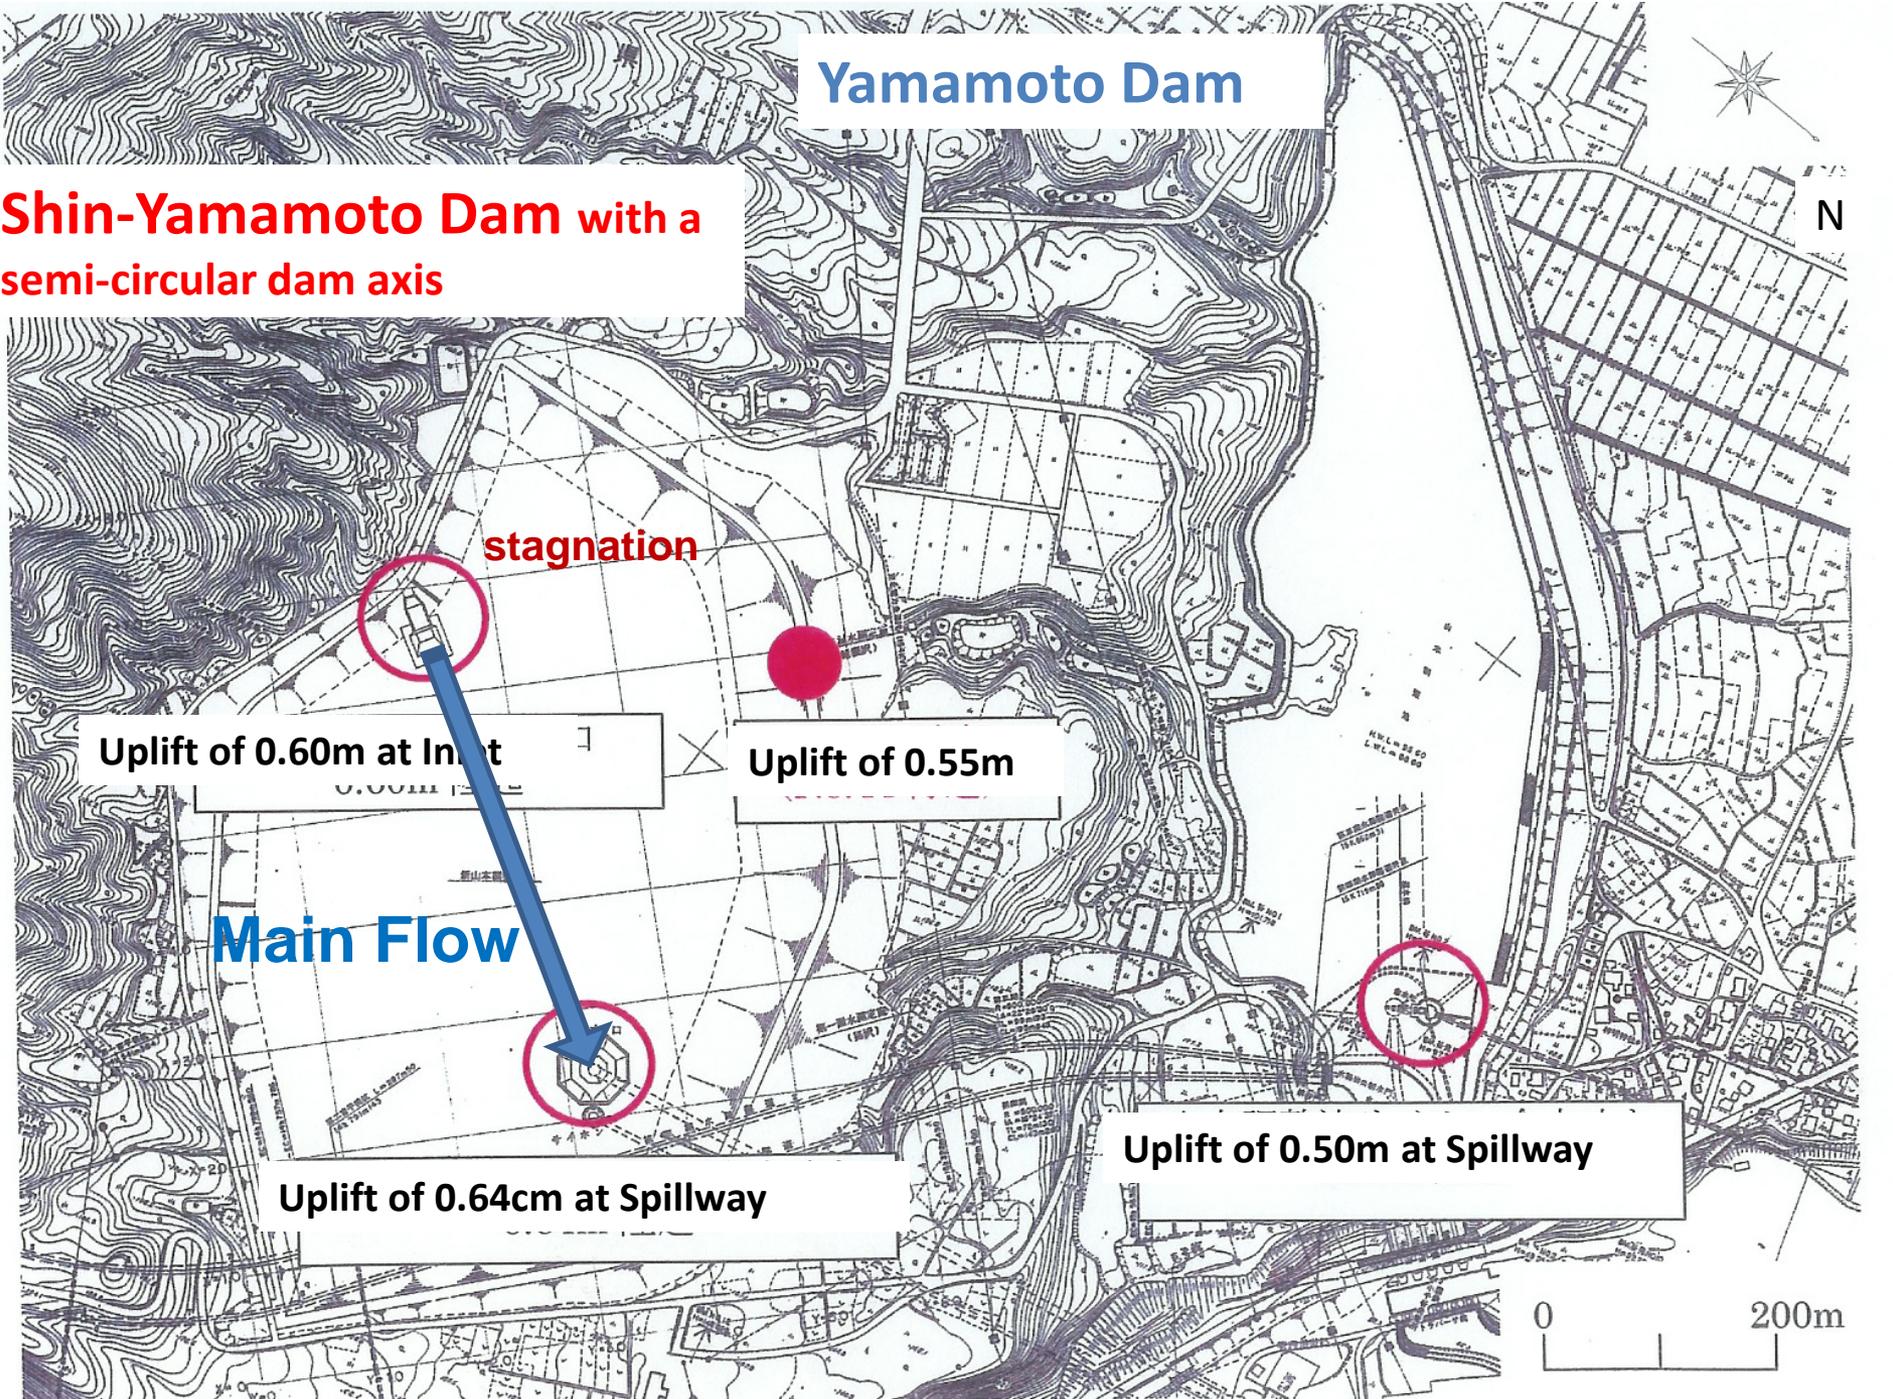
Shin-Yamamoto Dam with a semi-circular dam axis

Uplift of 0.60m at Inlet

Uplift of 0.55m

Uplift of 0.50m at Spillway

Uplift of 0.64cm at Spillway

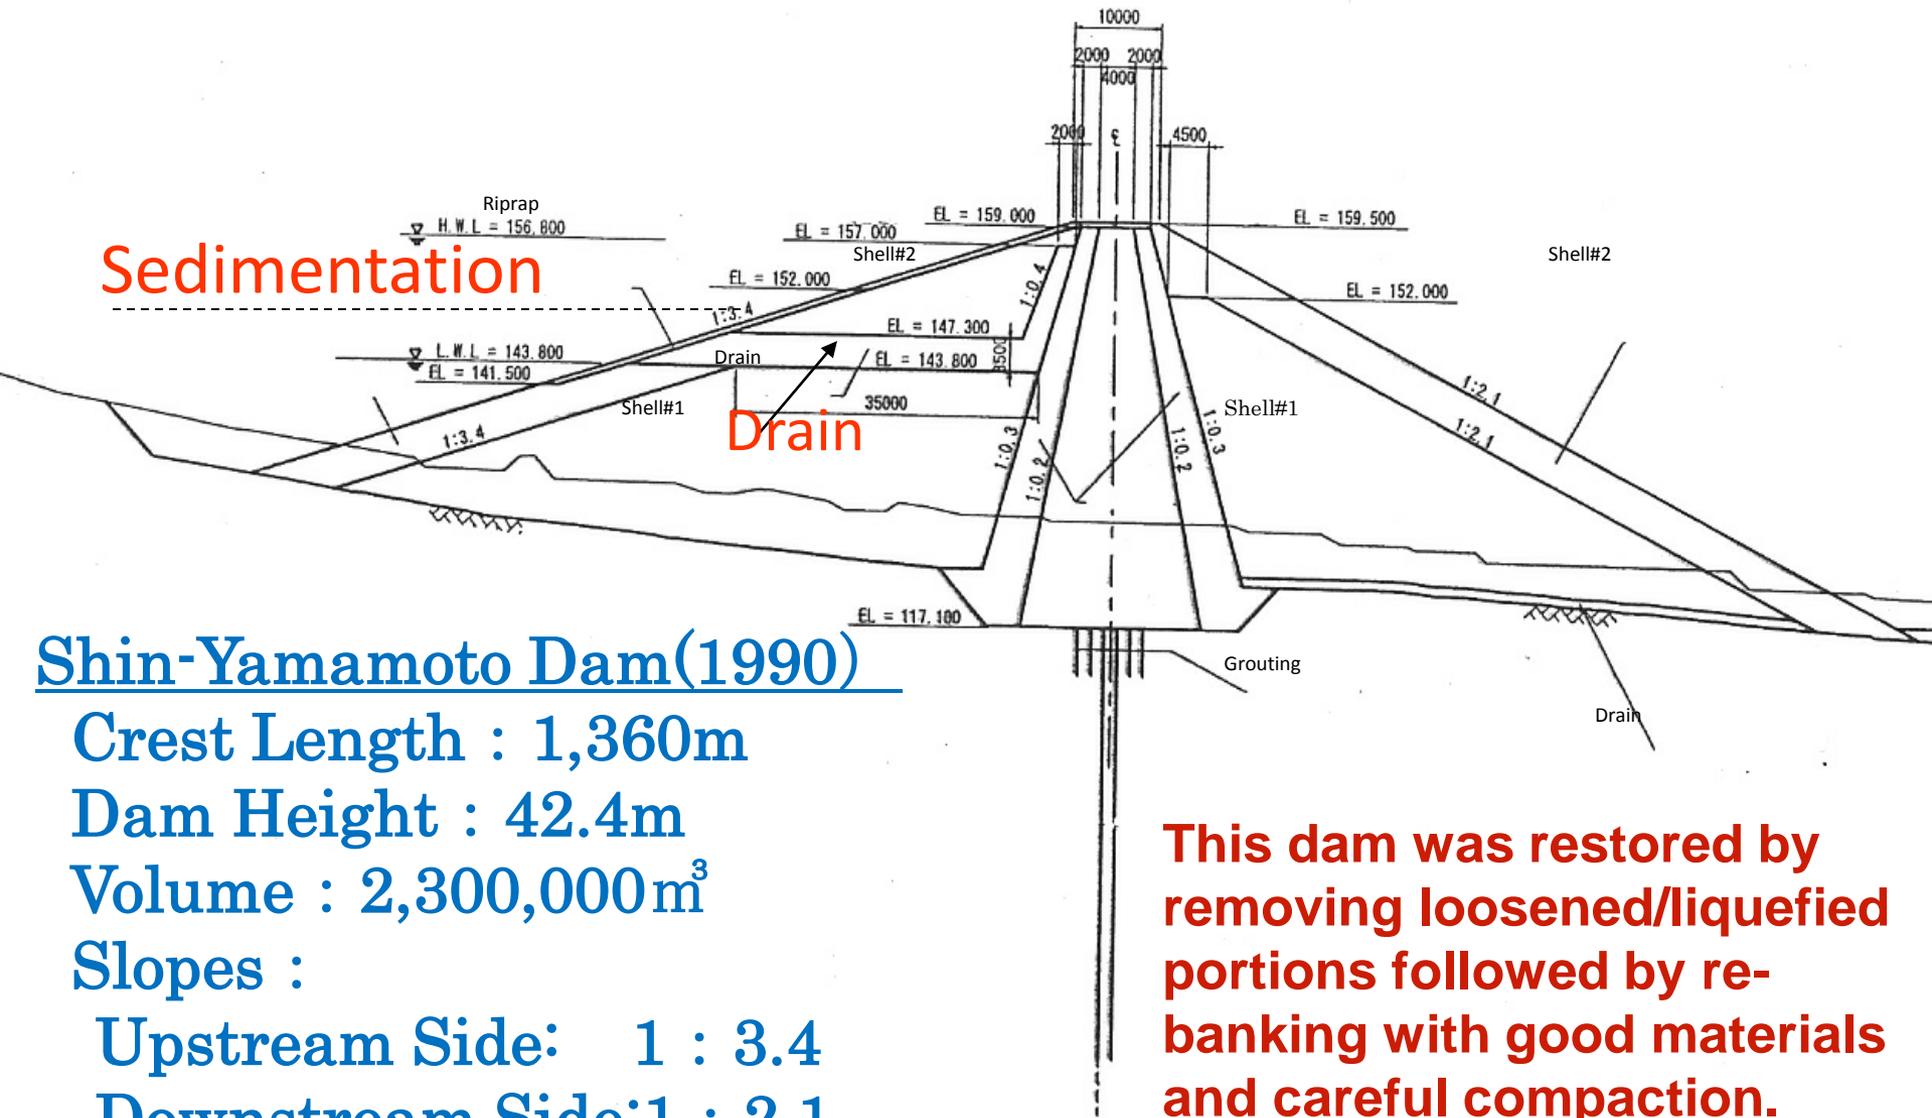
Standard Cross Section of Shin-Yamamoto Dam

Shin-Yamamoto Dam(1990)

- Crest Length : 1,360m
- Dam Height : 42.4m
- Volume : 2,300,000m³
- Slopes :
 - Upstream Side: 1 : 3.4
 - Downstream Side: 1 : 2.1

This dam was restored by removing loosened/liquefied portions followed by re-banking with good materials and careful compaction.

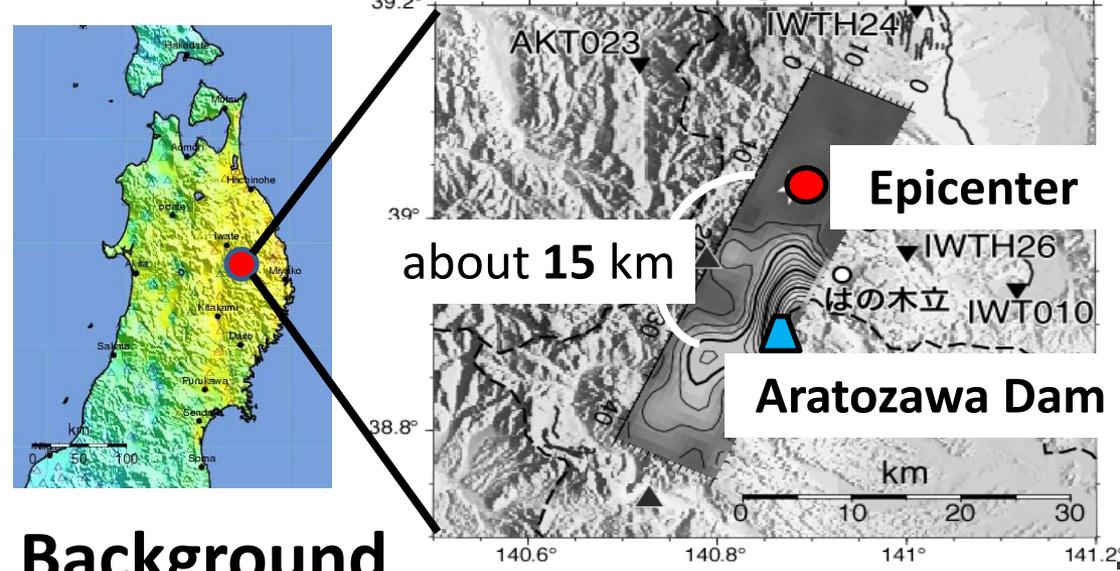
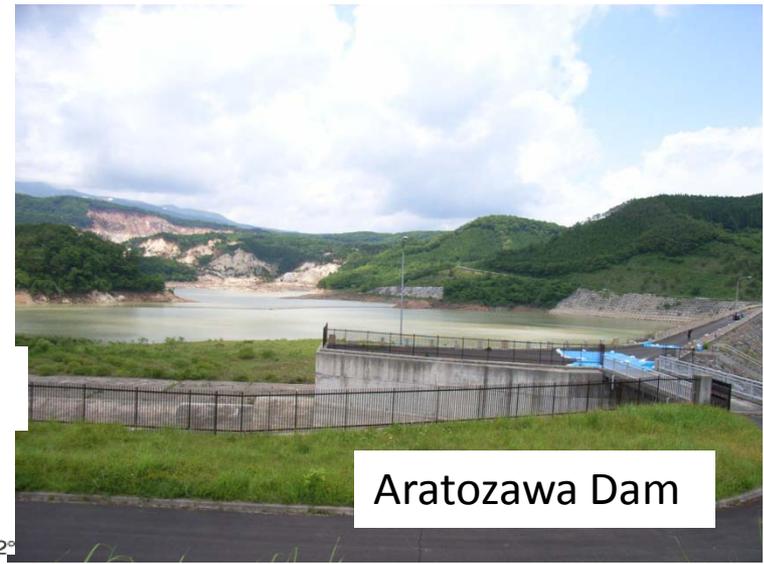
Aratozawa Dam

Constructed: 1994
Type: Center Clay-core Rock-fill Dam
Height: 74.4m

40cm settlement of the dam crest
Fortunately the dam escaped serious damage

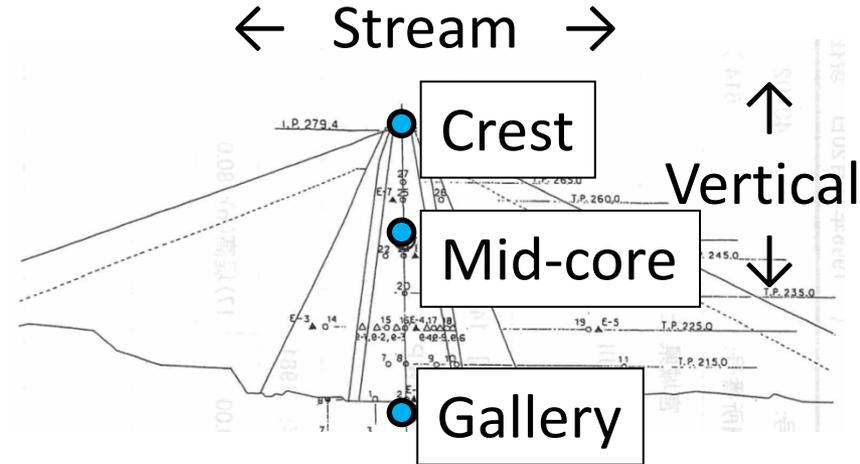
Peak Accelerations(gal)

Stream	Dam-axis	Vertical
Crest	525	535	622
Mid-core	535	478	470
Gallery	1024	899	691

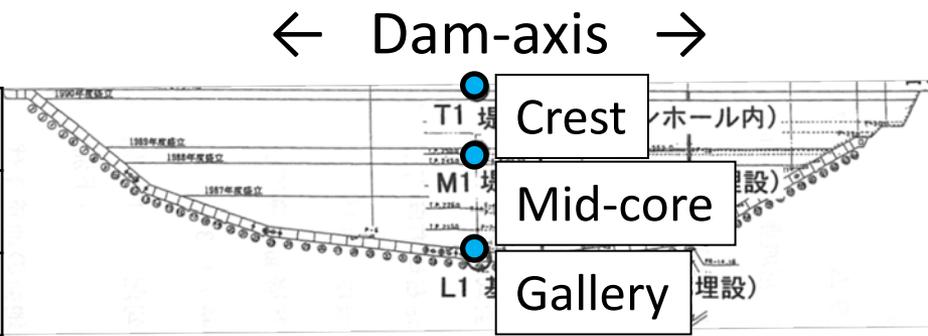
Transfer Functions of the dam

Transfer function between the gallery and crest (crest/gallery)

The peak period of the dam was 0.7sec/1.2 sec during the main shock and about 0.4sec in other smaller earthquakes.

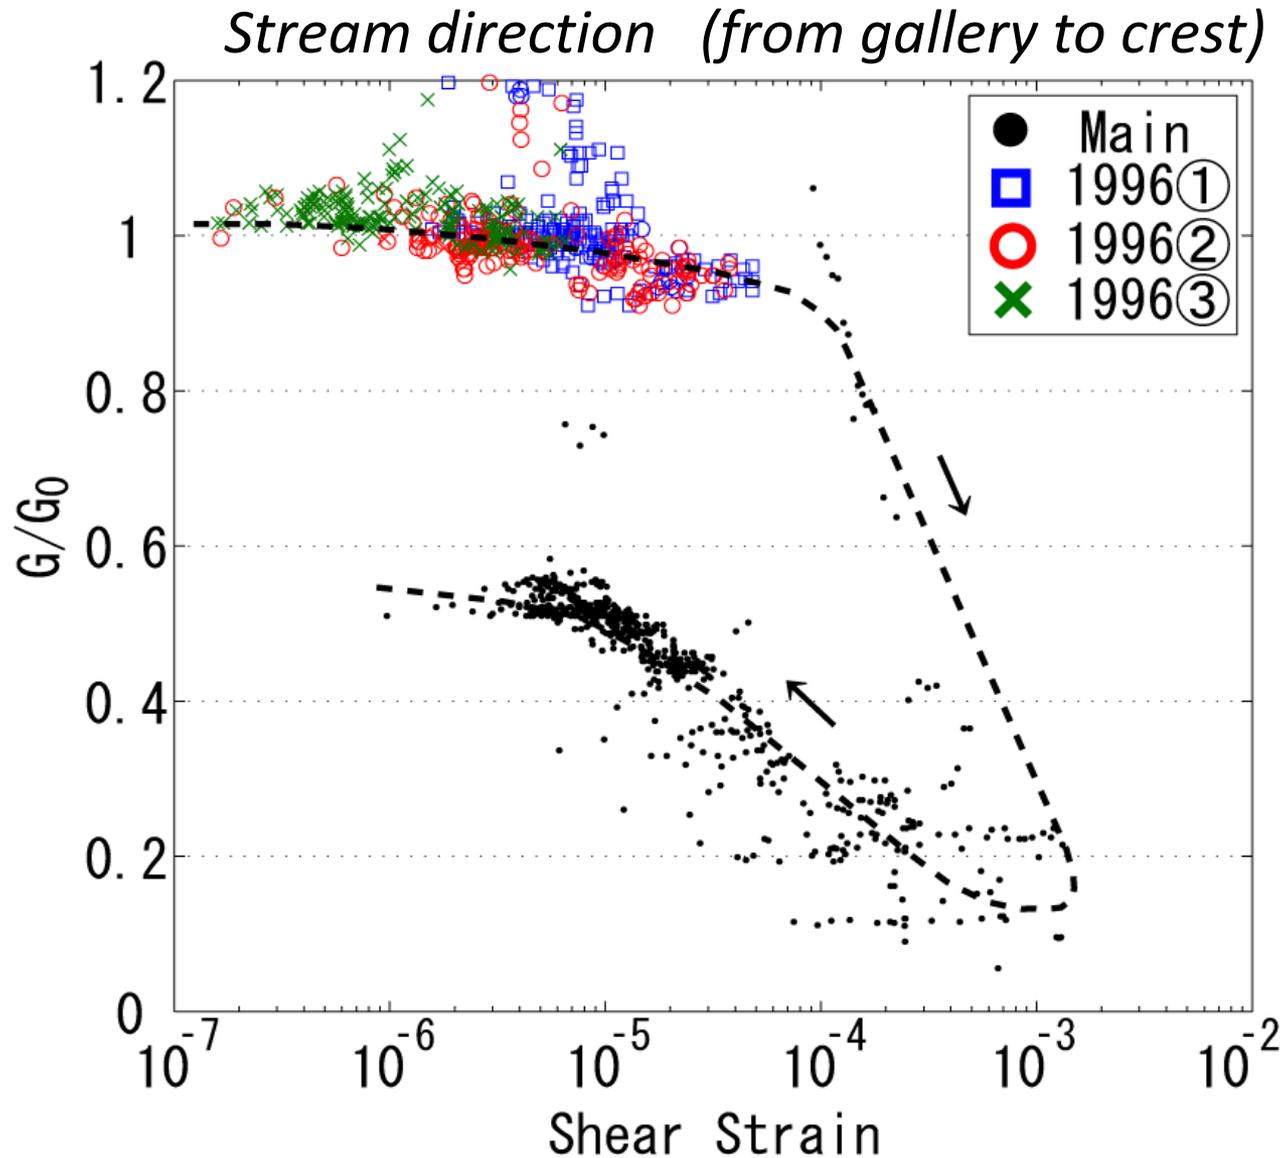
Shear Modulus vs. Shear Strain

This is evidently the nonlinear response of a rockfill dam.

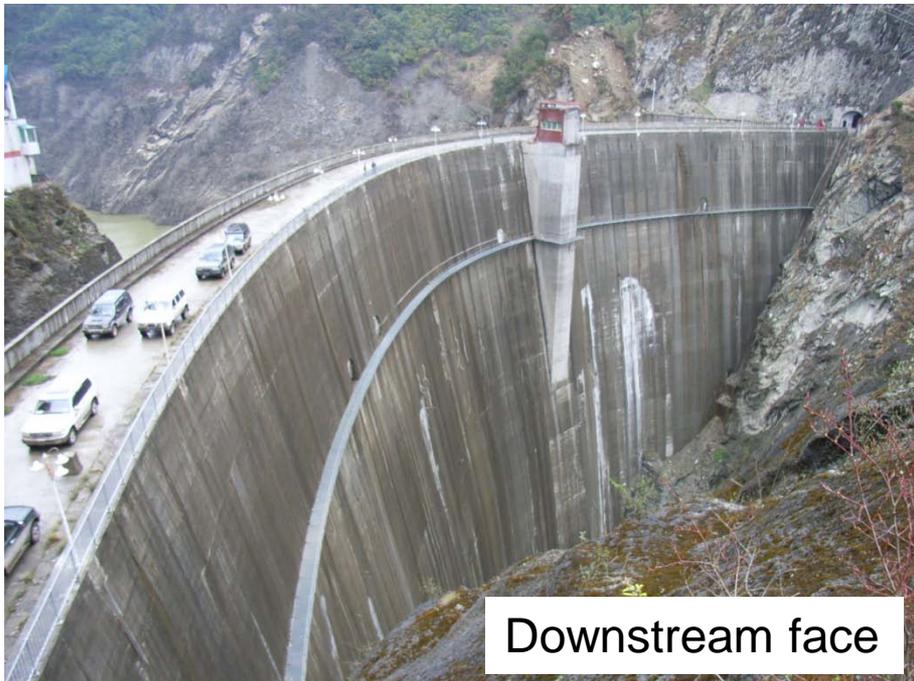
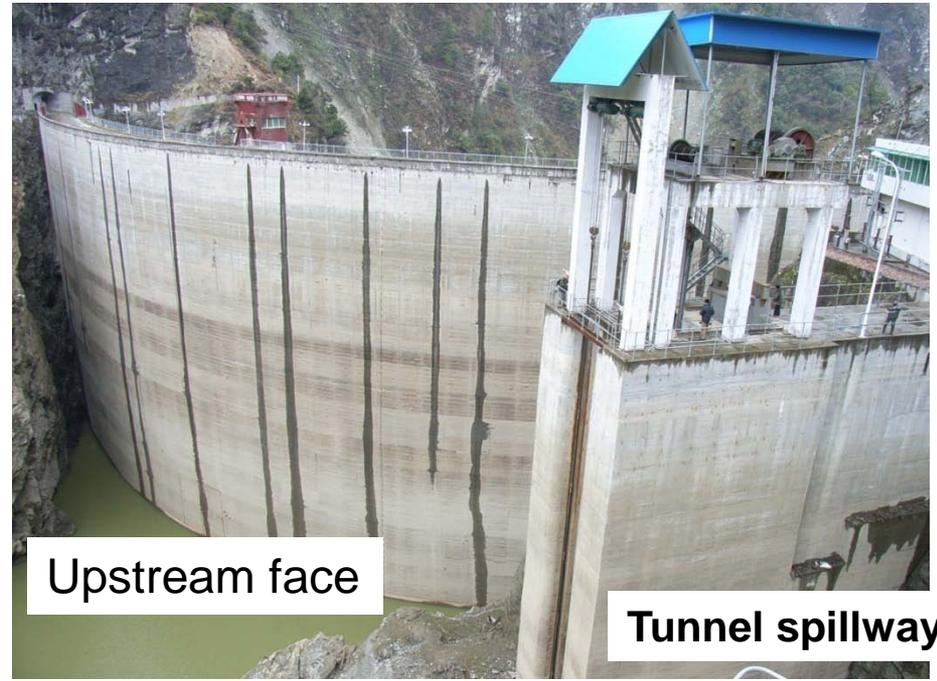
Shapai(沙牌) Dam:

RCC Arch dam
H=130m、L=250m
Constructed in 2003
Epicentral Dist. 30km

No damage to dam body,
but some damage to
spillway, elevator tower,
plumb line, etc. **Moreover,**
