Estimation of earthquake resistant and earthquake proof for distribution system on Hachinohe Regional Water Supply Authority

Noboru Murakami

Hachinohe Regional Water Supply Authority
(HRWSA)

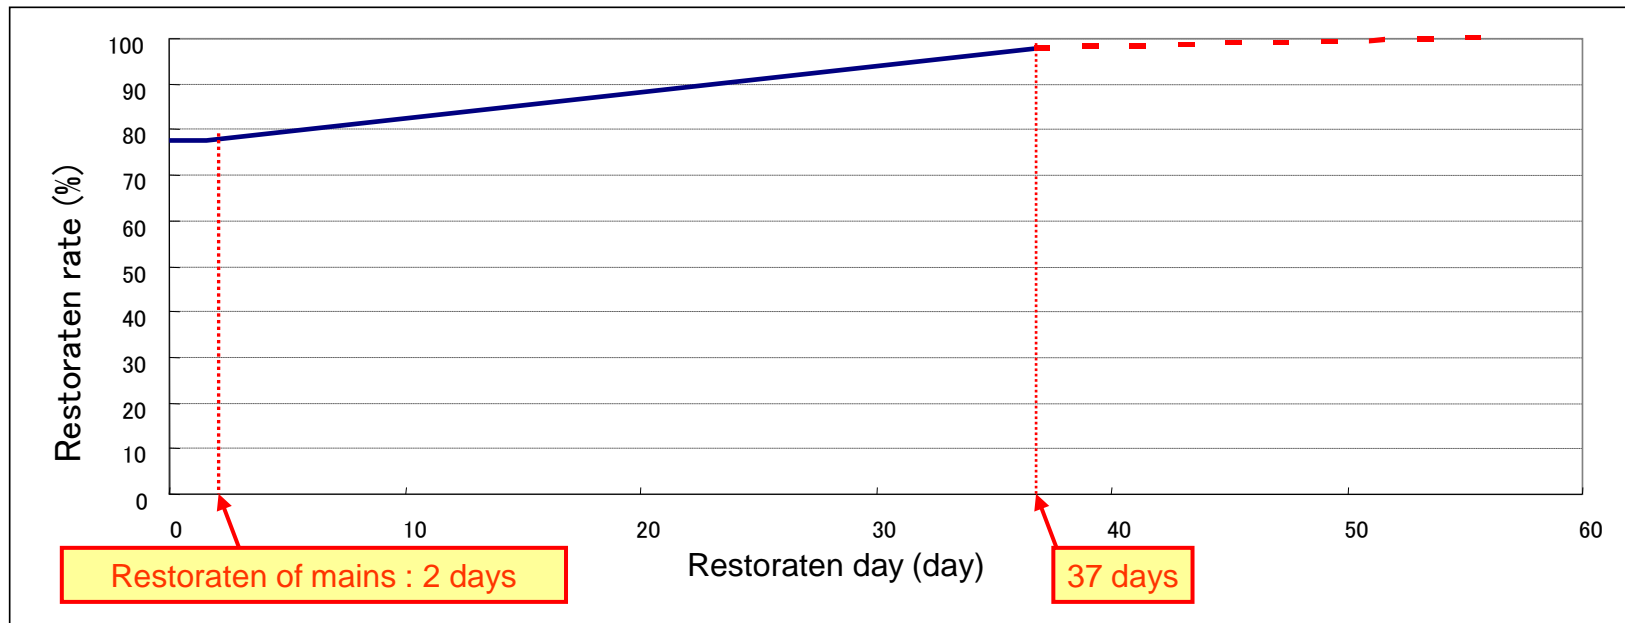
Water suspension ratio, population affected by water suspension and restoration day

- Water suspension ratio : **22.3%** (in water supply area)
- Population affected by water suspension : **74,200 people**
(in water supply area)
- Restoration day : **37 days** (Mains : **2 days**, Submains : **35 days**)

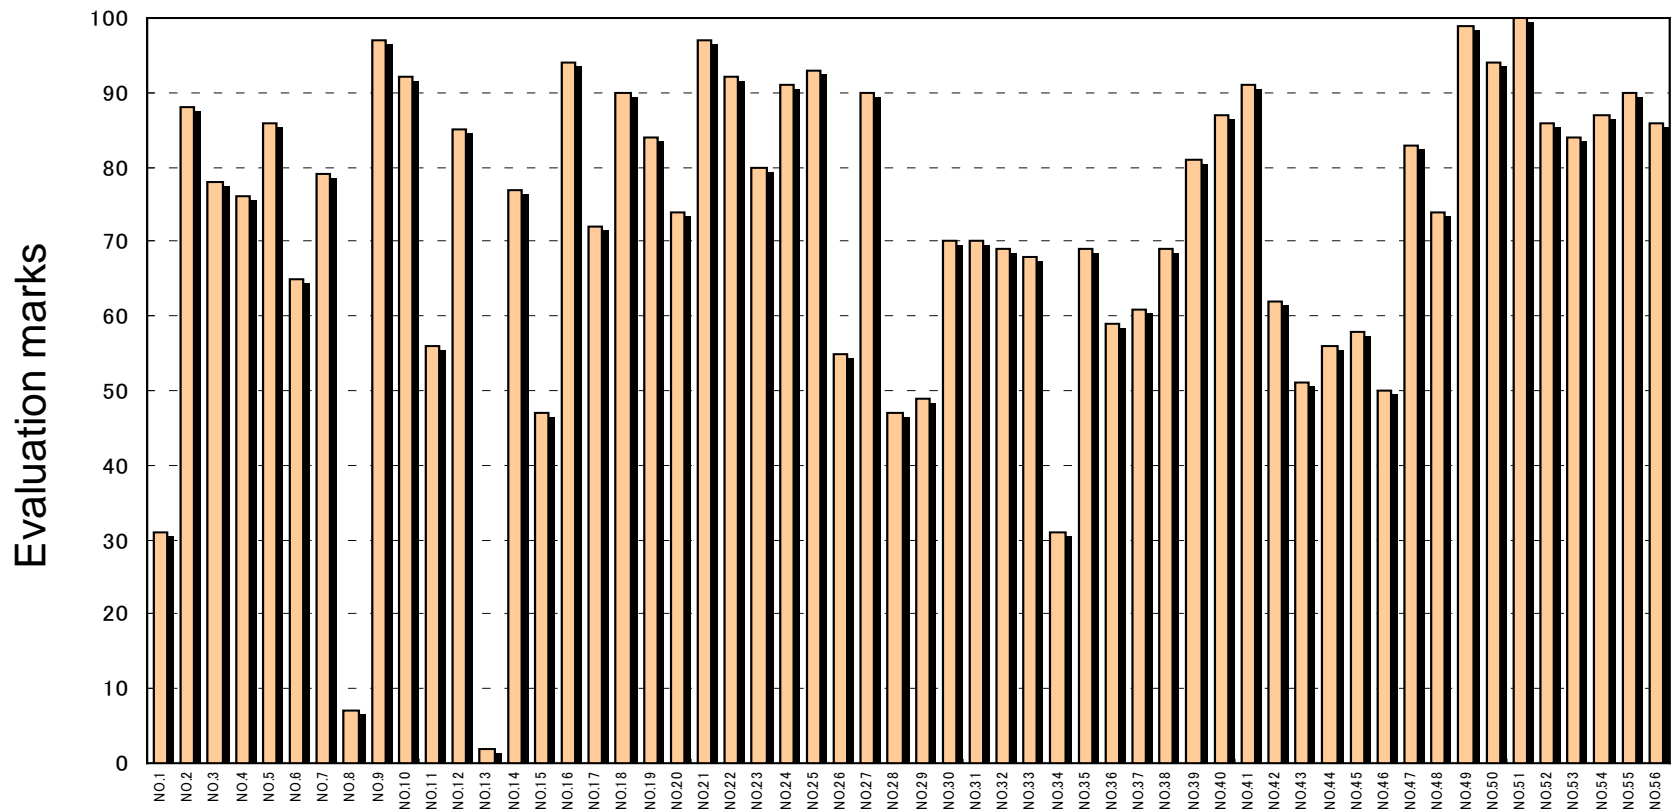
Evaluation of earthquake resistant

- Object items : water suspension ratio for Future Earthquake (%)
- Mark standard : water suspension ratio 100% = 1 point, 0%=100 points

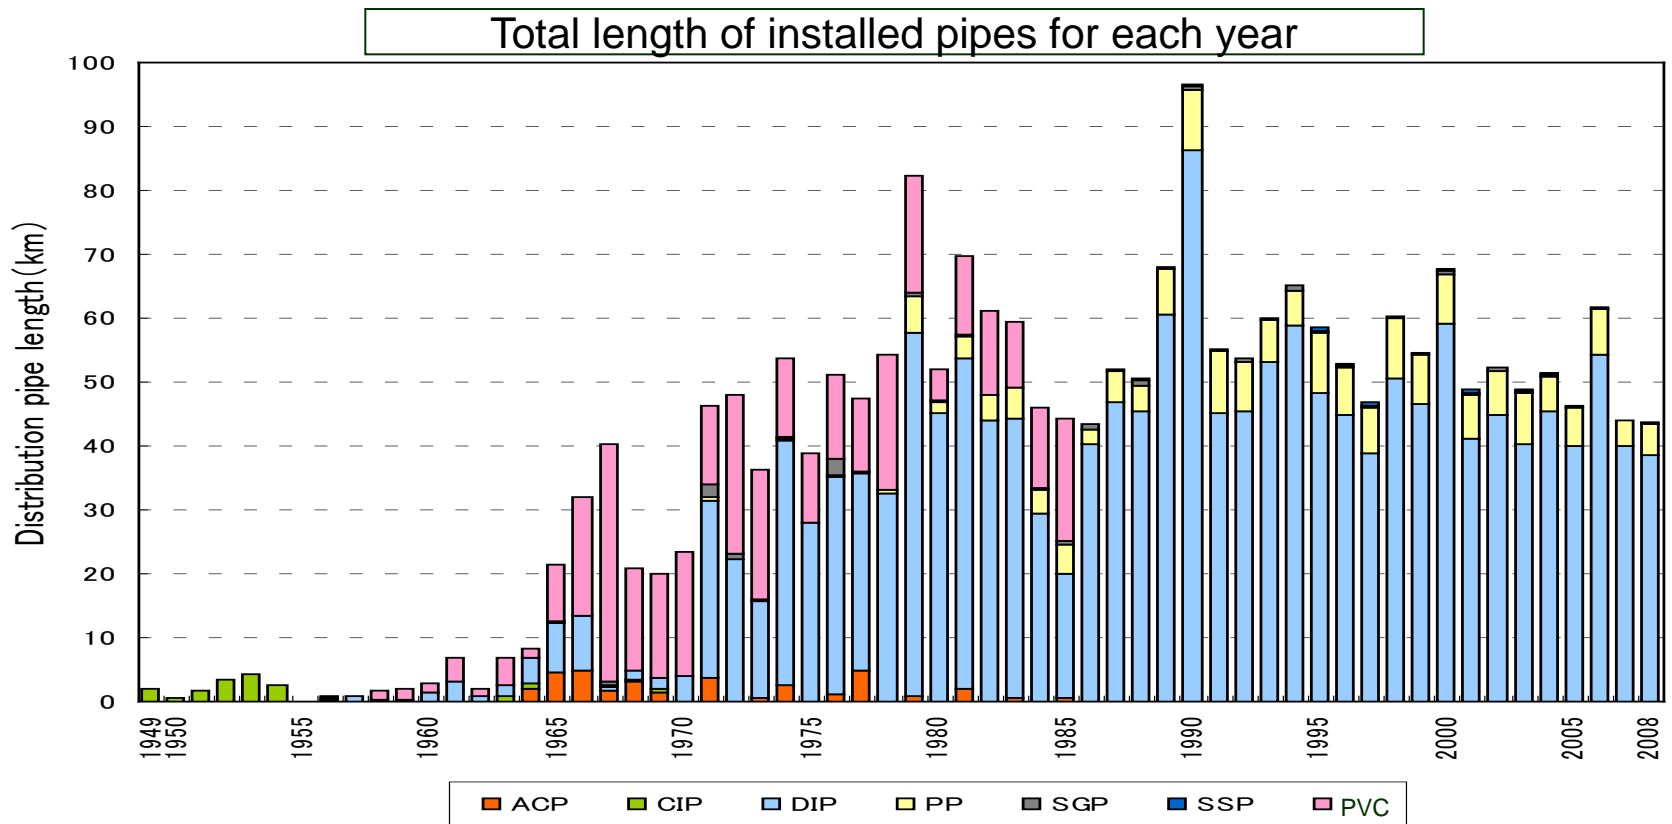
Results for Hachinohe-district distribution block

Present condition of distribution pipes (2,200km)

- DIP : 75% (1,650km)
- PVC : 16% (350km)
- PPφ50 : 7% (150km)
- Others : 2% (50km)
- Length of distribution pipes installed before 1969
(about 180km : 40 years passed in legal durability)

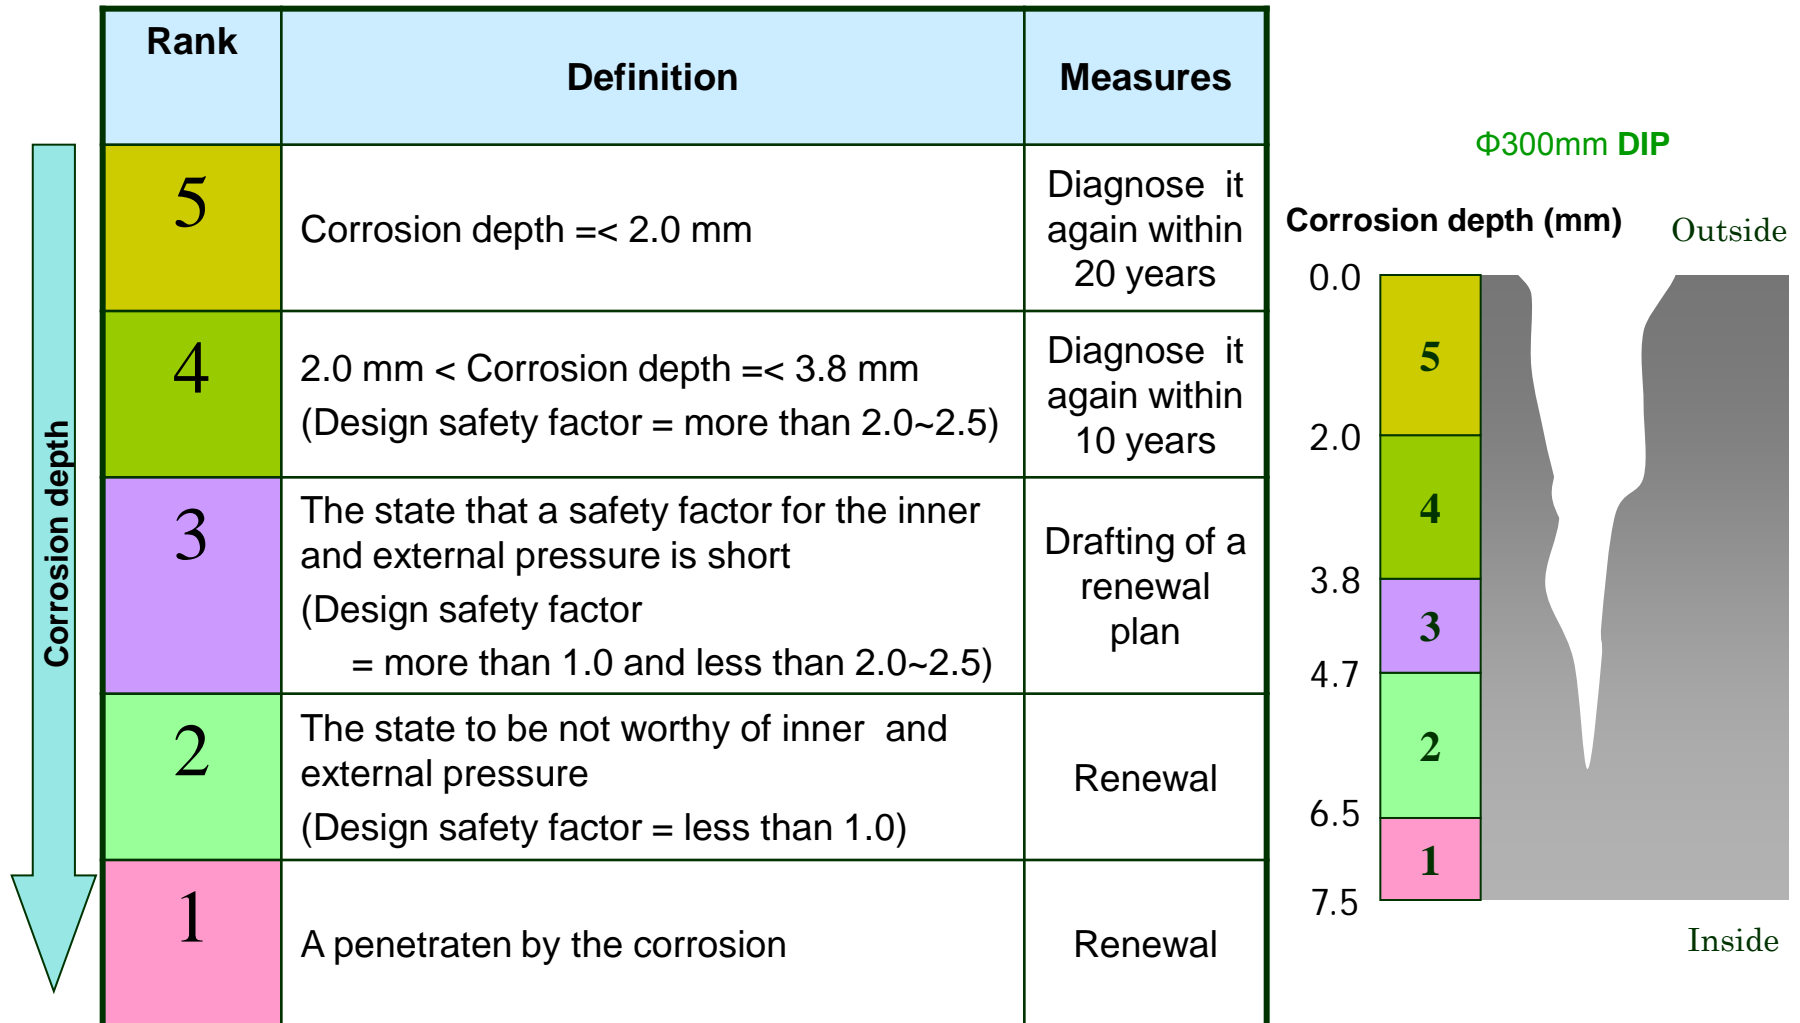
Judgment standard of corrosion depth

- 214 spots of corrosion on DIPs & CIPs without polyethylene sleeve were chosen and inspected.

Results of evaluation of corrosion ranks (DIP-CIP)

Length of distribution pipes
according to the corrosion ranks

Rank	1	2	3	4	5
Pipe length (km)	0.0	2.7	25.9	600.0	73.5

Renewal (CIP)

Diagnose it again within 10 years

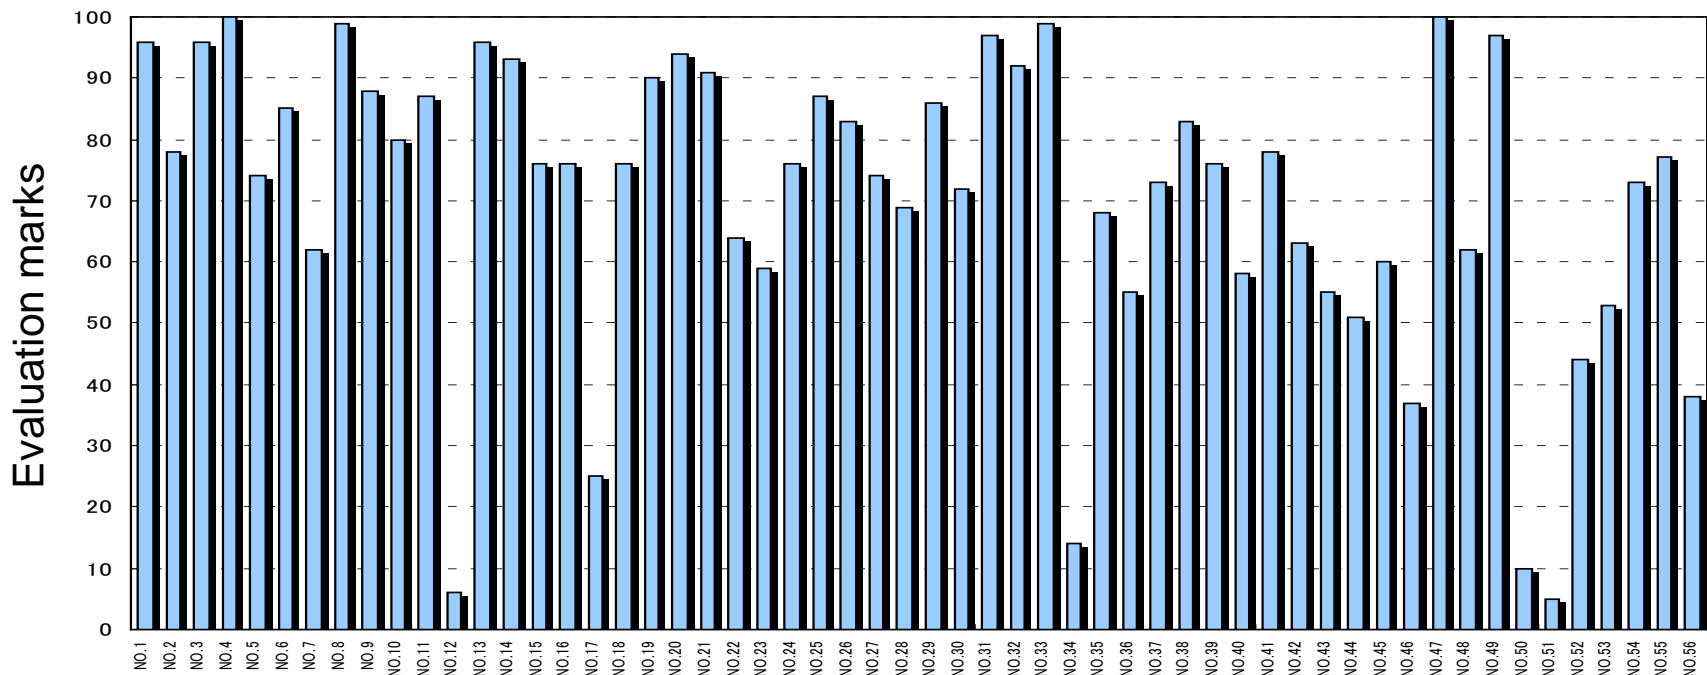
Results for Hachinohe-district distribution block

Evaluation of corrosion degrees

- Object items: 1) Corrosion ranks, 2) Break rate in normal conditions, 3) The number of years of installation
- Evaluation method : A geometric mean of the three object items
- Mark standard
 - 1) More than rank 4 (100 points), Less than rank 2 (1 point)
 - 2) More than 0.003 breaks / km (100 points), Less than 0.4 breaks / km (1 point)
 - 3) Less than 40 years (100 points), More than 55 years (1 point)
