Replacement of Ductile Iron Pipes in Early Days

The 6th Taiwan-US-Japan Workshop on Water System Seismic Practices October 15, 2009 TAIPEI

Kazuhiko Fujimura Tokyo Waterworks Service Co., Ltd., Japan (TSS)

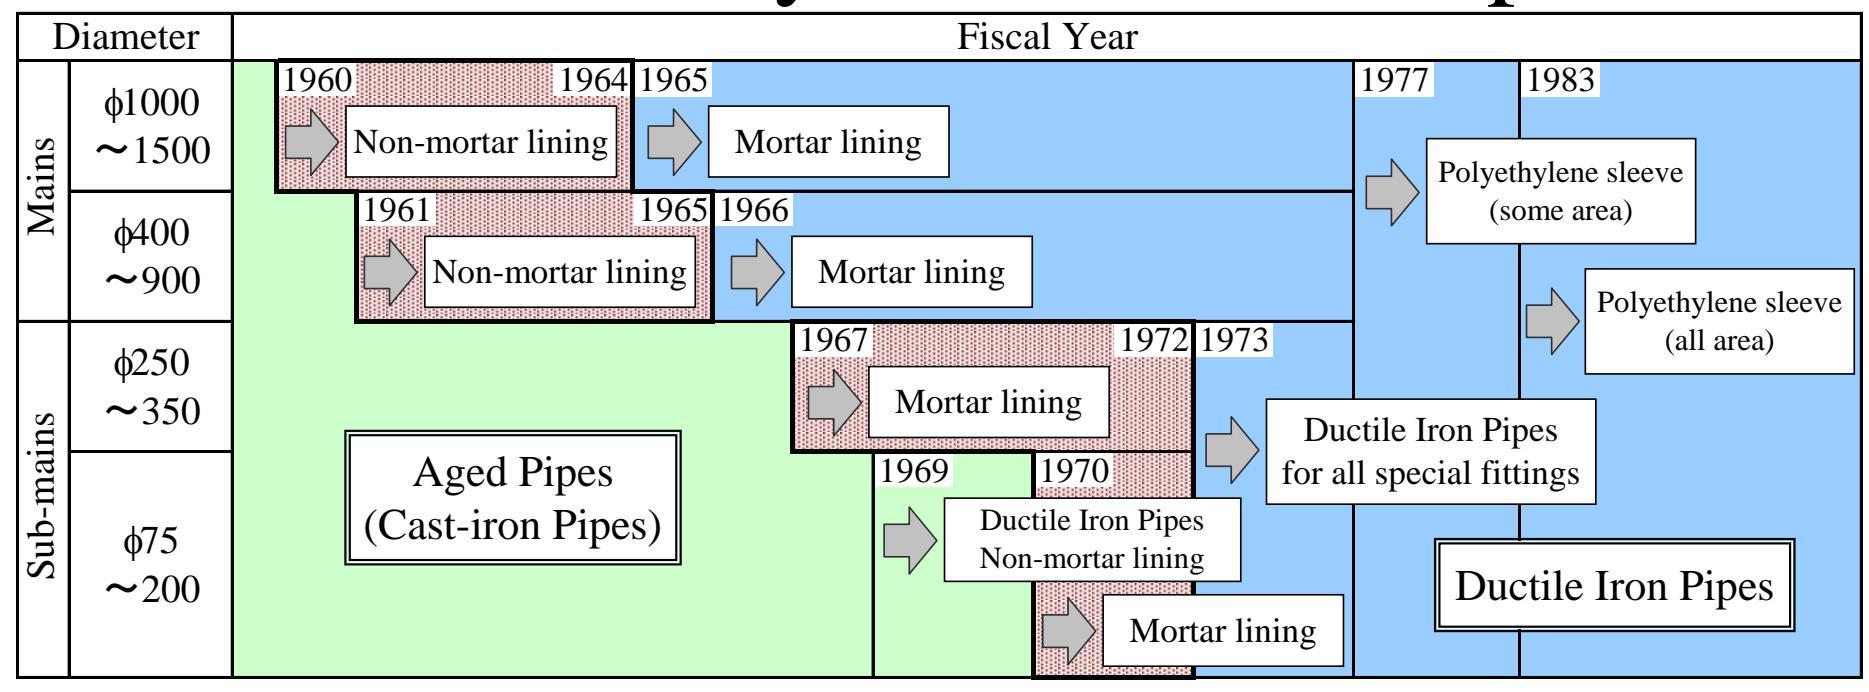
Early Ductile Iron Pipes

- Most special fittings are made of conventional cast-iron with lower strength and lower earthquake-resistance.
- No restraining function belongs to the joint.
- No mortar lining for corrosion-proof has been executed inside for several years since the beginning.
- No polyethylene sleeve for corrosion-proof.

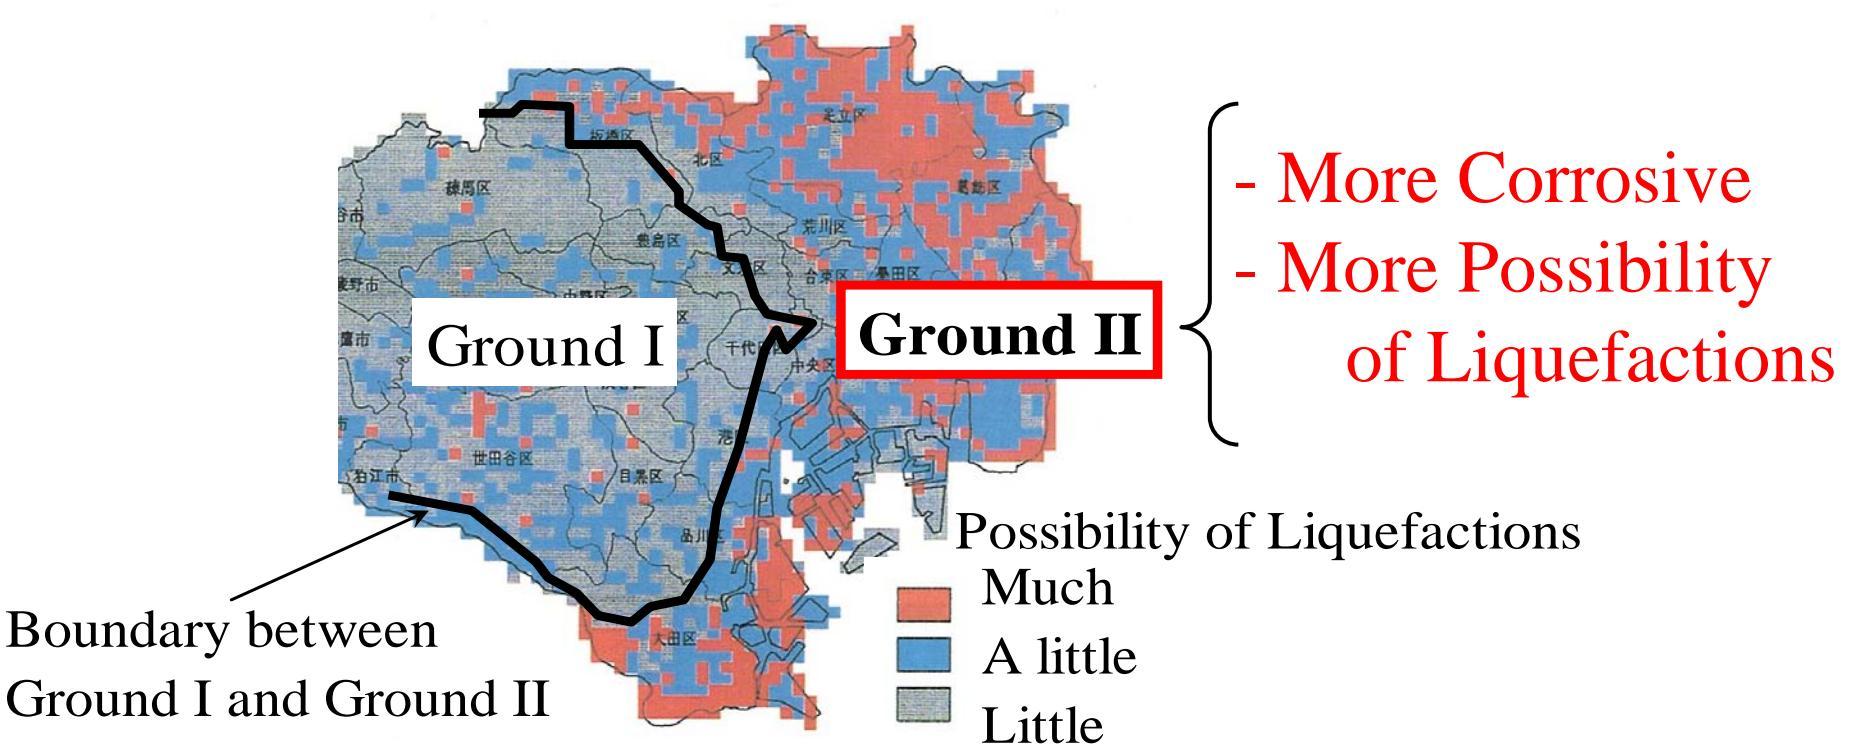
Result of Calculation of Laid Years which Come up to Respective Ranks

Diameter	Grou	ind I	Ground II		
(mm)	Rank IV	Rank V	Rank IV	Rank V	
75 - 400	48 years	65 years	39 years	52 years	
500 and over	over 65 years	over 82 years	over 52 years	over 67 years
